The Fire Resistance Performance of a Specimen of a Loadbearing Timber Floor Assembly Protected by a Plasterboard Ceiling Designed to Provide 60 minutes Fire Resistance, Incorporating Twenty Downlight Light Fittings, Tested in Accordance with BS 476: Part 21: 1987, Clause 7

371969B

**Integral LED**

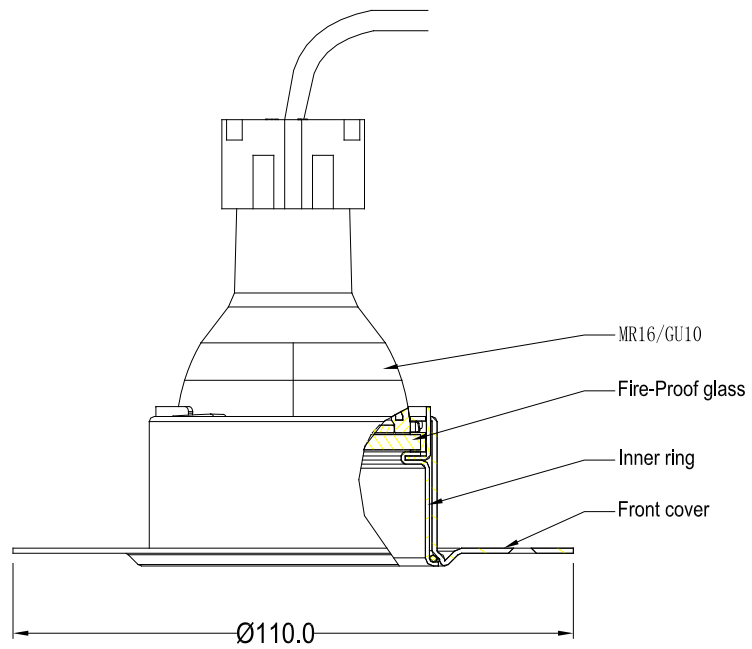
Figure 3 – Details of Downlighter Specimen A

Fixed  
ILD LFR60FXXX  
Cut out:  $\text{Ø}60$

i. front cover	: Steel
ii. inner ring	: Steel
iii. spring	: Stainless steel
iv. diffuser	: Pyrex glass
Overall dimensions and construction	: See Figures 3 to 7.
Cut out size	: Varies see relevant figure.
Driver	: None
Lamp	: GU10/MR16

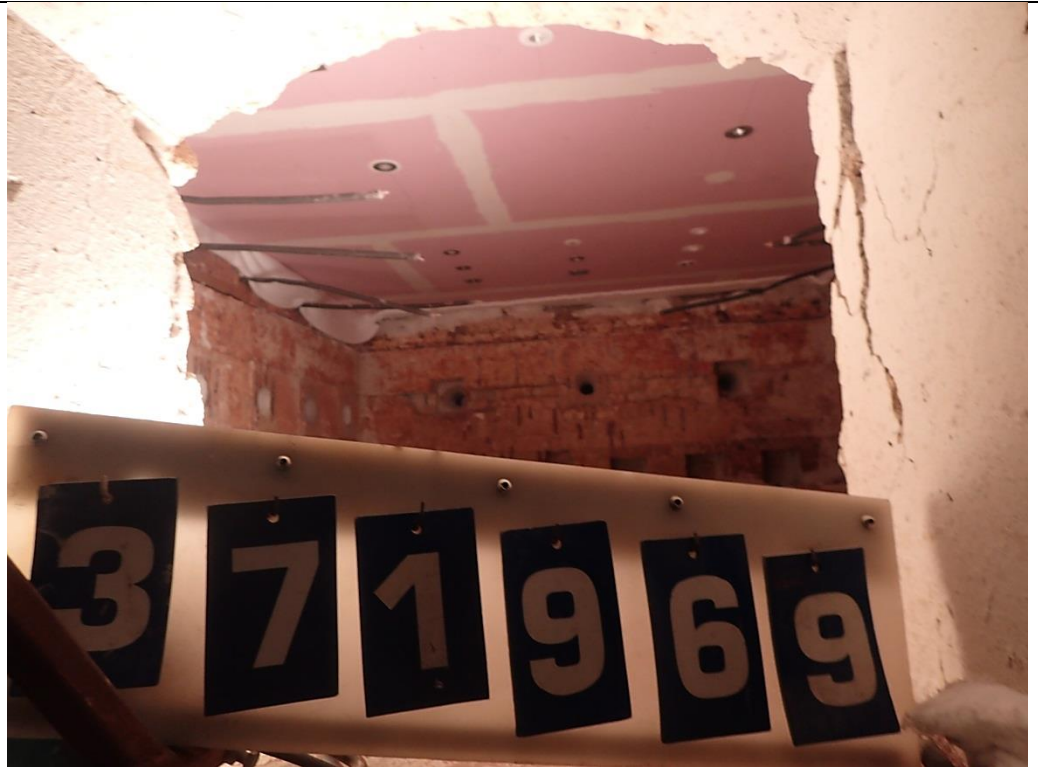
The exposed face of the assembly prior to testing

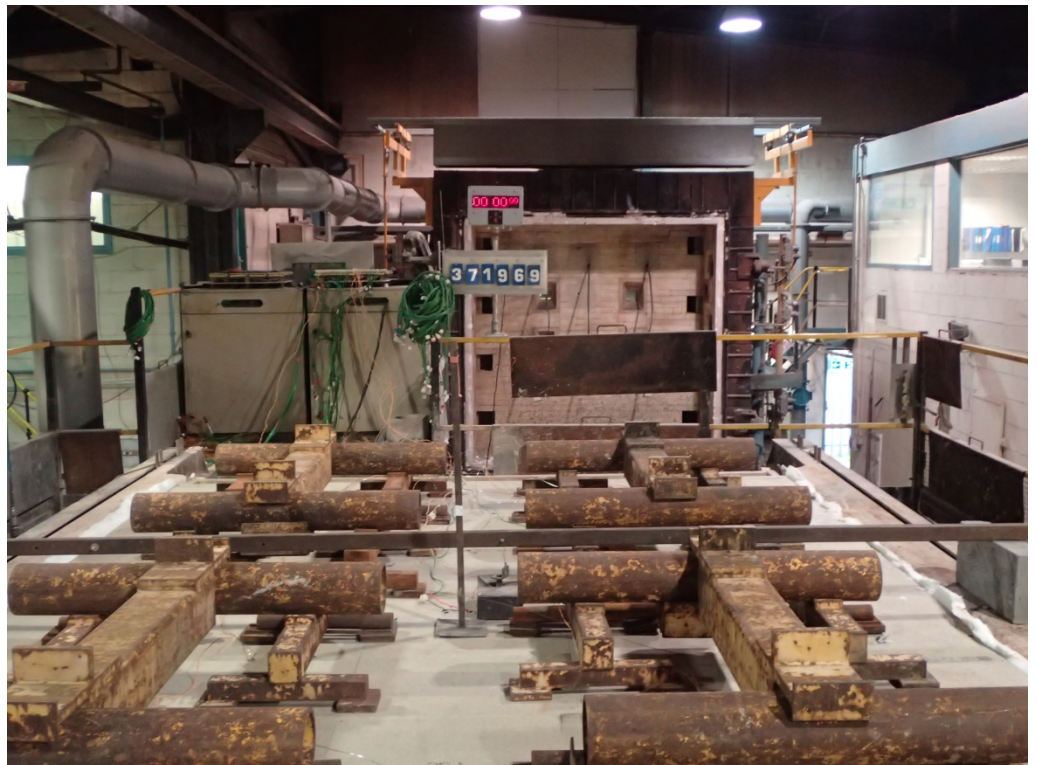
The unexposed face of the assembly after 10 minutes of testing

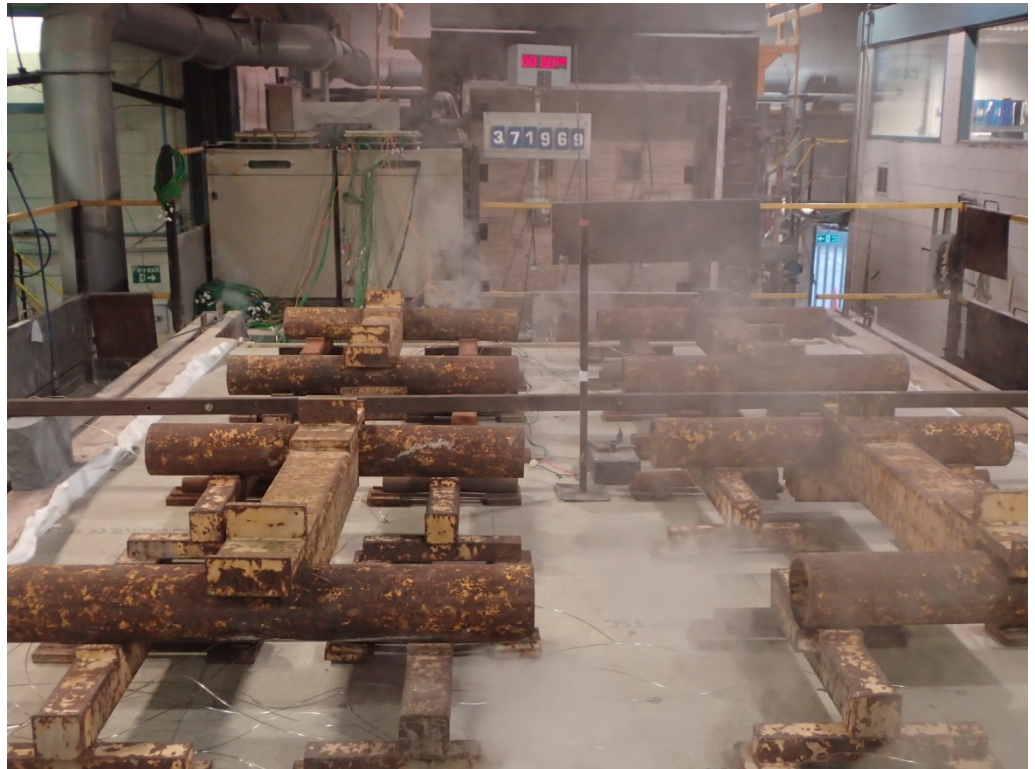
The unexposed face of the assembly after 20 minutes of testing

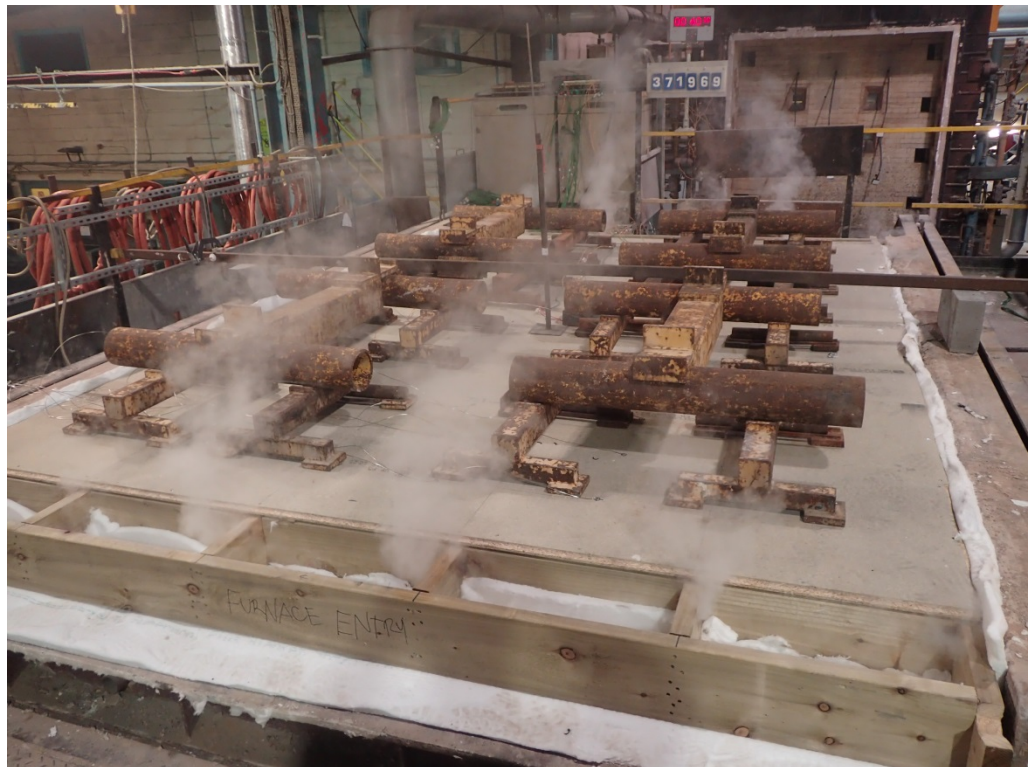
The unexposed face of the assembly after 40 minutes of testing

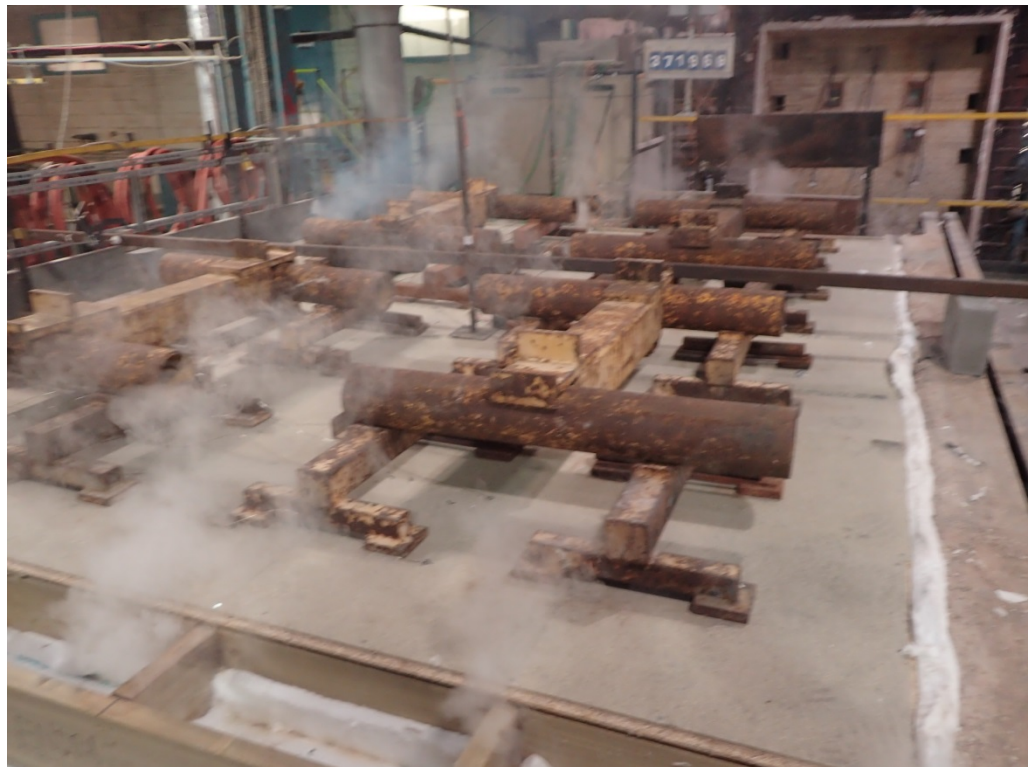
The unexposed face of the assembly after 60 minutes of testing

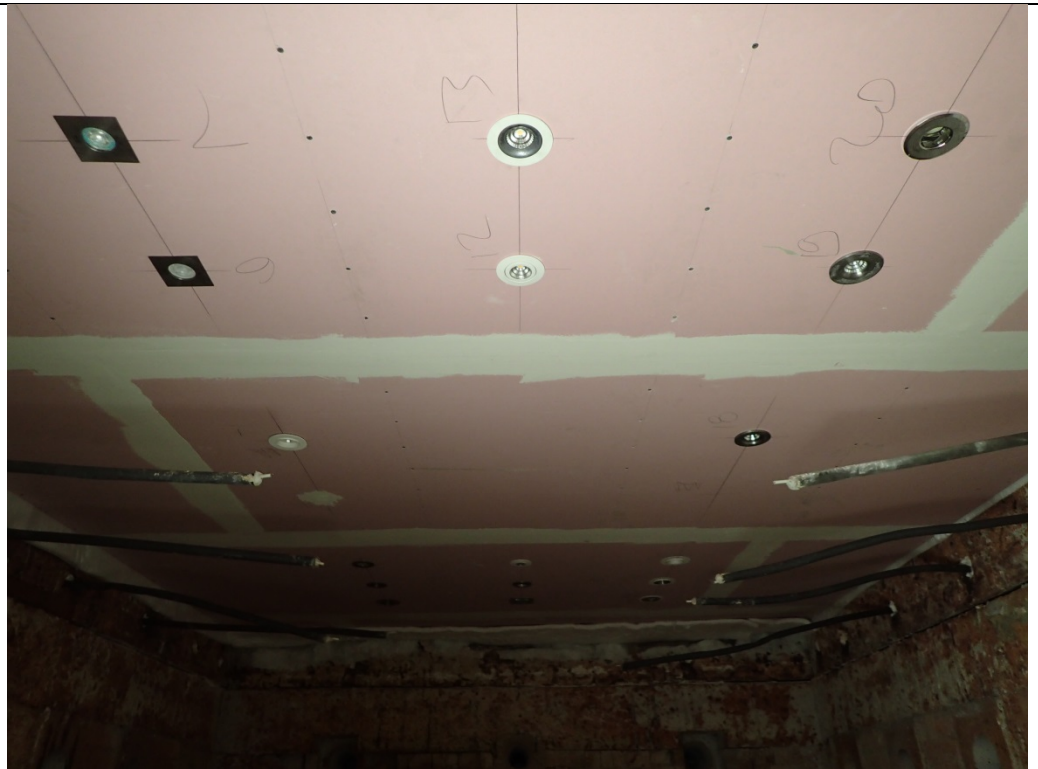
The exposed face of the assembly prior to testing

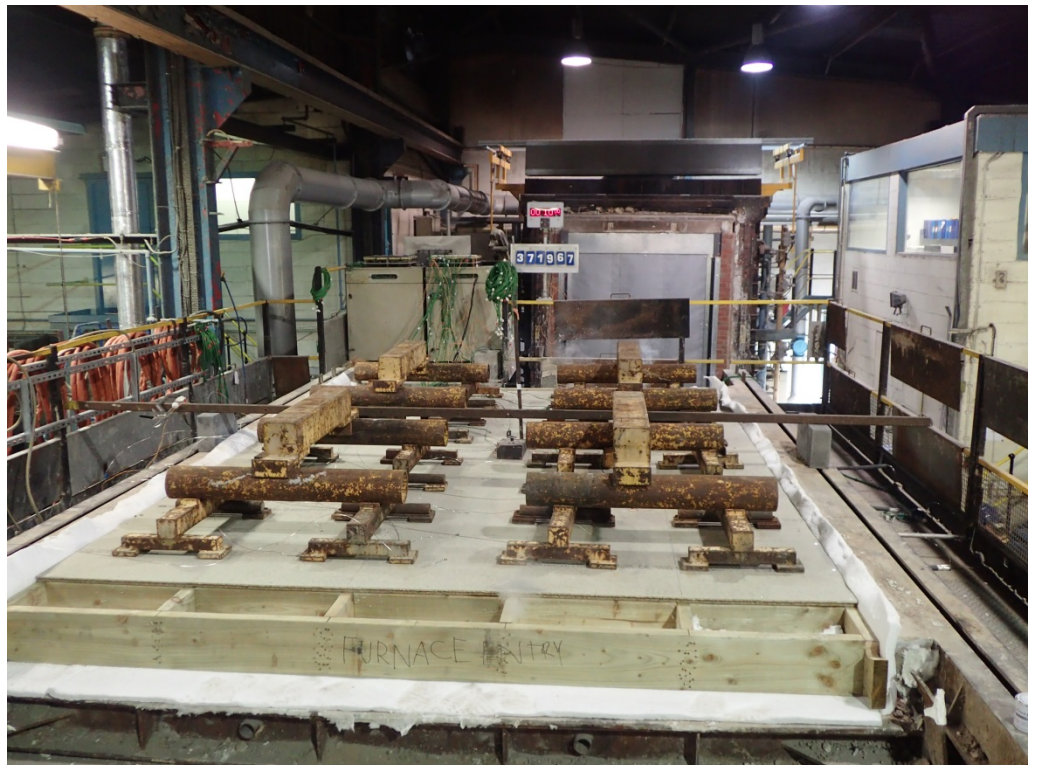
The unexposed face of the assembly after 10 minutes of testing

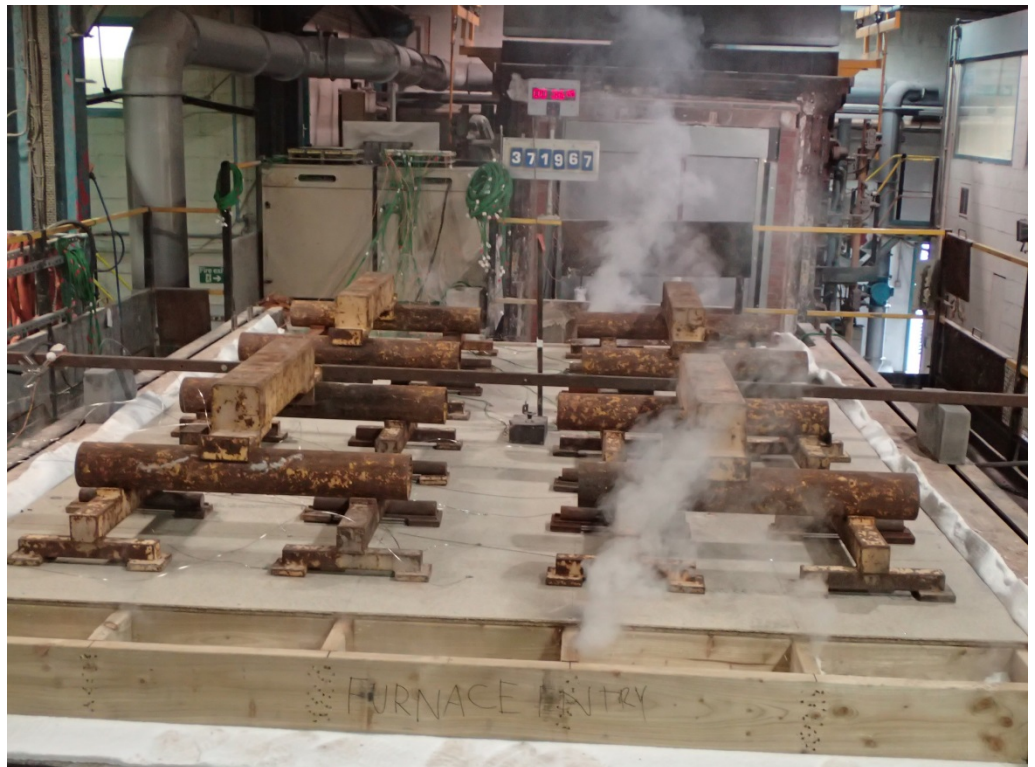
The unexposed face of the assembly after 36 minutes of testing

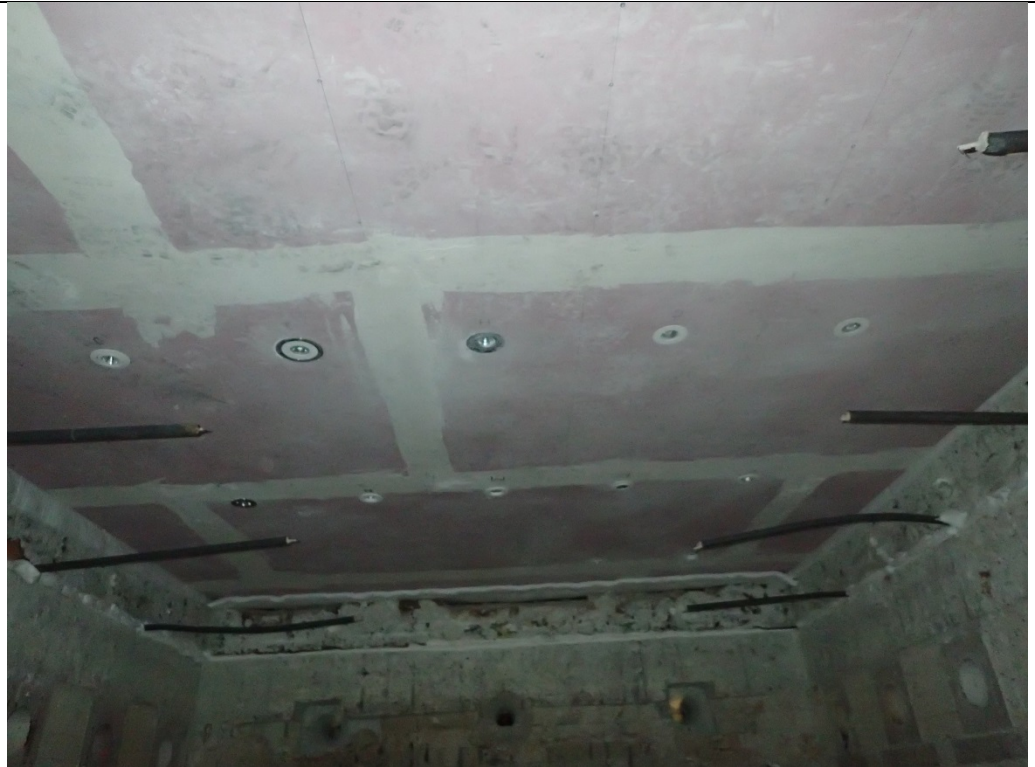
The exposed face of the assembly prior to testing

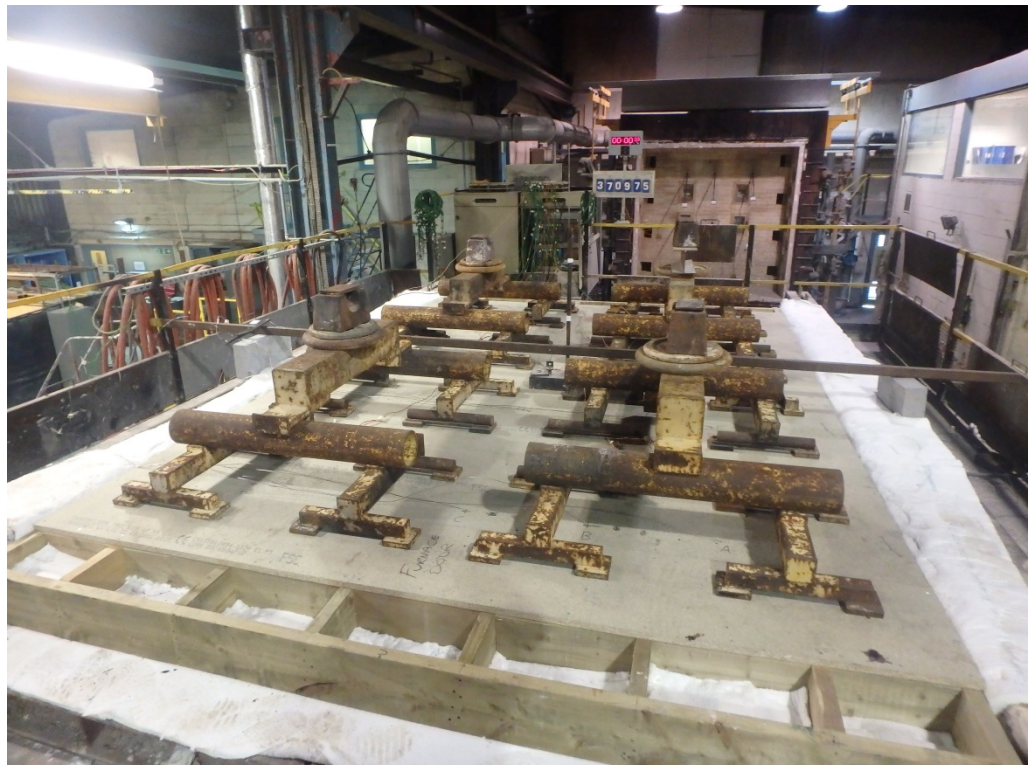
The unexposed face of the assembly prior to the start of the test

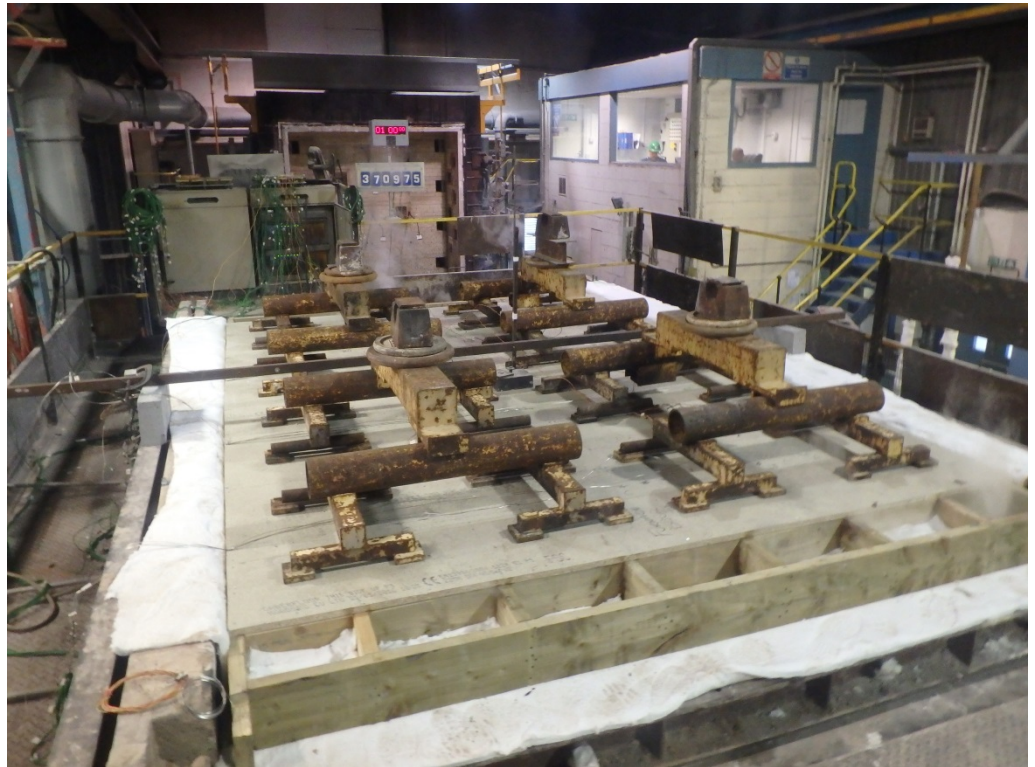
The unexposed face of the assembly after 60 minutes of testing

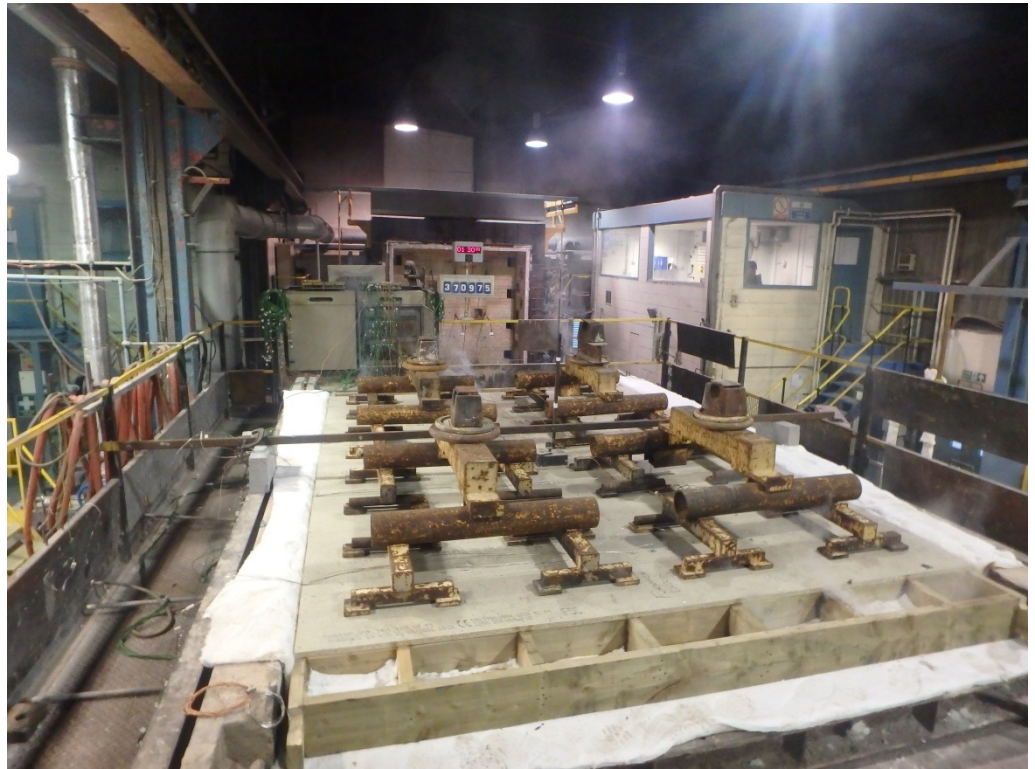
The unexposed  
face of the  
assembly after 90  
minutes of testing
