The Fire Resistance Performance of a Specimen of a Loadbearing Timber Floor Assembly Protected by a Plasterboard Ceiling Designed to Provide 60 minutes Fire Resistance, Incorporating Twenty Downlight Light Fittings, Tested in Accordance with BS 476: Part 21: 1987, Clause 7

371969B

**Integral LED**

**Objective** To determine the fire resistance performance of a loadbearing timber floor assembly protected by a plasterboard ceiling designed to provide 60 minutes fire resistance, incorporating twenty downlight light fittings, when tested in accordance with Clause 7 of BS 476: Part 21: 1987.

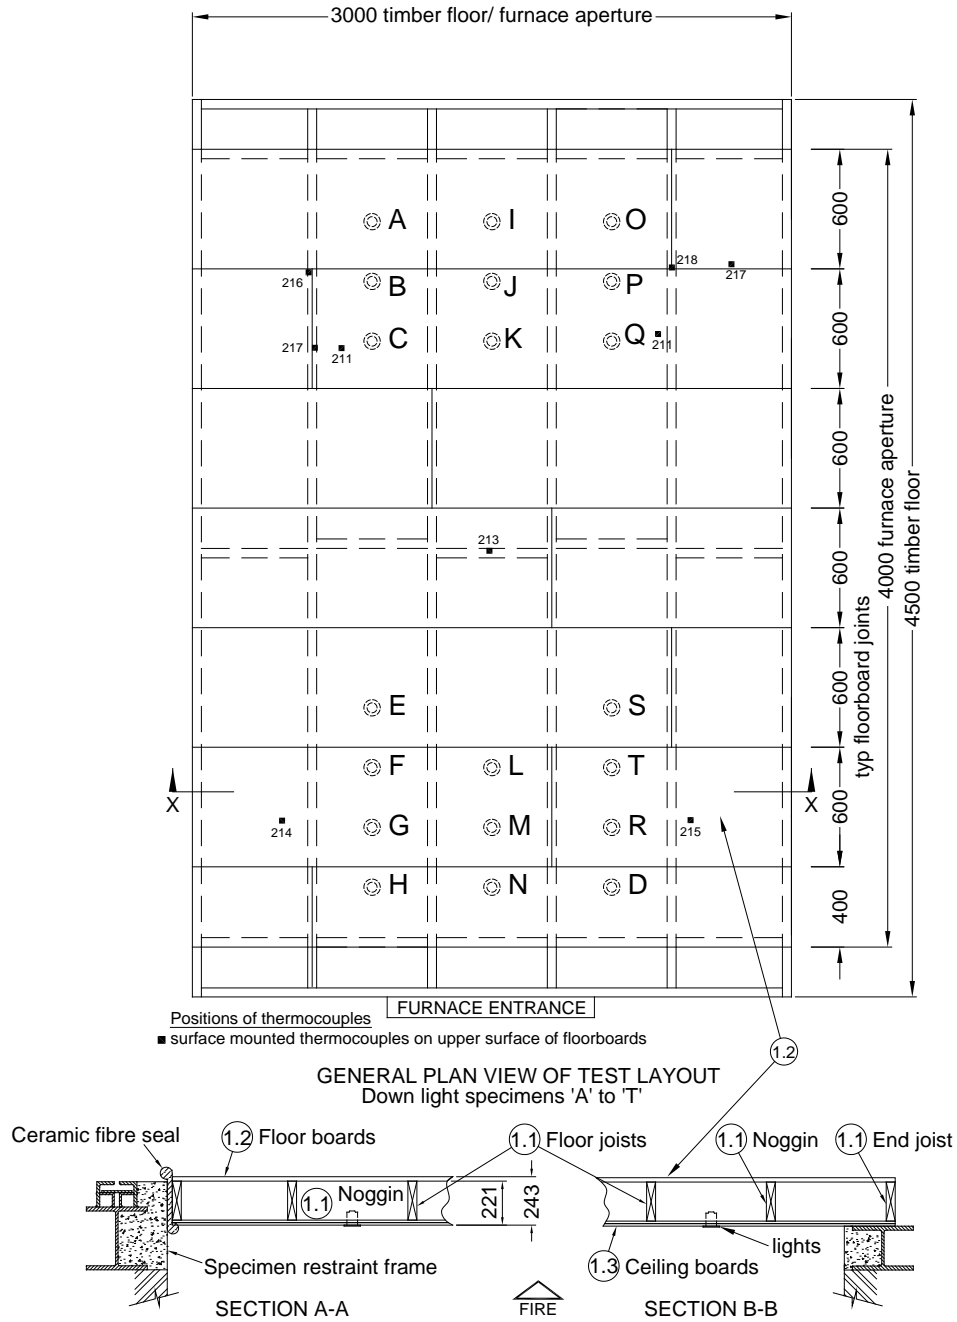
Figure 1- General Elevation of Test Specimens

**Summary of Tested Assembly** The timber floor had overall nominal dimensions of 4500 mm long by 3000 mm wide and comprised softwood timber joists at 600 mm centres. The upper surface of the floor comprised nominally 22 mm thick tongue and grooved chipboard flooring.

The floor assembly was protected on its underside by a direct fixed ceiling, formed from two layers of 12.5 mm thick British Gypsum Fireline plasterboard, both layers were screw fixed to the underside of the floor joists.

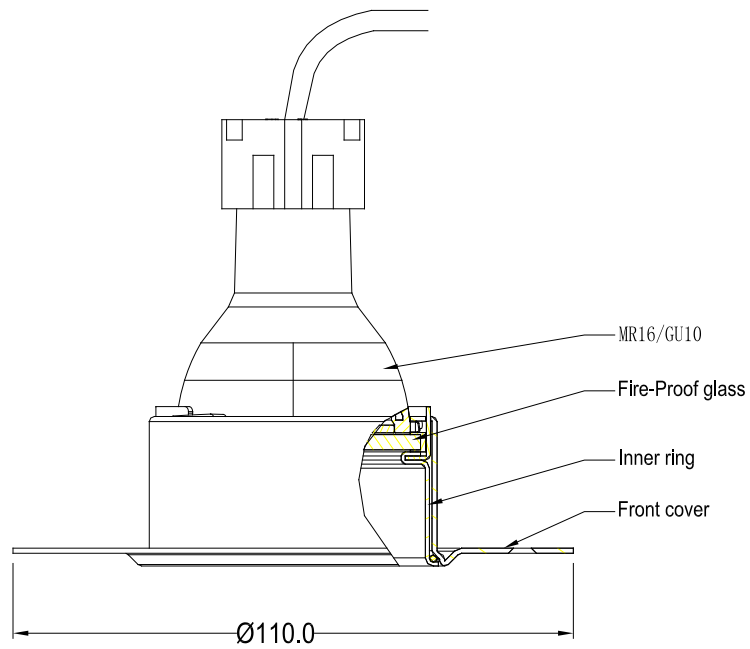
Figure 3 – Details of Downlighter Specimen A

Fixed  
ILD LFR60FXXX  
Cut out:  $\text{Ø}60$

i. front cover	: Steel
ii. inner ring	: Steel
iii. spring	: Stainless steel
iv. diffuser	: Pyrex glass
Overall dimensions and construction	: See Figures 3 to 7.
Cut out size	: Varies see relevant figure.
Driver	: None
Lamp	: GU10/MR16

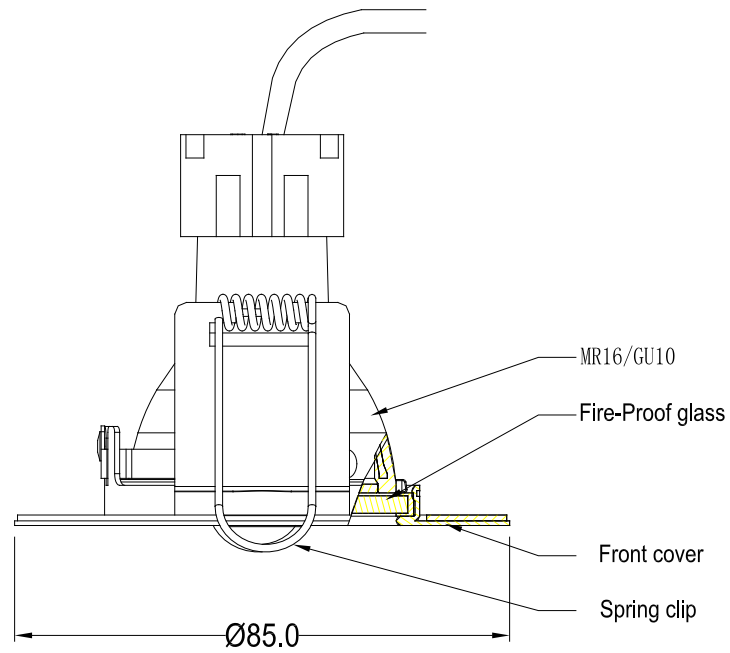
Figure 6 – Details of Downlighter Specimen D

Fixed  
ILD LFR70DXXX  
Cut out:  $\text{Ø}70$

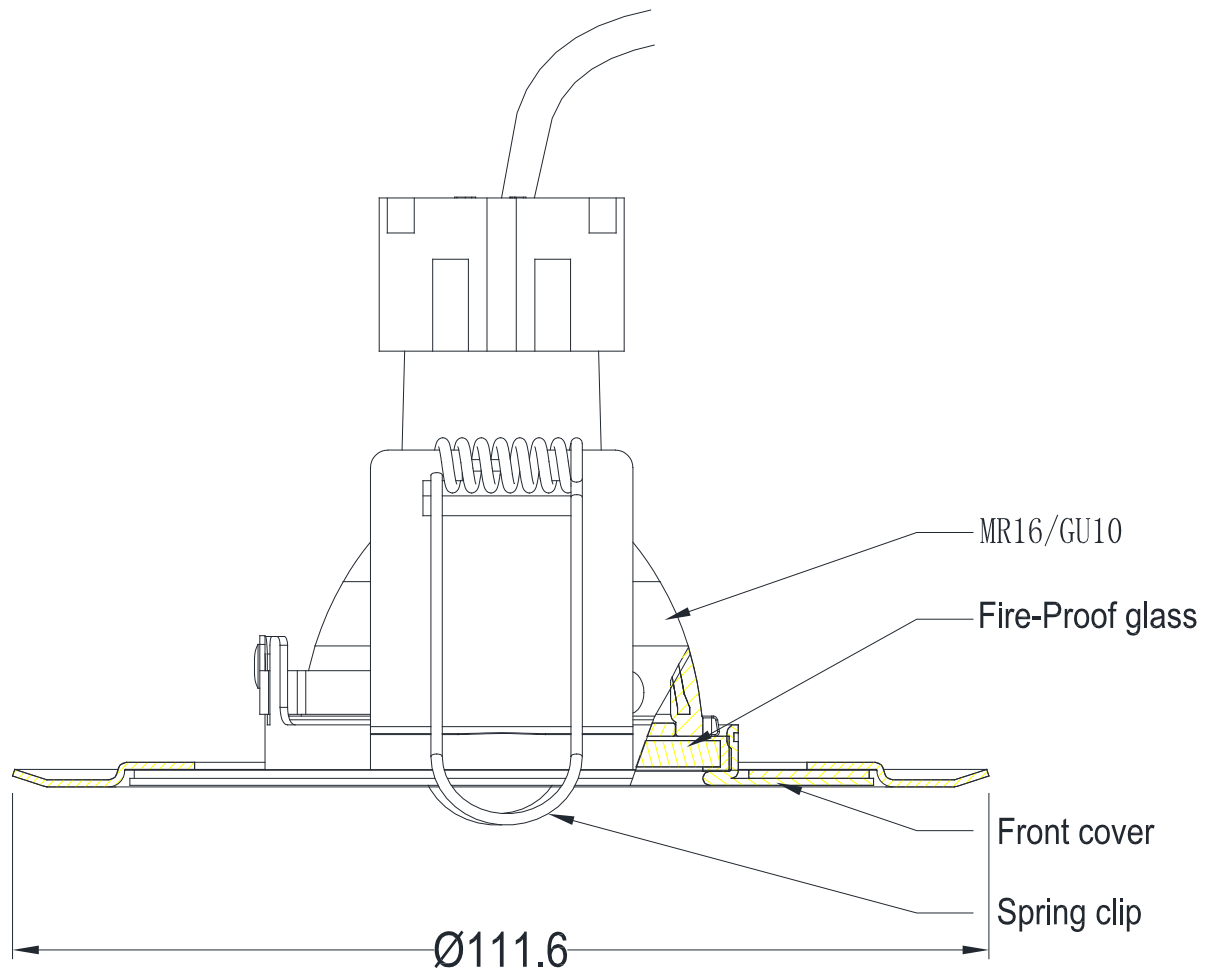
Figure 7 – Details of Downlighter Specimen E

Fixed  
ILD LFR70DXXX  
accessory of Slim Fire  
Cut out:  $\text{Ø}100\text{mm}$

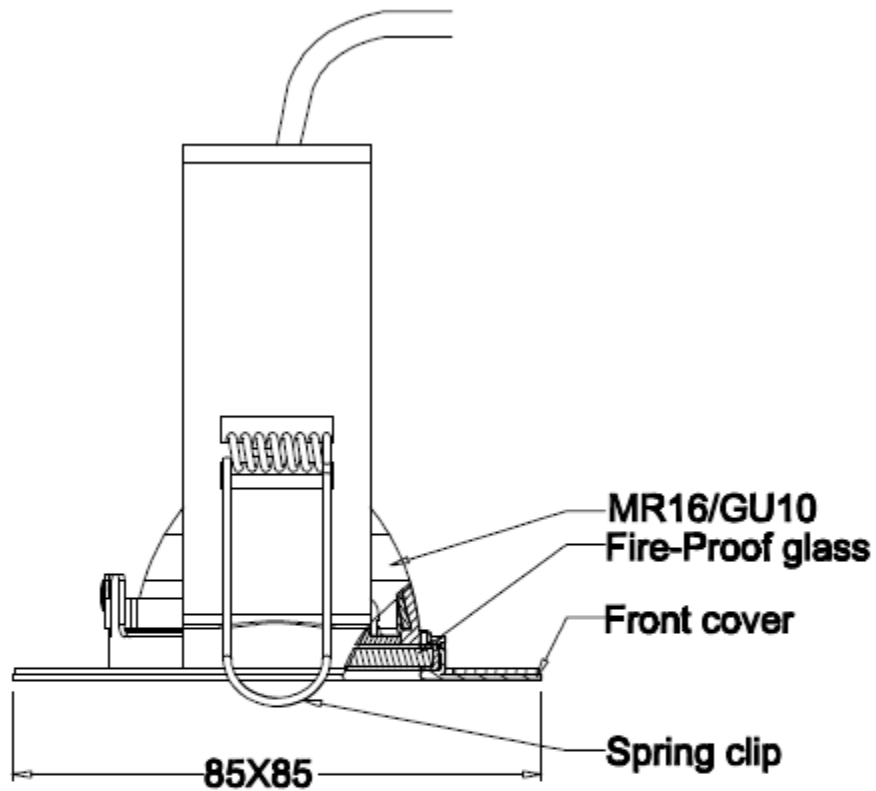
**Figure 9 – Details of Downlighter Specimen G**

**Fixed model  
ILD LFR70DXXX  
Slim fire square bezel with bracket  
Cut out: Ø70mm**

<b><u>Item</u></b>	<b><u>Description</u></b>
<b>3. Specimen F, G, H, I</b>	
Manufacturer	: Integral LED
Type	: Square, fixed, LED recessed downlight
Reference	: See Figures 8 to 11.
Materials	
i. front cover	: Steel
ii. spring	: Stainless steel
iii. diffuser	: Pyrex glass
Overall dimensions and construction	: Please see Figures 8 to 11
Cut out size	: Various see relevant figures
Driver	: None
Lamp	: GU10/MR16
<b>4. Specimen J</b>	: Specimen reported separately
<b>5. Specimen K, L</b>	: Specimens reported separately
<b>6. Specimen M, N</b>	: Specimens reported separately
<b>7. Specimens O</b>	: Specimen reported separately
<b>8. Specimens P</b>	: Specimen reported separately
<b>9. Specimen Q</b>	: Specimen reported separately
<b>10. Specimens R, S</b>	: Specimens reported separately
<b>11. Specimen T</b>	: Specimen reported separately

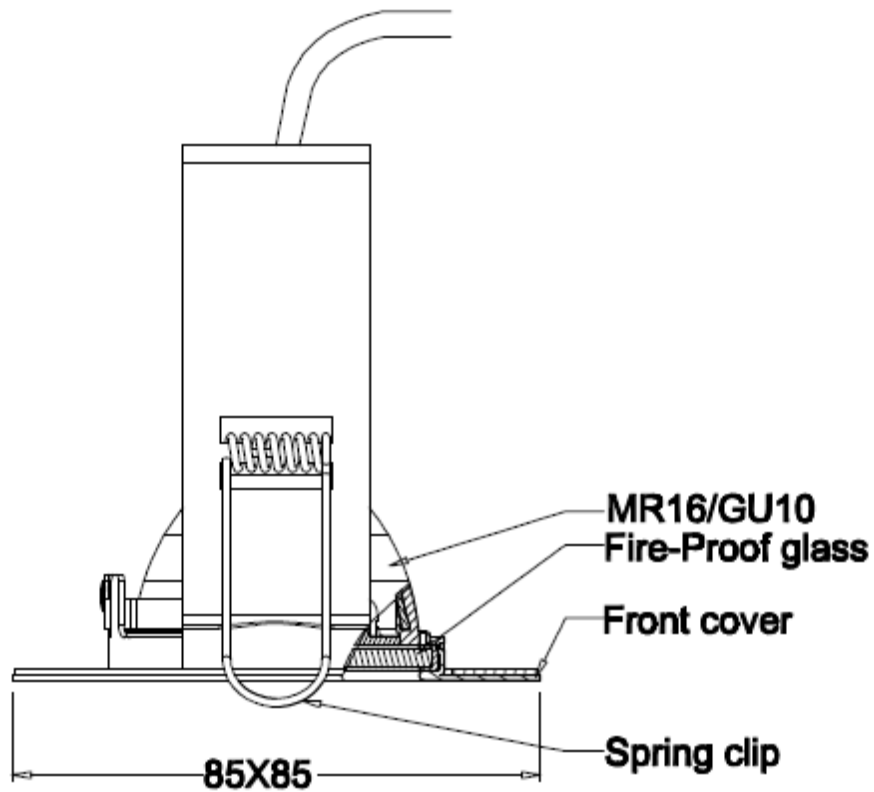
Figure 9 – Details of Downlighters Specimen G

**Fixed model  
ILD LFR70DXXX  
Slim fire square bezel with bracket  
Cut out: Ø70mm**

<b><u>Item</u></b>	<b><u>Description</u></b>
<b>3. Specimen F, G, H, I</b>	
Manufacturer	: Integral LED
Type	: Square, fixed, LED recessed downlight
Reference	: See Figs 8 to 11.
Materials	
i. front cover	: Steel
ii. spring	: Stainless steel
iii. diffuser	: Pyrex glass
Overall dimensions and construction	: Please see Figs. 8 to 11
Cut out size	: Various see relevant figures
Driver	: None
Lamp	: GU10/MR16
<b>4. Specimen J</b>	: Specimen reported separately
<b>5. Specimen K, L</b>	: Specimens reported separately
<b>6. Specimen M, N</b>	: Specimens reported separately
<b>7. Specimens O</b>	: Specimen reported separately
<b>8. Specimens P</b>	: Specimen reported separately
<b>9. Specimen Q</b>	: Specimen reported separately
<b>10. Specimens R, S</b>	: Specimens reported separately
<b>11. Specimen T</b>	: Specimen reported separately

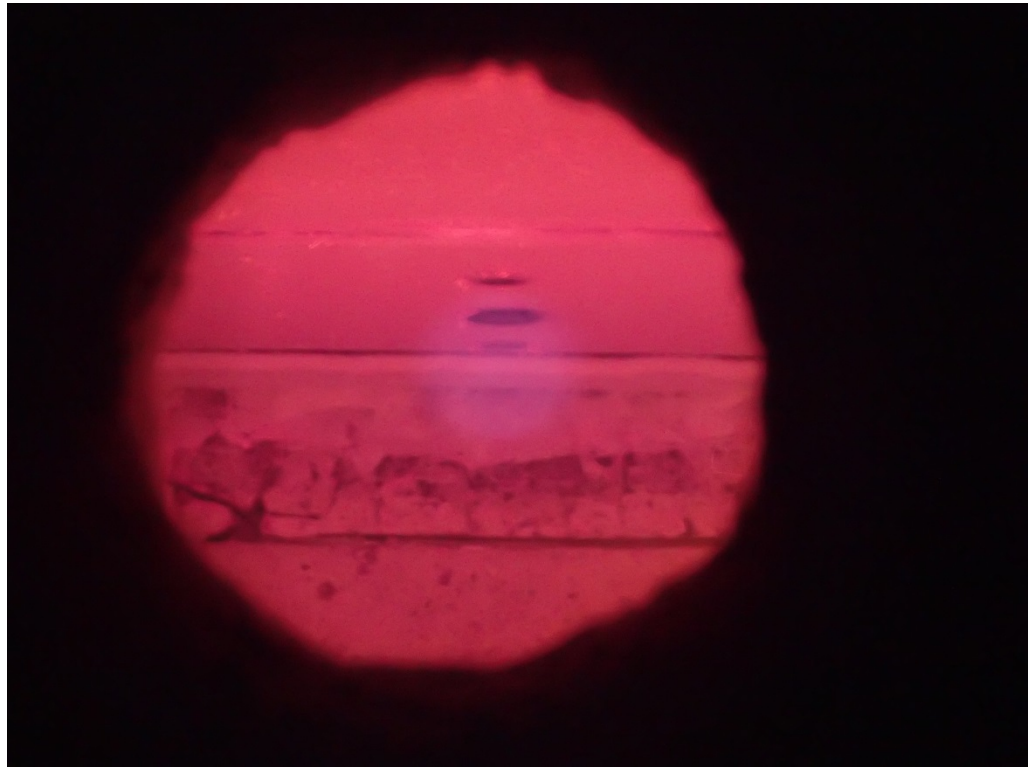
View of the exposed ceiling after a test duration of approximately 30 minutes

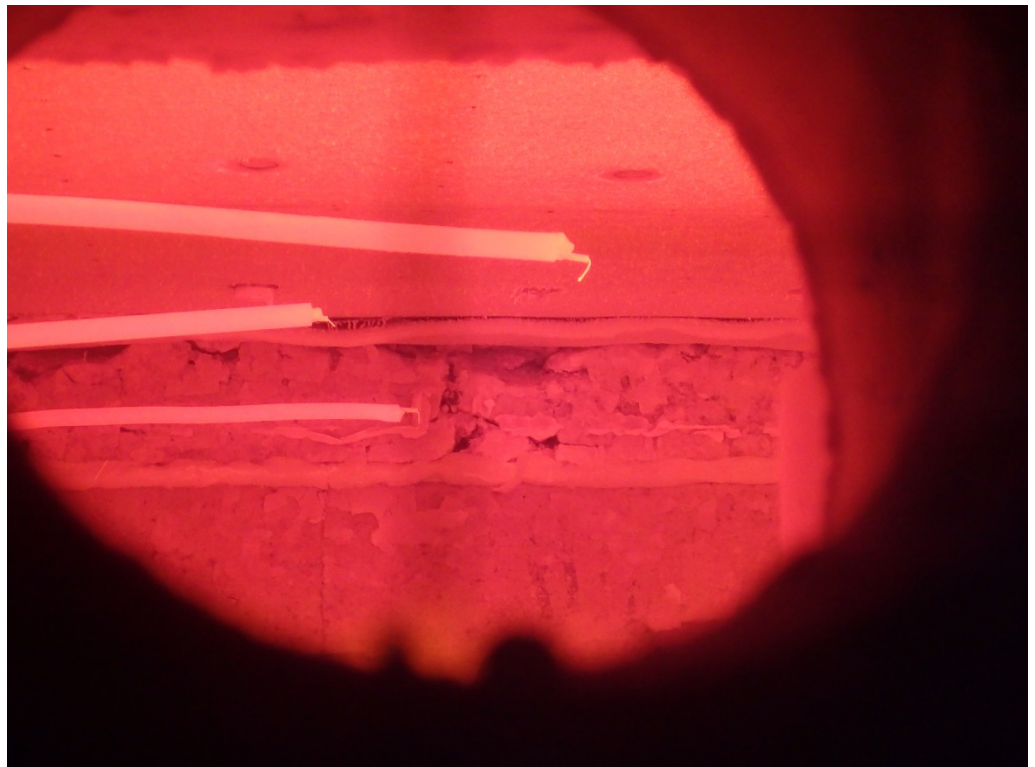
The exposed face of the assembly after a test duration of 60 minutes

<b>21</b>	<b>11</b>	<b>Viewed from exposed face.</b>  Downlighters M and P have detached from the ceiling/floor assembly.
<b>30</b>	<b>00</b>	No visible significant changes to both faces.
<b>45</b>	<b>00</b>	No visible significant changes to both faces.
<b>60</b>	<b>00</b>	No visible significant changes to both faces.
<b>75</b>	<b>00</b>	No visible significant changes to both faces.
<b>84</b>	<b>05</b>	Joints in the first layer of plasterboard to exposed face have widened.
<b>90</b>	<b>00</b>	Cracking noises can be heard. Smoke releases through the ends of the specimen assembly increase in volume. Cavity temperature is in excess of 300°C. Deflection ratio increases. Specimen continues to satisfy the loadbearing capacity, integrity and insulation, allowing the test to continue.
<b>91</b>	<b>00</b>	<b>Viewed from exposed face.</b>  Plasterboard on the exposed face begins to detach from the joists.
