The Fire Resistance Performance of a Loadbearing Timber Floor Assembly Protected by a Plasterboard Ceiling Designed to Provide 30 minutes Fire Resistance, Incorporating Twenty Three Downlight Fittings, When Tested Accordance with BS EN 1365 - 2: 2014

WF Report No: 385023-B

Integral LED

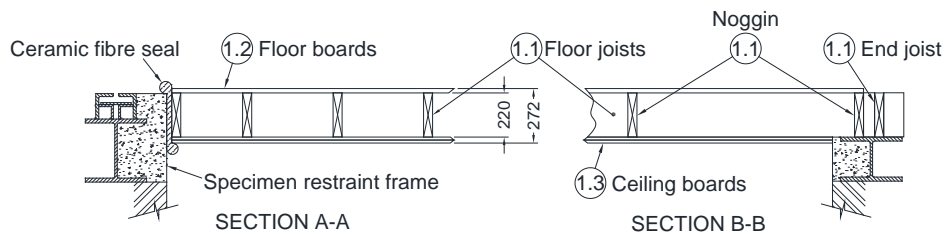
Figure 1- General Elevation of Test Construction

Key
 ■ Surface thermocouple

PLAN OF THERMOCOUPLE POSITIONS
