The Fire Resistance Performance of a Loadbearing Timber Floor Assembly Protected by a Plasterboard Ceiling Designed to Provide 30 minutes Fire Resistance, Incorporating Twenty Three Downlight Fittings, When Tested Accordance with BS EN 1365 - 2: 2014

**WF Report No: 385023-B**

The Fire Resistance Performance of a Loadbearing Timber Floor Assembly Protected by a Plasterboard Ceiling Designed to Provide 60 minutes Fire Resistance, Incorporating Twenty Three Downlight Fittings, When Tested Accordance with BS EN 1365 - 2: 2014

388542A Issue 2

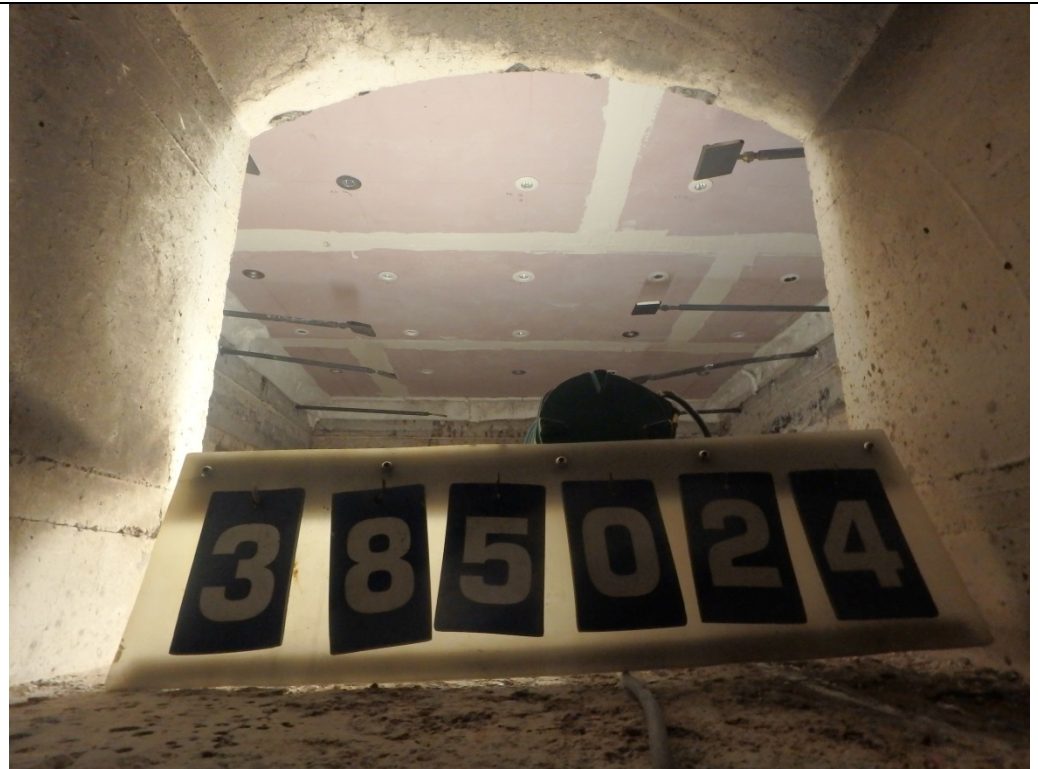
The exposed face of the assembly prior to the start of the test

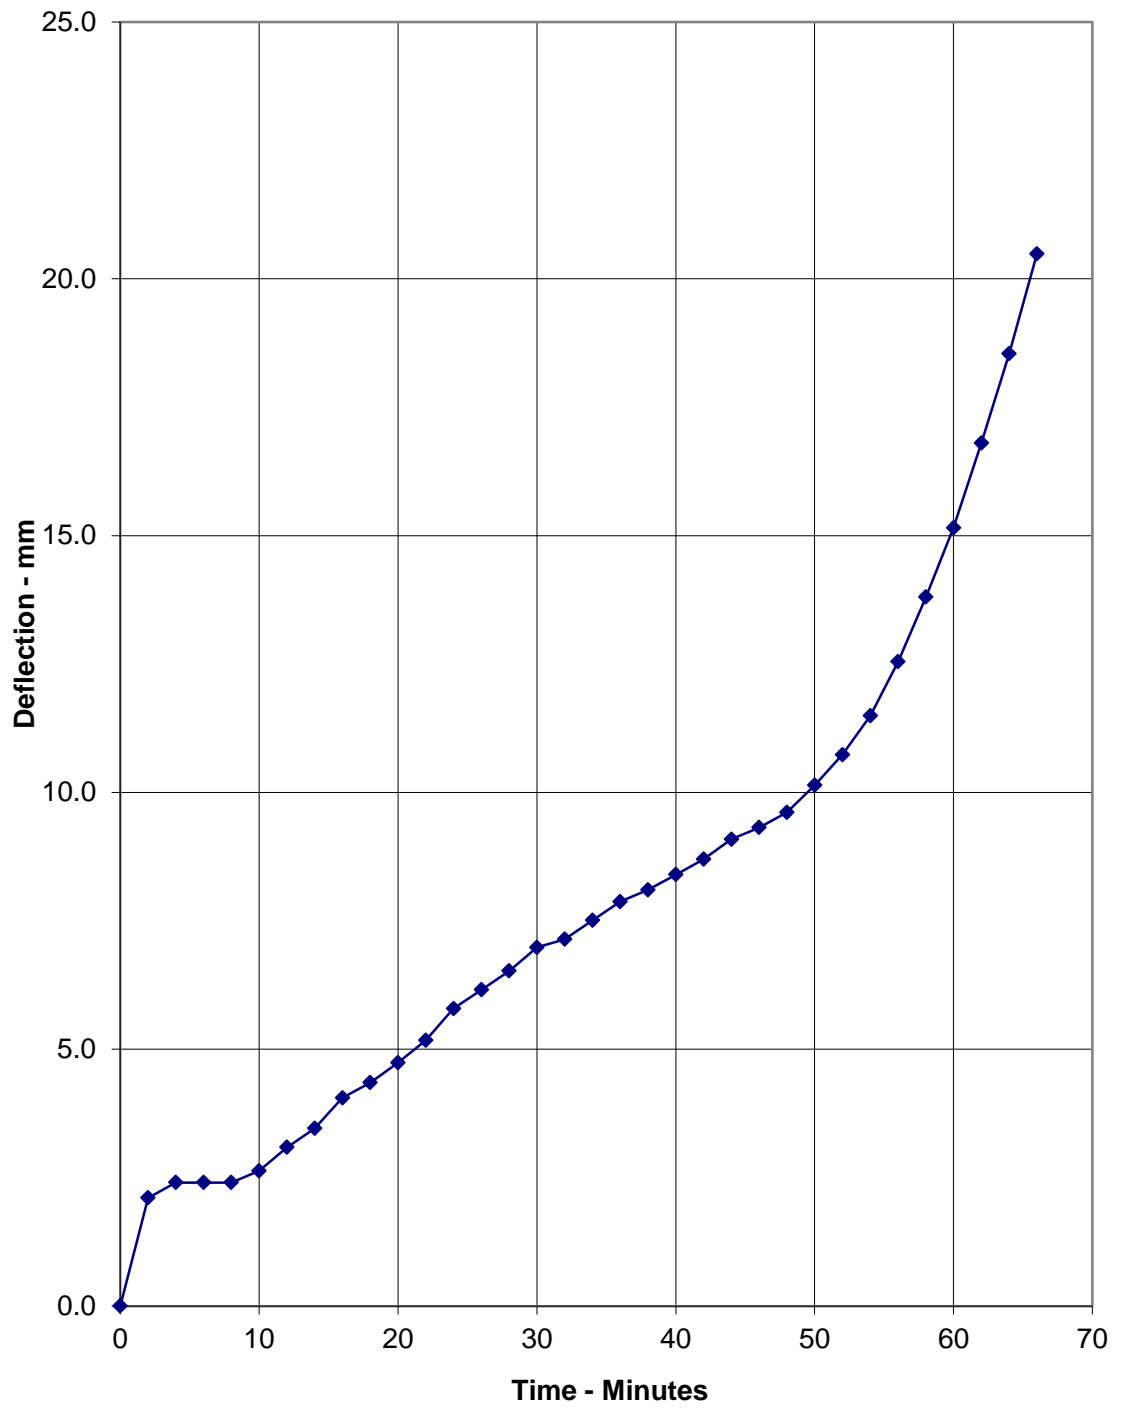
Graph showing the central vertical deflection of the floor assembly during the test
