The Fire Resistance Performance of a Loadbearing Timber Floor Assembly Protected by a Plasterboard Ceiling Designed to Provide 30 minutes Fire Resistance, Incorporating Twenty Three Downlight Fittings, When Tested Accordance with BS EN 1365 - 2: 2014

**WF Report No: 385023-B**

**This test report is additional to that issued as WF Test report No. 385023 and dated 15<sup>th</sup> December 2017. The original test report remains valid and is not replaced by this additional test report.**

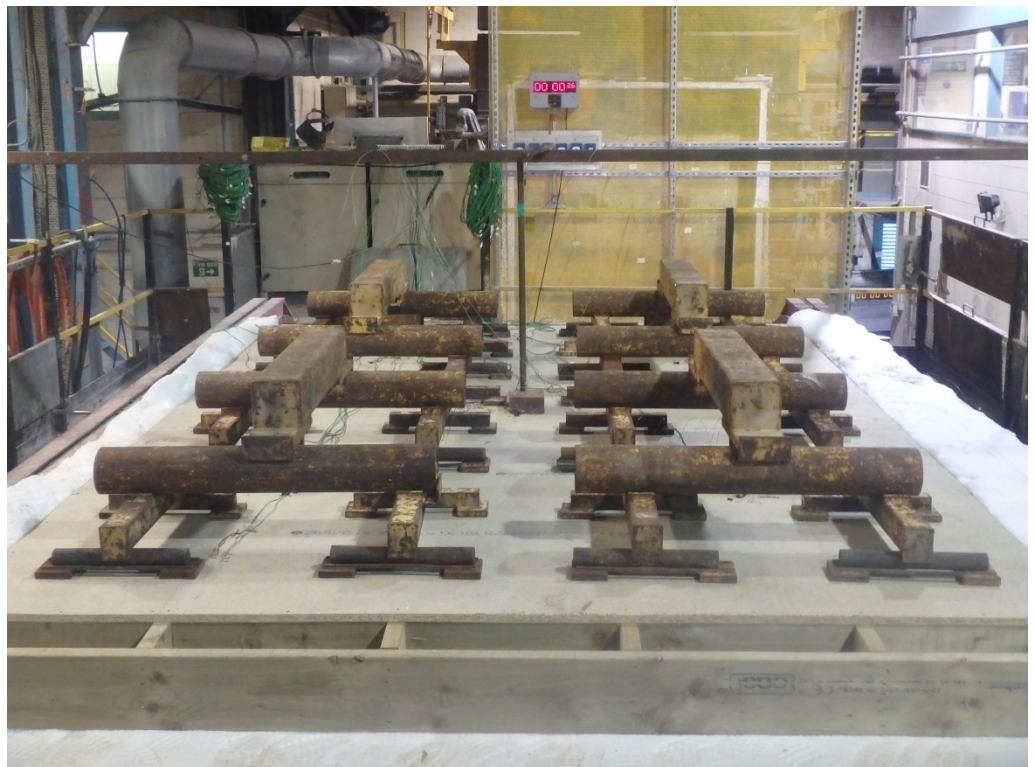
The unexposed face of the assembly prior to the start of the test
