The Fire Resistance Performance of a Loadbearing Timber Floor Assembly Protected by a Plasterboard Ceiling Designed to Provide 30 minutes Fire Resistance, Incorporating Twenty Three Downlight Fittings, When Tested Accordance with BS EN 1365 - 2: 2014

WF Report No: 385023-B

Objective To determine the fire resistance performance of a loadbearing timber floor assembly protected by a plasterboard ceiling designed to provide 30 minutes fire resistance, incorporating twenty three down light fittings, when tested in accordance with BS EN 1365 - 2: 2014.

388542A Issue 2

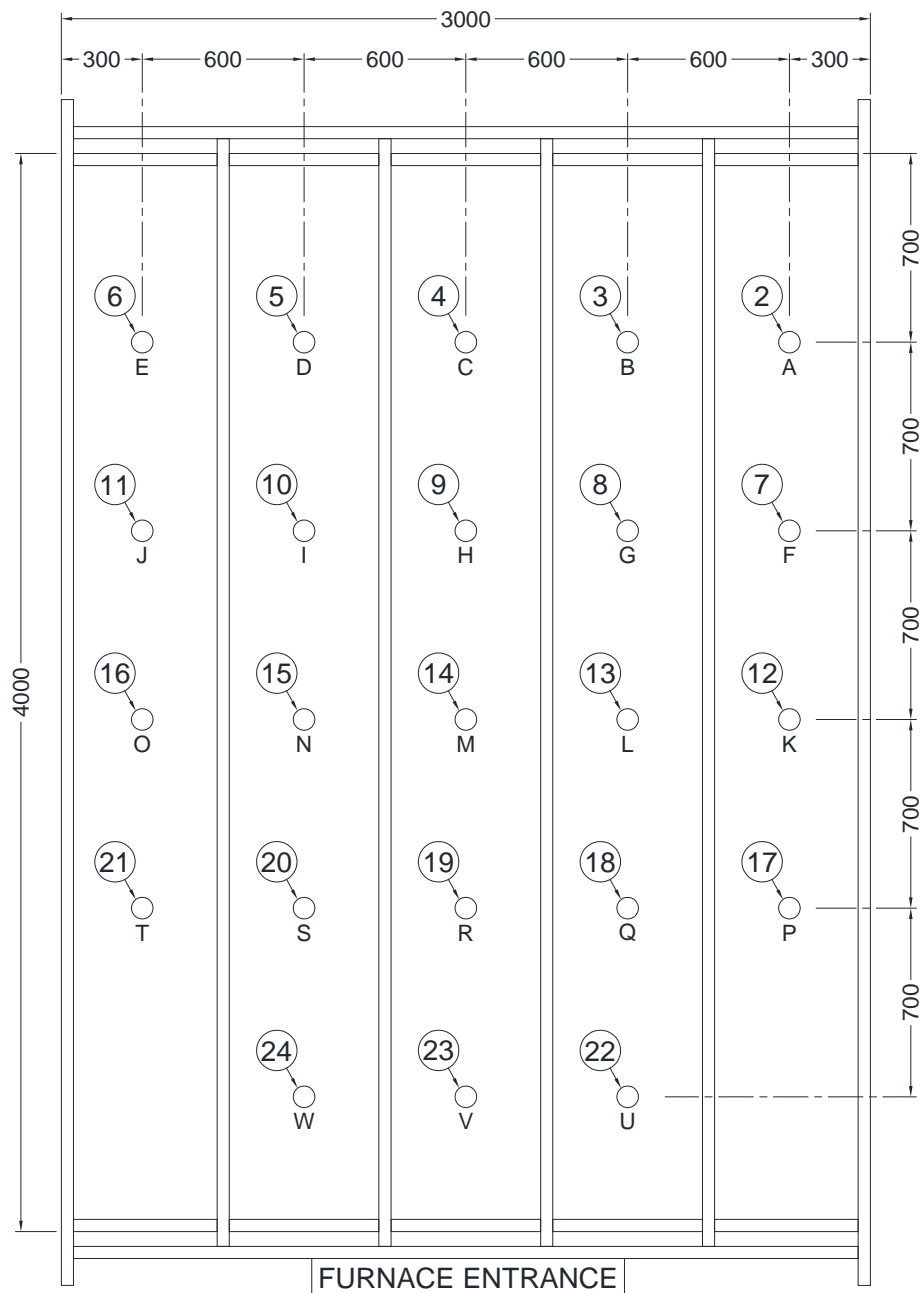
Figure 2 – Details of Downlighter Positions

The ceiling incorporated 22 down lighter light fittings, 2 of which are subject to this test report and were referenced as follows:

Test Ref.	Model Ref.	Description
I	ILDLFR70AXXX	Round, fixed, LED recessed downlight
M	ILDLFR92CXXX	Round, tiltable, LED recessed downlight
A-H, J-L and N-W	Items reported separately

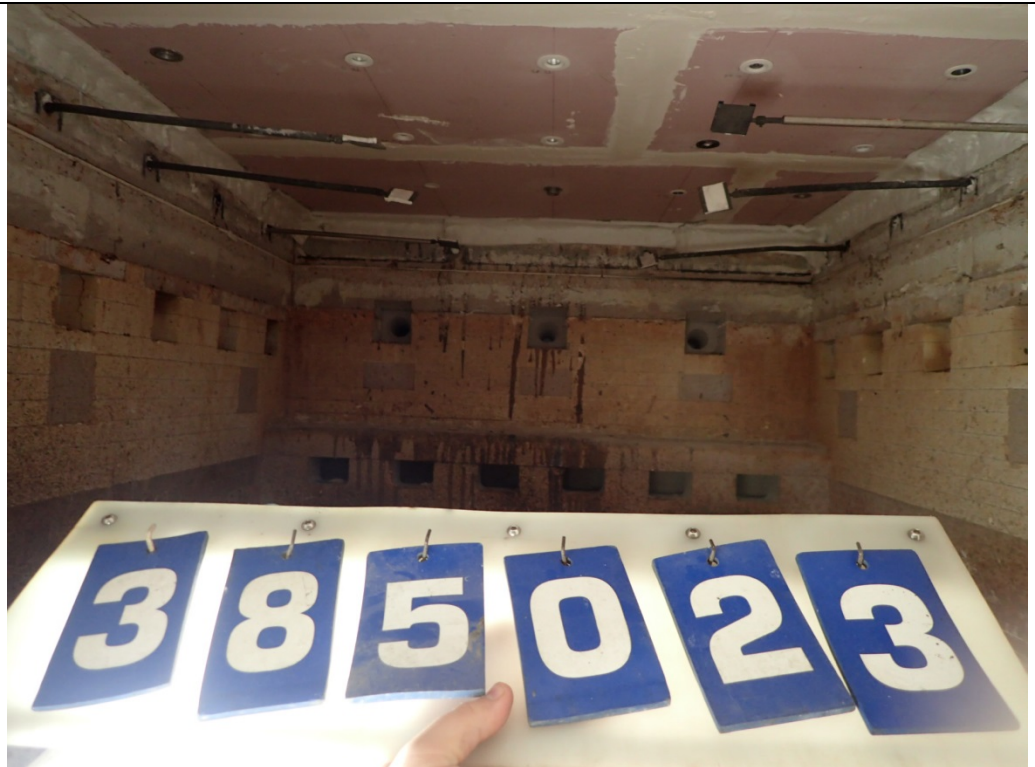
The exposed face of the assembly prior to the start of the test

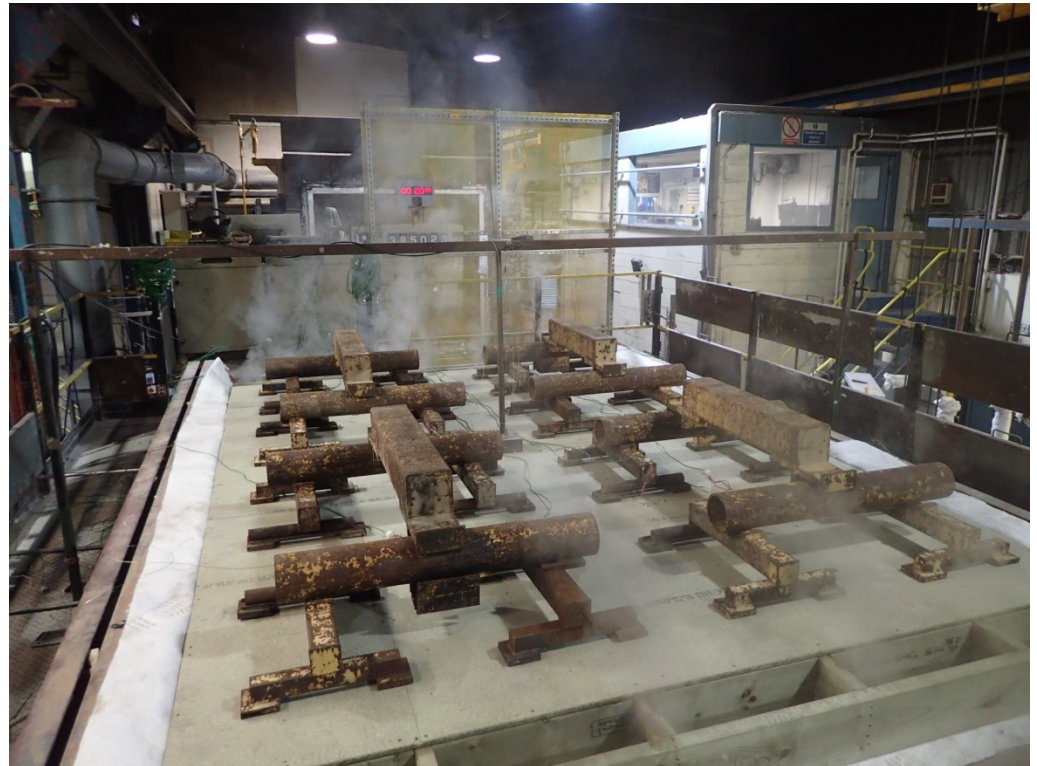
The unexposed face of the assembly after 20 minutes of testing

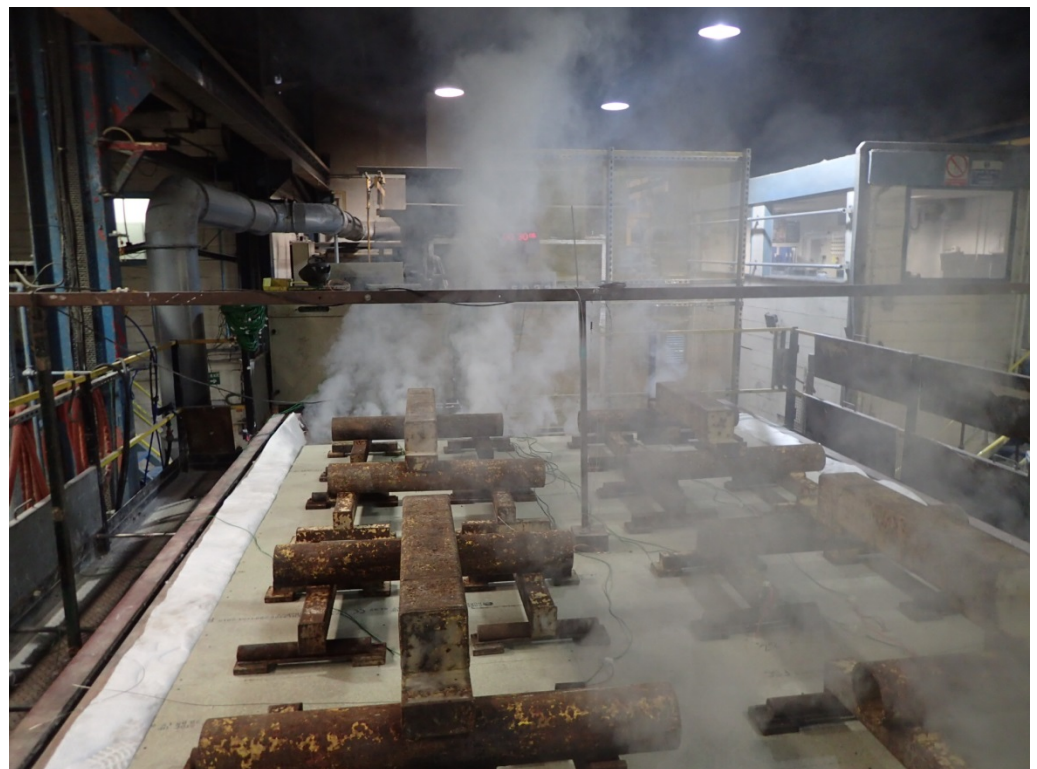
The unexposed surface of the assembly after a test duration of 30 minutes

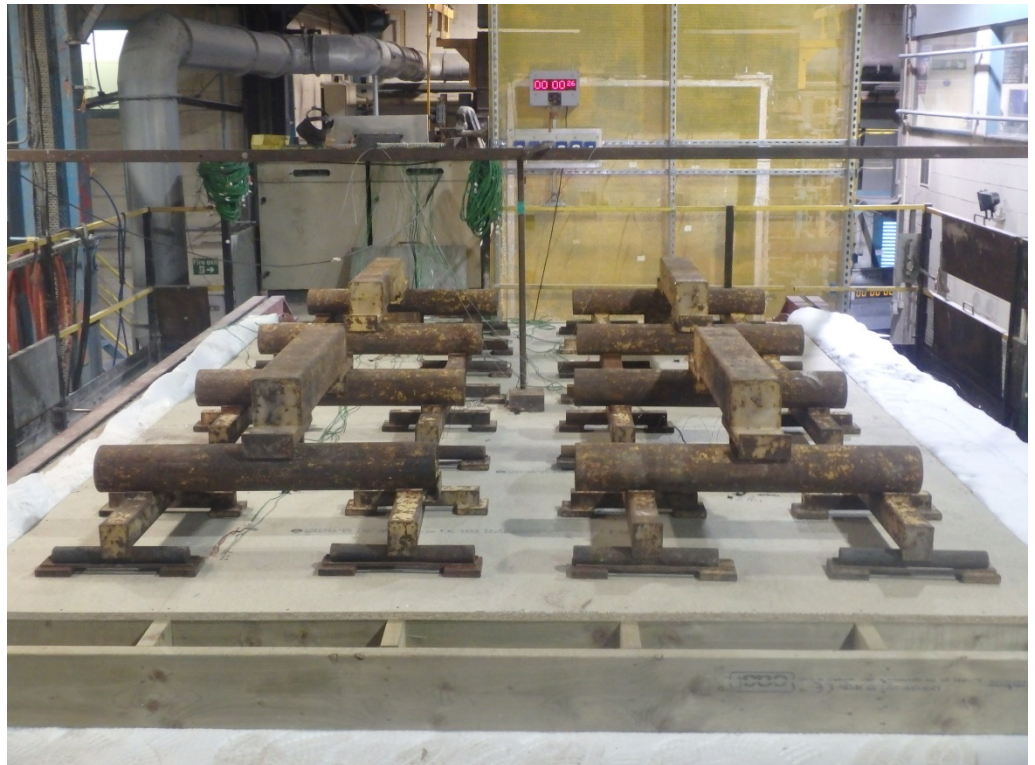
The unexposed face of the assembly prior to the start of the test

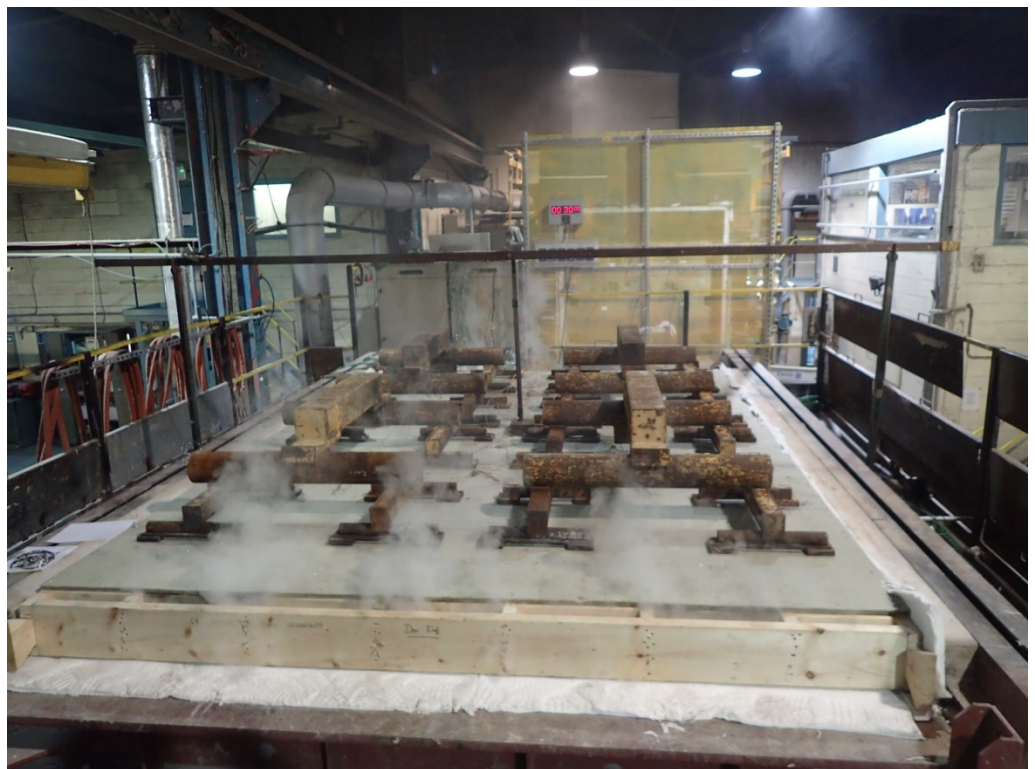
The unexposed face of the assembly after 30 minutes of testing
