The Fire Resistance Performance of a Specimen of a Loadbearing Timber Floor Assembly Protected by a Plasterboard Ceiling Designed to Provide 60 minutes Fire Resistance, Incorporating Twenty Downlight Light Fittings, Tested in Accordance with BS 476: Part 21: 1987, Clause 7

371969B

**Integral LED**

19<sup>th</sup> May 2017

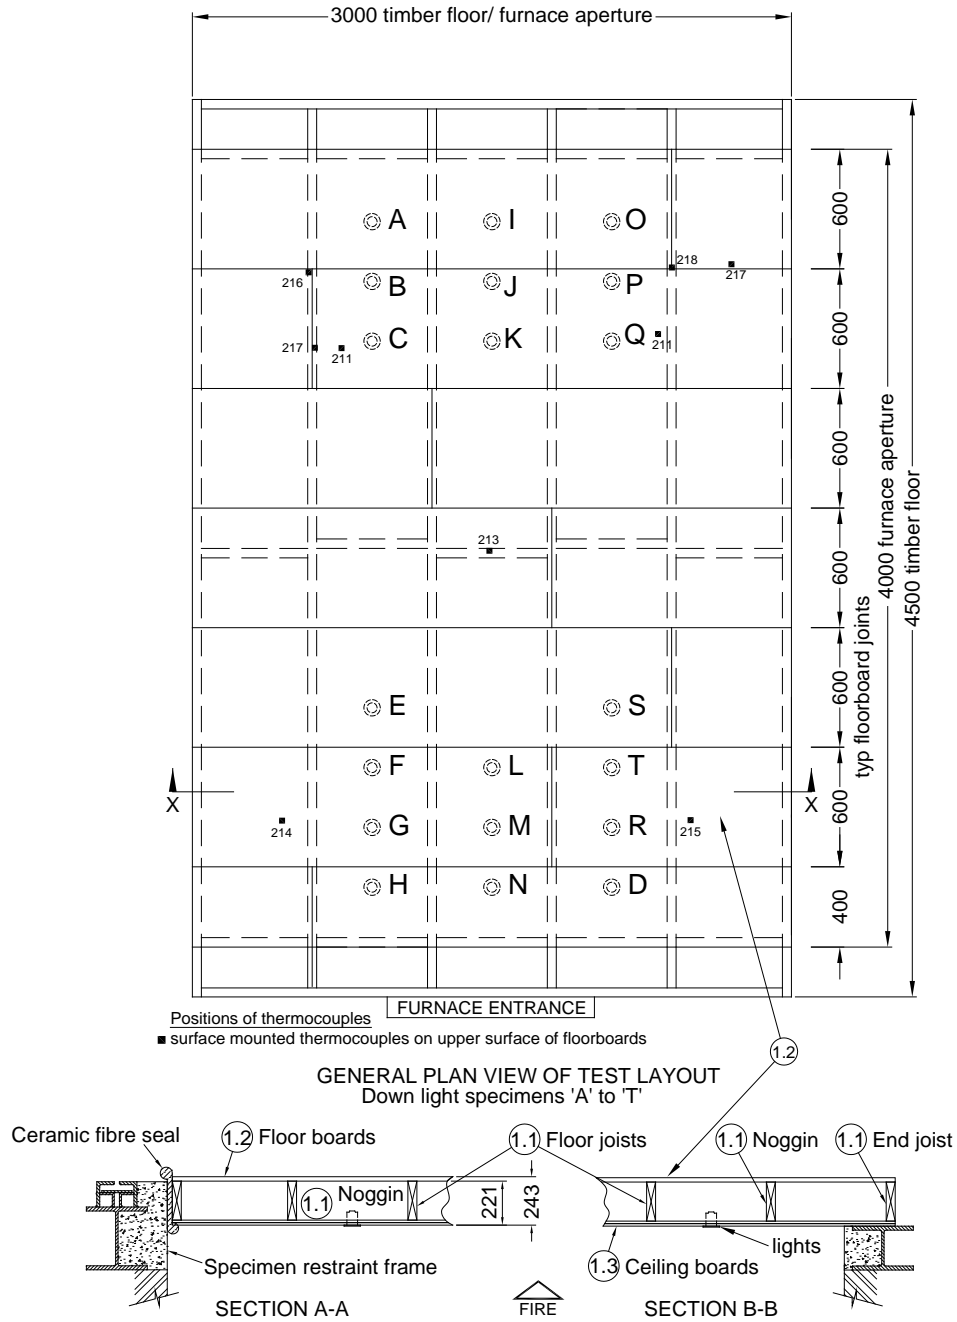
Figure 1- General Elevation of Test Specimens

**Summary of Tested Assembly** The timber floor had overall nominal dimensions of 4500 mm long by 3000 mm wide and comprised softwood timber joists at 600 mm centres. The upper surface of the floor comprised nominally 22 mm thick tongue and grooved chipboard flooring.

The floor assembly was protected on its underside by a direct fixed ceiling, formed from two layers of 12.5 mm thick British Gypsum Fireline plasterboard, both layers were screw fixed to the underside of the floor joists.

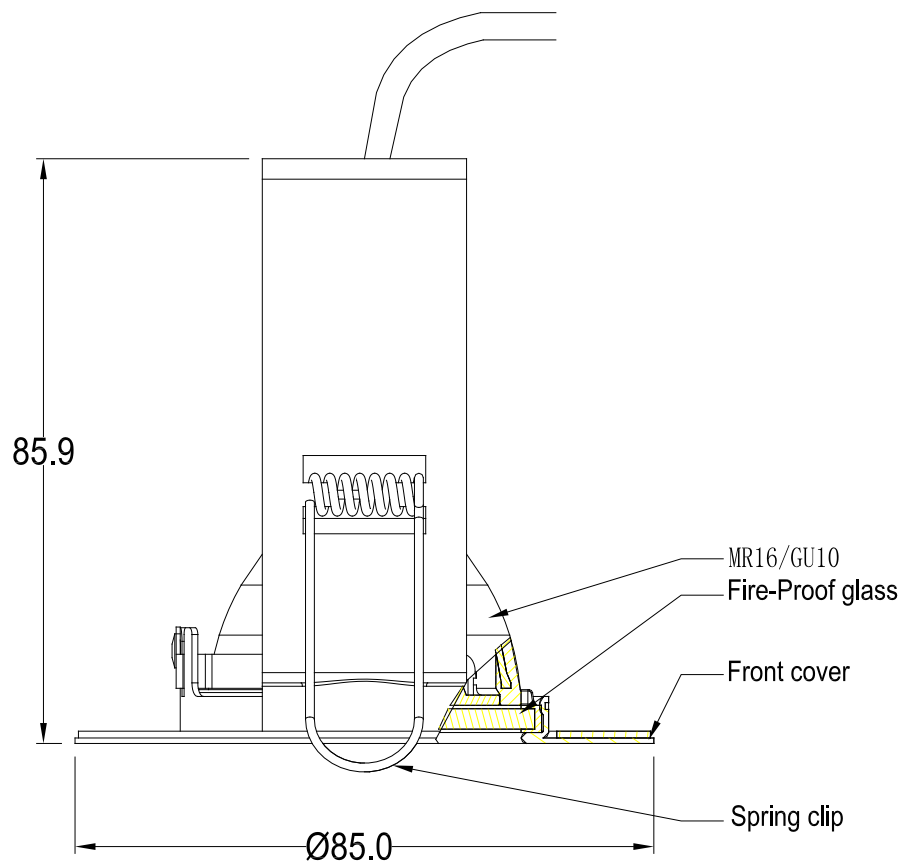
Figure 5 – Details of Downlighter Specimen C

Fixed  
ILDLFR70DXXX  
with bracket  
Cut out:  $\phi 70$

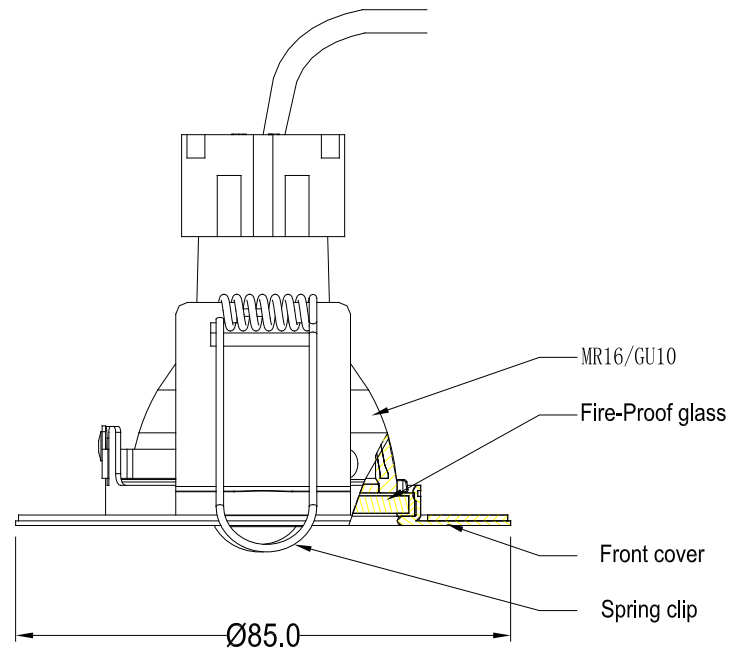
Figure 6 – Details of Downlighter Specimen D

Fixed  
ILD LFR70DXXX  
Cut out:  $\text{Ø}70$

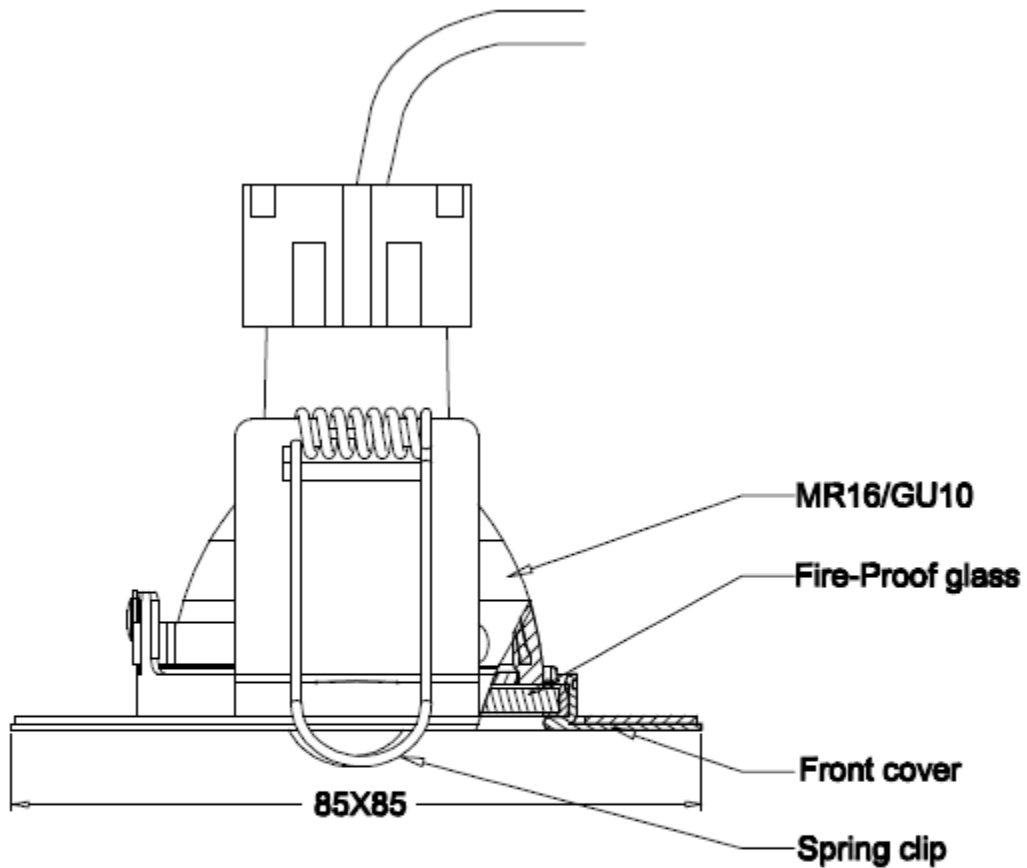
Figure 8 – Details of Downlighter Specimen F

**Fixed model  
ILDLFR70DXXX  
Slim fire square bezel  
Cut out:Ø70mm**

<b><u>Item</u></b>	<b><u>Description</u></b>
<b>3. Specimen F, G, H, I</b>	
Manufacturer	: Integral LED
Type	: Square, fixed, LED recessed downlight
Reference	: See Figures 8 to 11.
Materials	
i. front cover	: Steel
ii. spring	: Stainless steel
iii. diffuser	: Pyrex glass
Overall dimensions and construction	: Please see Figures 8 to 11
Cut out size	: Various see relevant figures
Driver	: None
Lamp	: GU10/MR16
<b>4. Specimen J</b>	: Specimen reported separately
<b>5. Specimen K, L</b>	: Specimens reported separately
<b>6. Specimen M, N</b>	: Specimens reported separately
<b>7. Specimens O</b>	: Specimen reported separately
<b>8. Specimens P</b>	: Specimen reported separately
<b>9. Specimen Q</b>	: Specimen reported separately
<b>10. Specimens R, S</b>	: Specimens reported separately
<b>11. Specimen T</b>	: Specimen reported separately

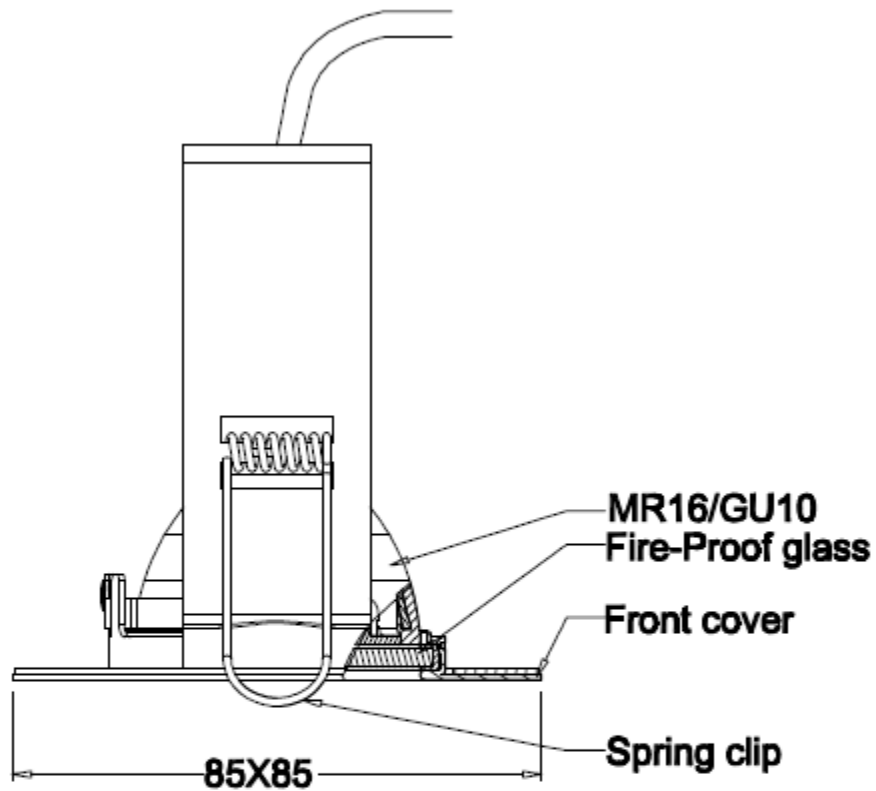
Figure 9 – Details of Downlighter Specimen G

**Fixed model**  
**ILDLFR70DXXX**  
**Slim fire square bezel with bracket**  
**Cut out:Ø70mm**

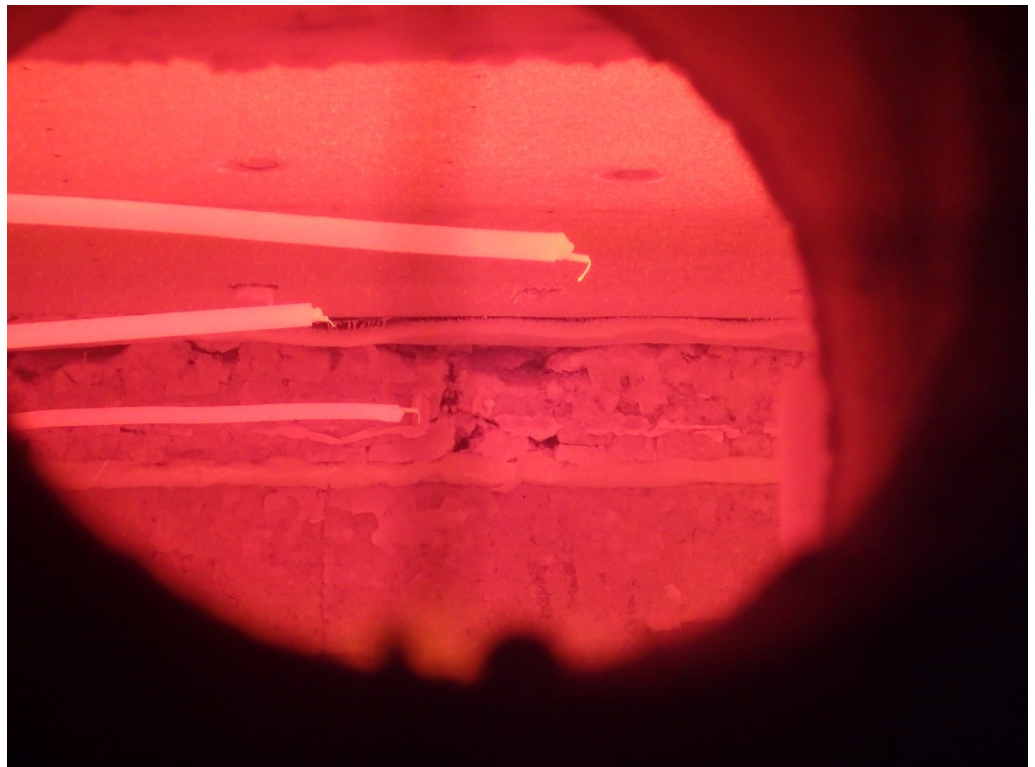
The exposed face of the assembly after a test duration of 60 minutes

<b>21</b>	<b>11</b>	<b>Viewed from exposed face.</b>  Downlighters M and P have detached from the ceiling/floor assembly.
<b>30</b>	<b>00</b>	No visible significant changes to both faces.
<b>45</b>	<b>00</b>	No visible significant changes to both faces.
<b>60</b>	<b>00</b>	No visible significant changes to both faces.
<b>75</b>	<b>00</b>	No visible significant changes to both faces.
<b>84</b>	<b>05</b>	Joints in the first layer of plasterboard to exposed face have widened.
<b>90</b>	<b>00</b>	Cracking noises can be heard. Smoke releases through the ends of the specimen assembly increase in volume. Cavity temperature is in excess of 300°C. Deflection ratio increases. Specimen continues to satisfy the loadbearing capacity, integrity and insulation, allowing the test to continue.
<b>91</b>	<b>00</b>	<b>Viewed from exposed face.</b>  Plasterboard on the exposed face begins to detach from the joists.
