The Fire Resistance Performance of a Specimen of a Loadbearing Timber Floor Assembly Protected by a Plasterboard Ceiling Designed to Provide 60 minutes Fire Resistance, Incorporating Twenty Downlight Light Fittings, Tested in Accordance with BS 476: Part 21: 1987, Clause 7

371969B

**Integral LED**

19<sup>th</sup> May 2017

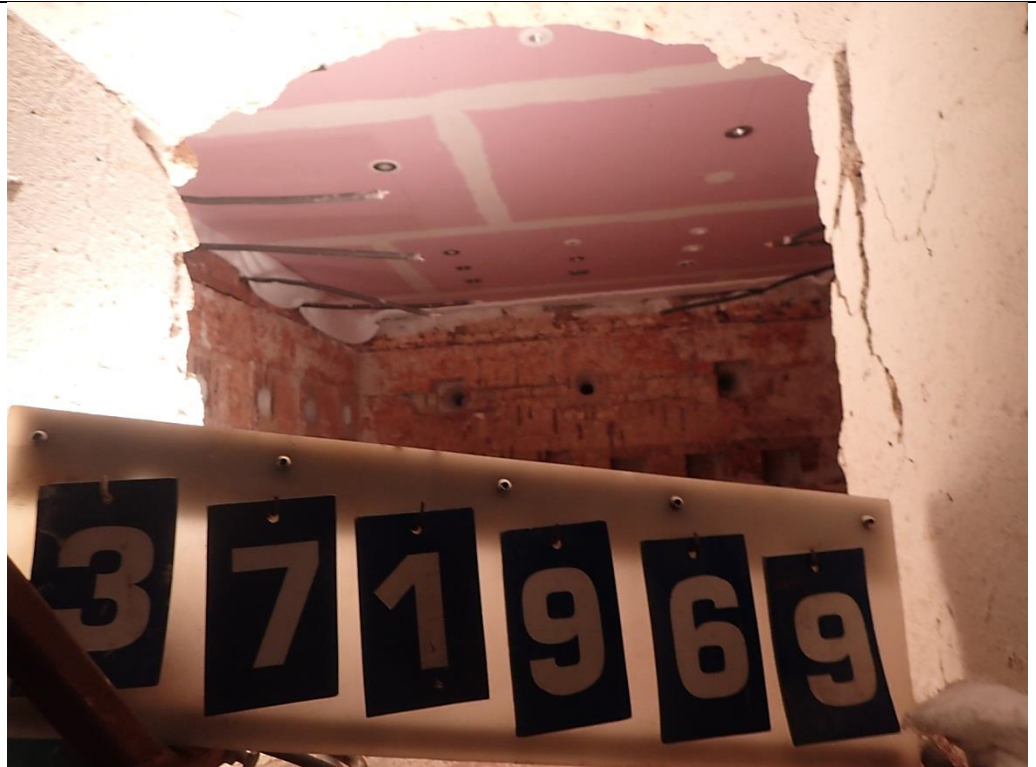
The exposed face of the assembly prior to testing

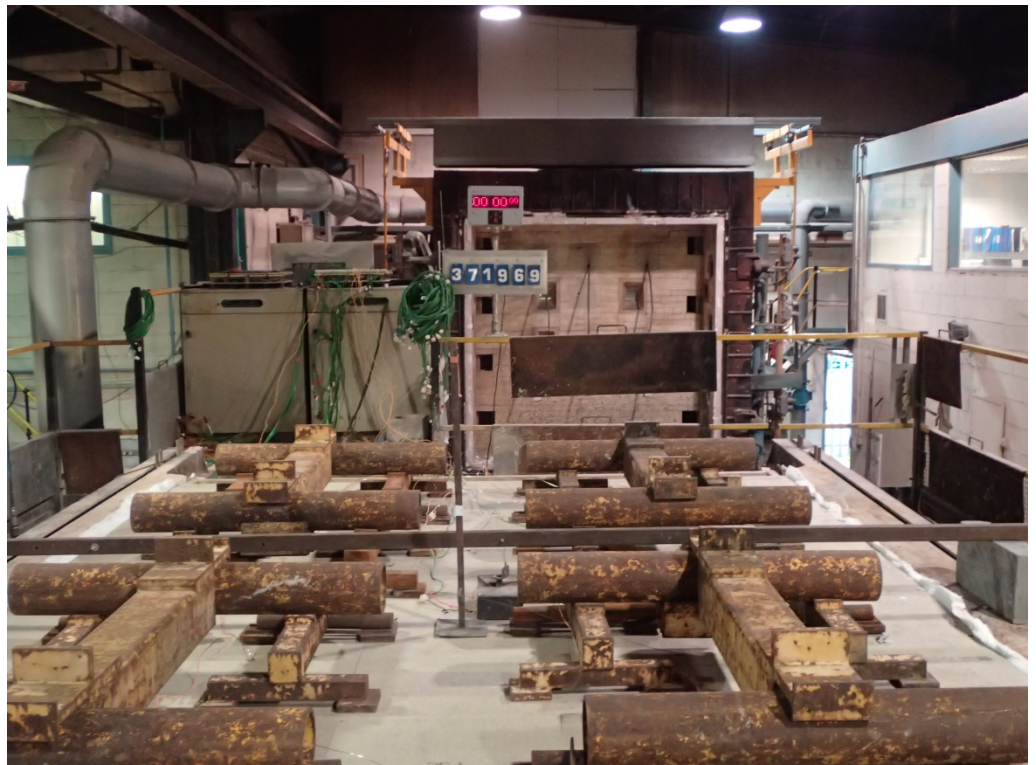
The unexposed face of the assembly after 10 minutes of testing

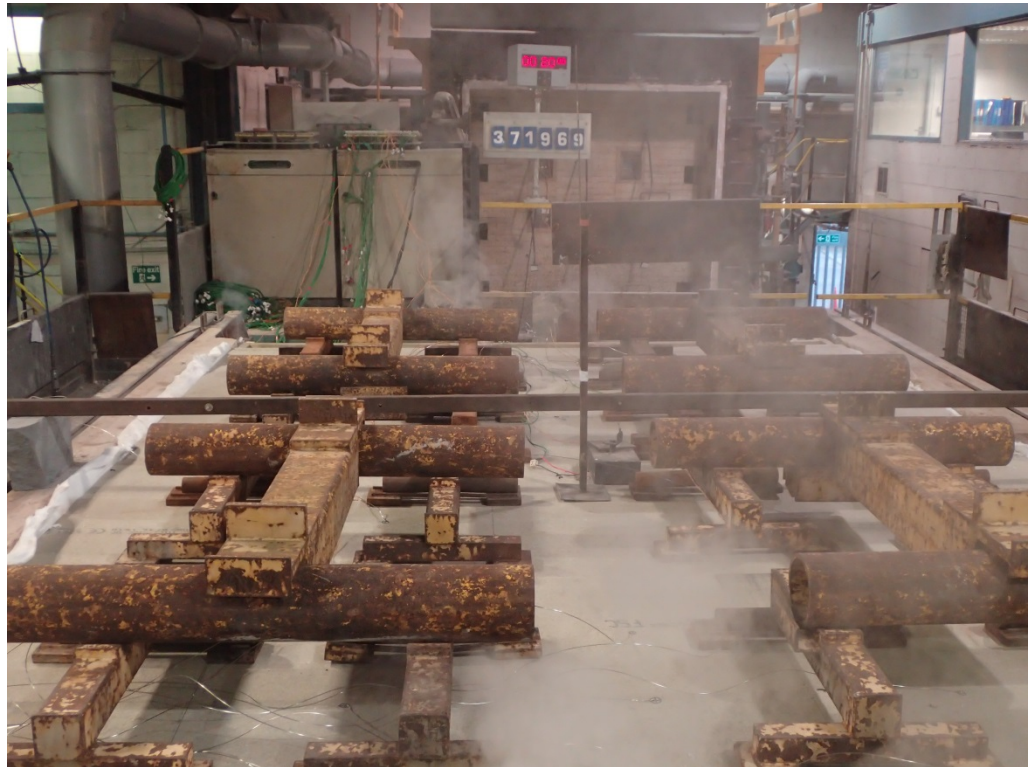
The unexposed  
face of the  
assembly after 20  
minutes of testing

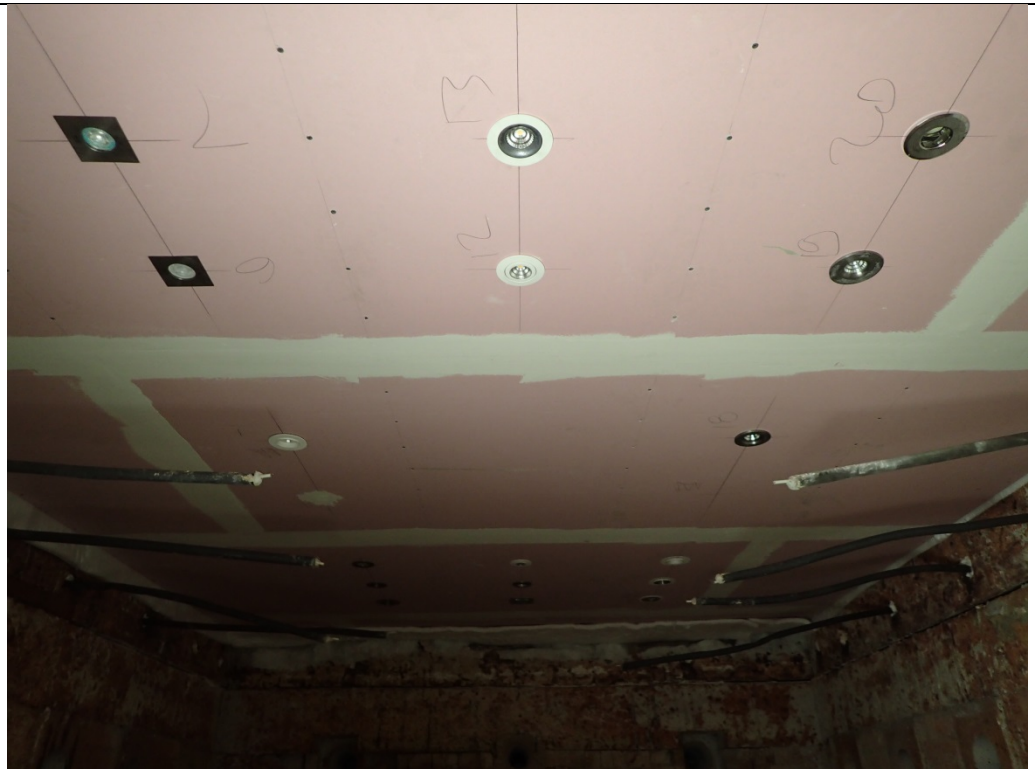
The exposed face of the assembly prior to testing

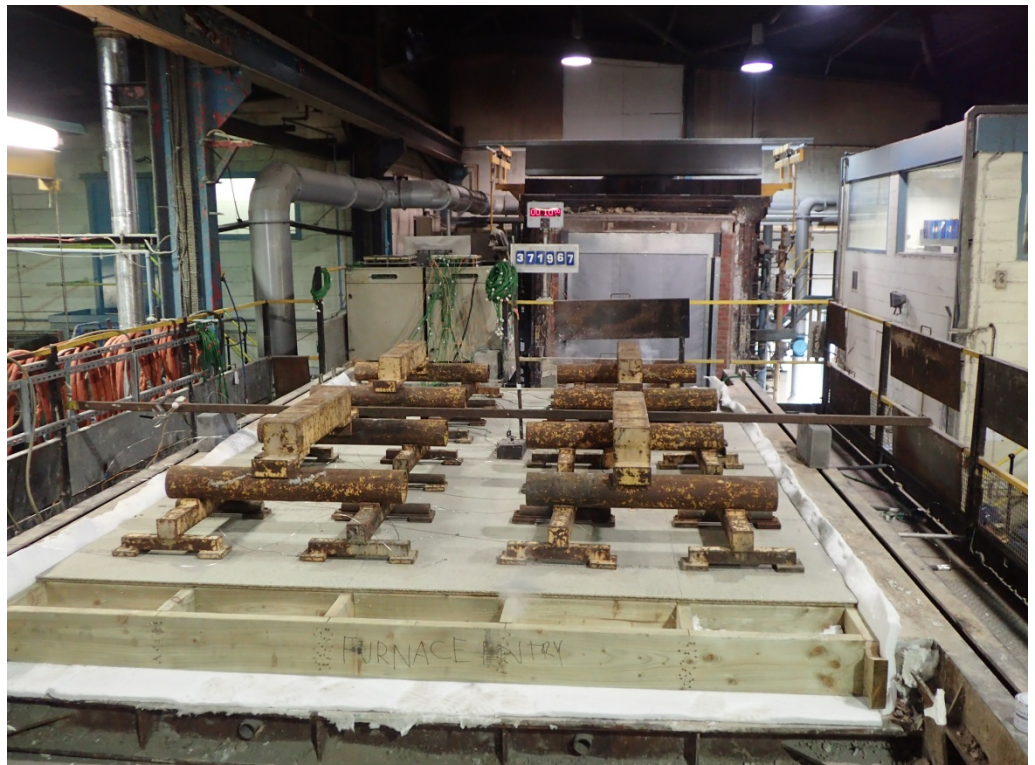
The unexposed face of the assembly after 10 minutes of testing

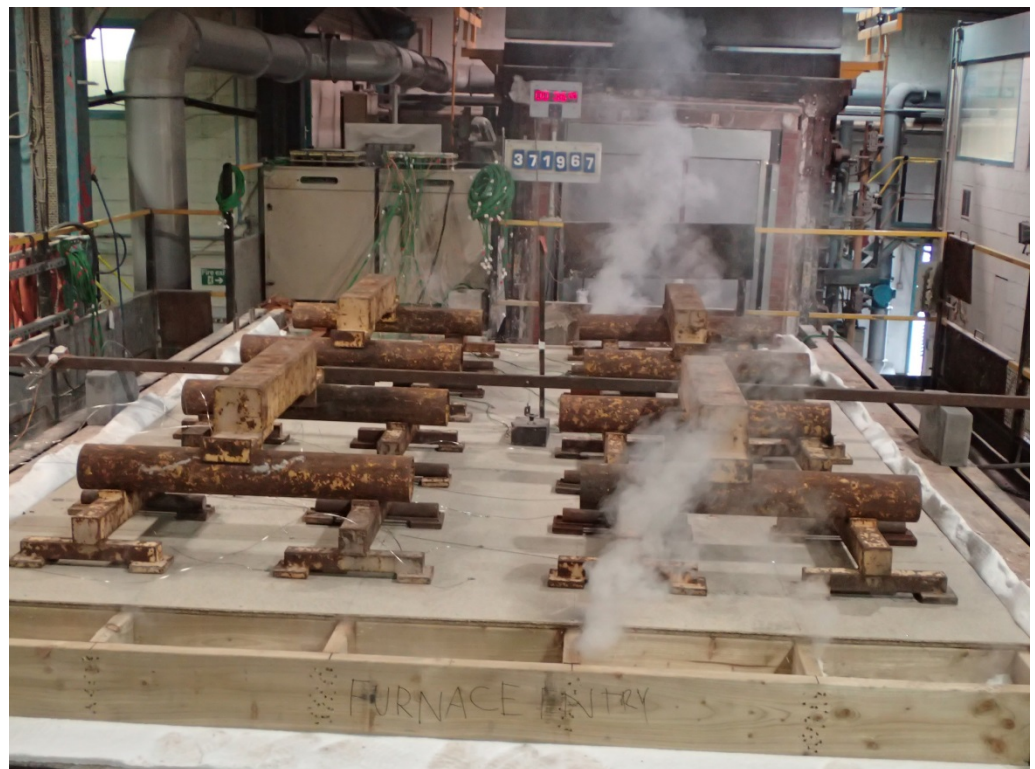
The unexposed  
face of the  
assembly after 36  
minutes of testing

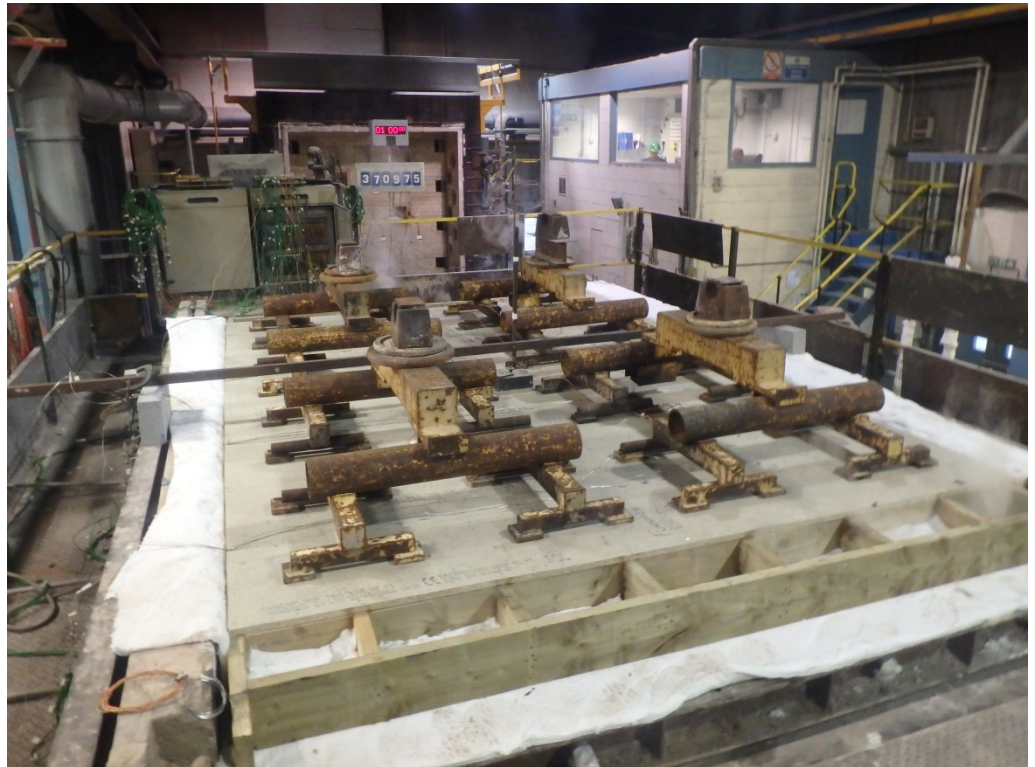
The unexposed  
face of the  
assembly after 60  
minutes of testing

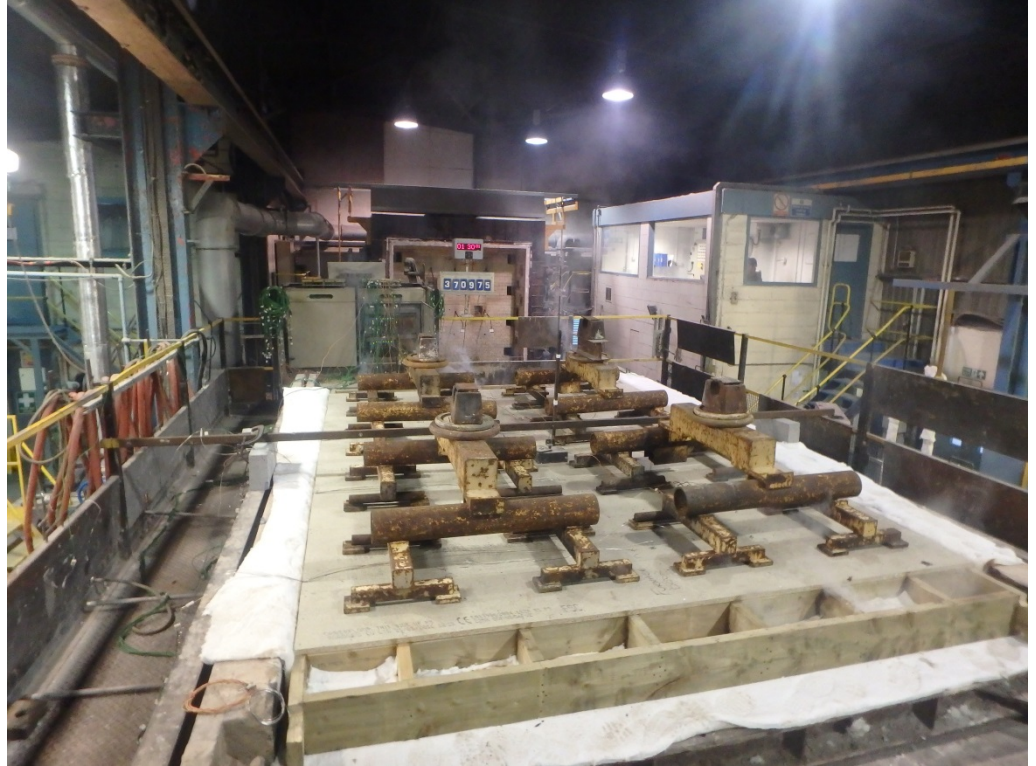
The unexposed  
face of the  
assembly after 90  
minutes of testing
