The Fire Resistance Performance of a Specimen of a Loadbearing Timber Floor Assembly Protected by a Plasterboard Ceiling Designed to Provide 60 minutes Fire Resistance, Incorporating Twenty Downlight Light Fittings, Tested in Accordance with BS 476: Part 21: 1987, Clause 7

371969B

Integral LED

19th May 2017

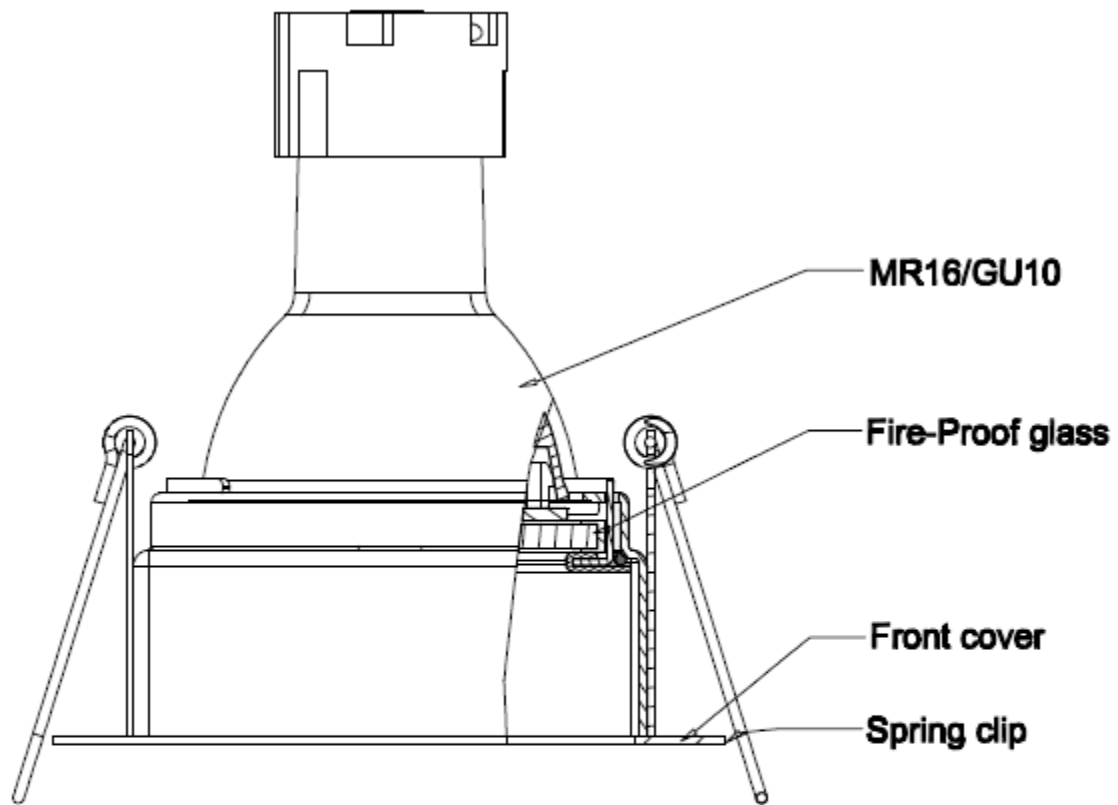
Figure 10 – Details of Downlighter Specimen H

**Fixed model
ILD LFR70EXXX
Slim fire square bezel
Cut out: Ø70X70mm**

<u>Item</u>	<u>Description</u>
3. Specimen F, G, H, I	
Manufacturer	: Integral LED
Type	: Square, fixed, LED recessed downlight
Reference	: See Figures 8 to 11.
Materials	
i. front cover	: Steel
ii. spring	: Stainless steel
iii. diffuser	: Pyrex glass
Overall dimensions and construction	: Please see Figures 8 to 11
Cut out size	: Various see relevant figures
Driver	: None
Lamp	: GU10/MR16
4. Specimen J	: Specimen reported separately
5. Specimen K, L	: Specimens reported separately
6. Specimen M, N	: Specimens reported separately
7. Specimens O	: Specimen reported separately
8. Specimens P	: Specimen reported separately
9. Specimen Q	: Specimen reported separately
10. Specimens R, S	: Specimens reported separately
11. Specimen T	: Specimen reported separately

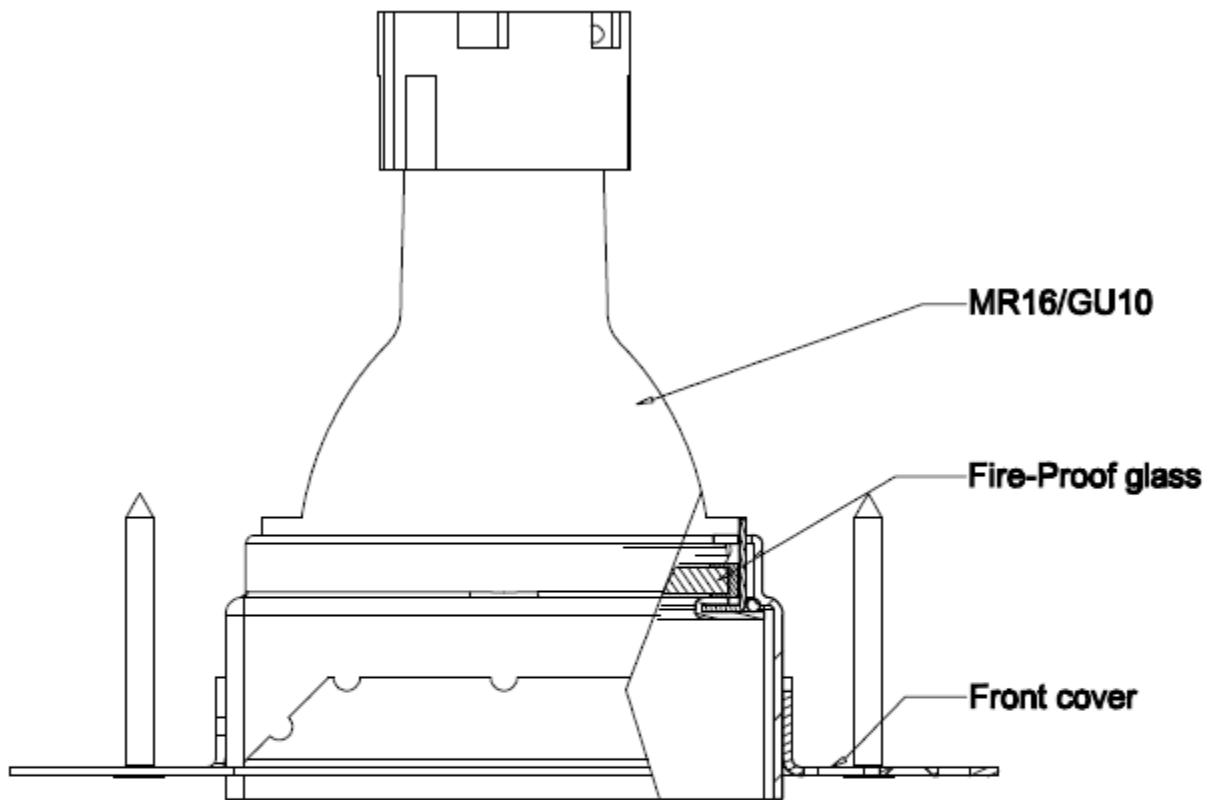
Figure 11 – Details of Downlighter Specimen I

**Fixed model
ILD LFR70FXXX
Trimless fire square bezel
Cut out: Ø70X70mm**

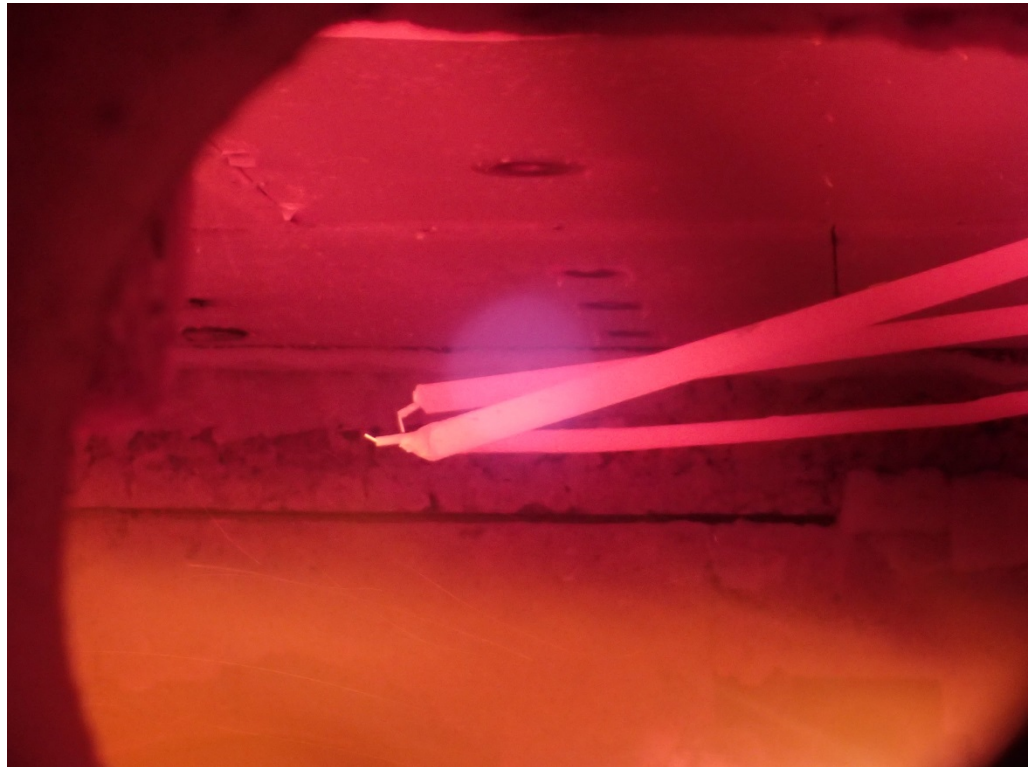
The exposed ceiling assembly after a test duration of approximately 40 minutes

55	00	The gaps between the joints in the ceiling are widening on the exposed face.
60	00	The test specimen is maintaining its loadbearing capacity, integrity, and insulation.
66	00	The test specimen is maintaining its loadbearing capacity, integrity, and insulation. The test is discontinued.

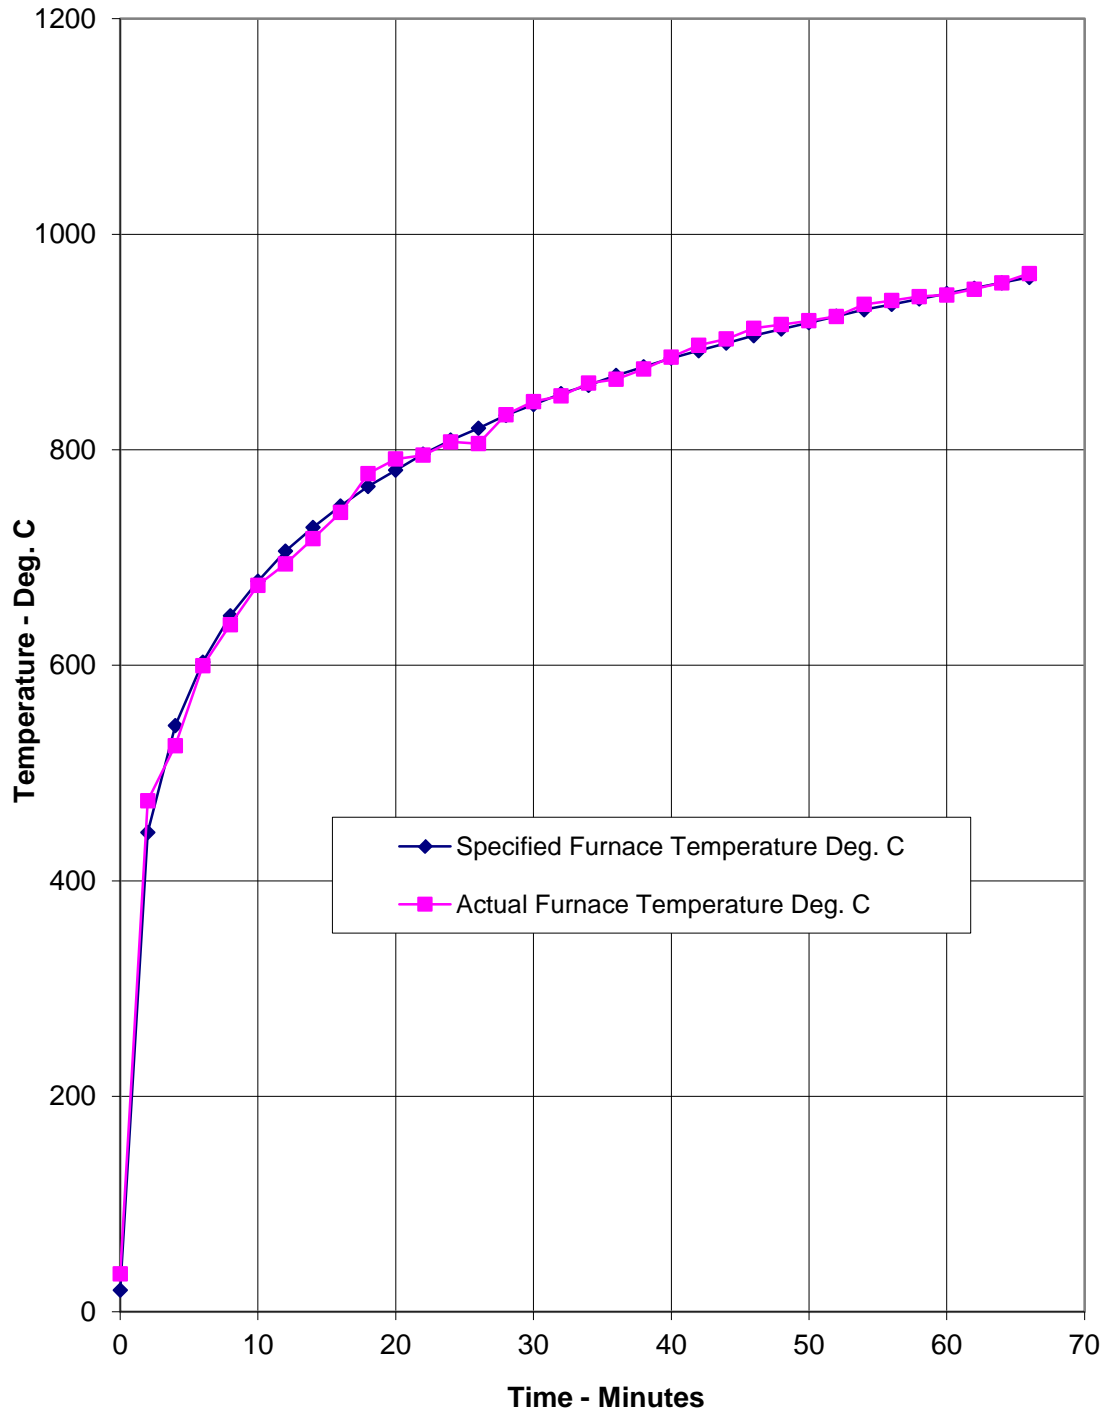
Graph showing specified and actual furnace temperatures

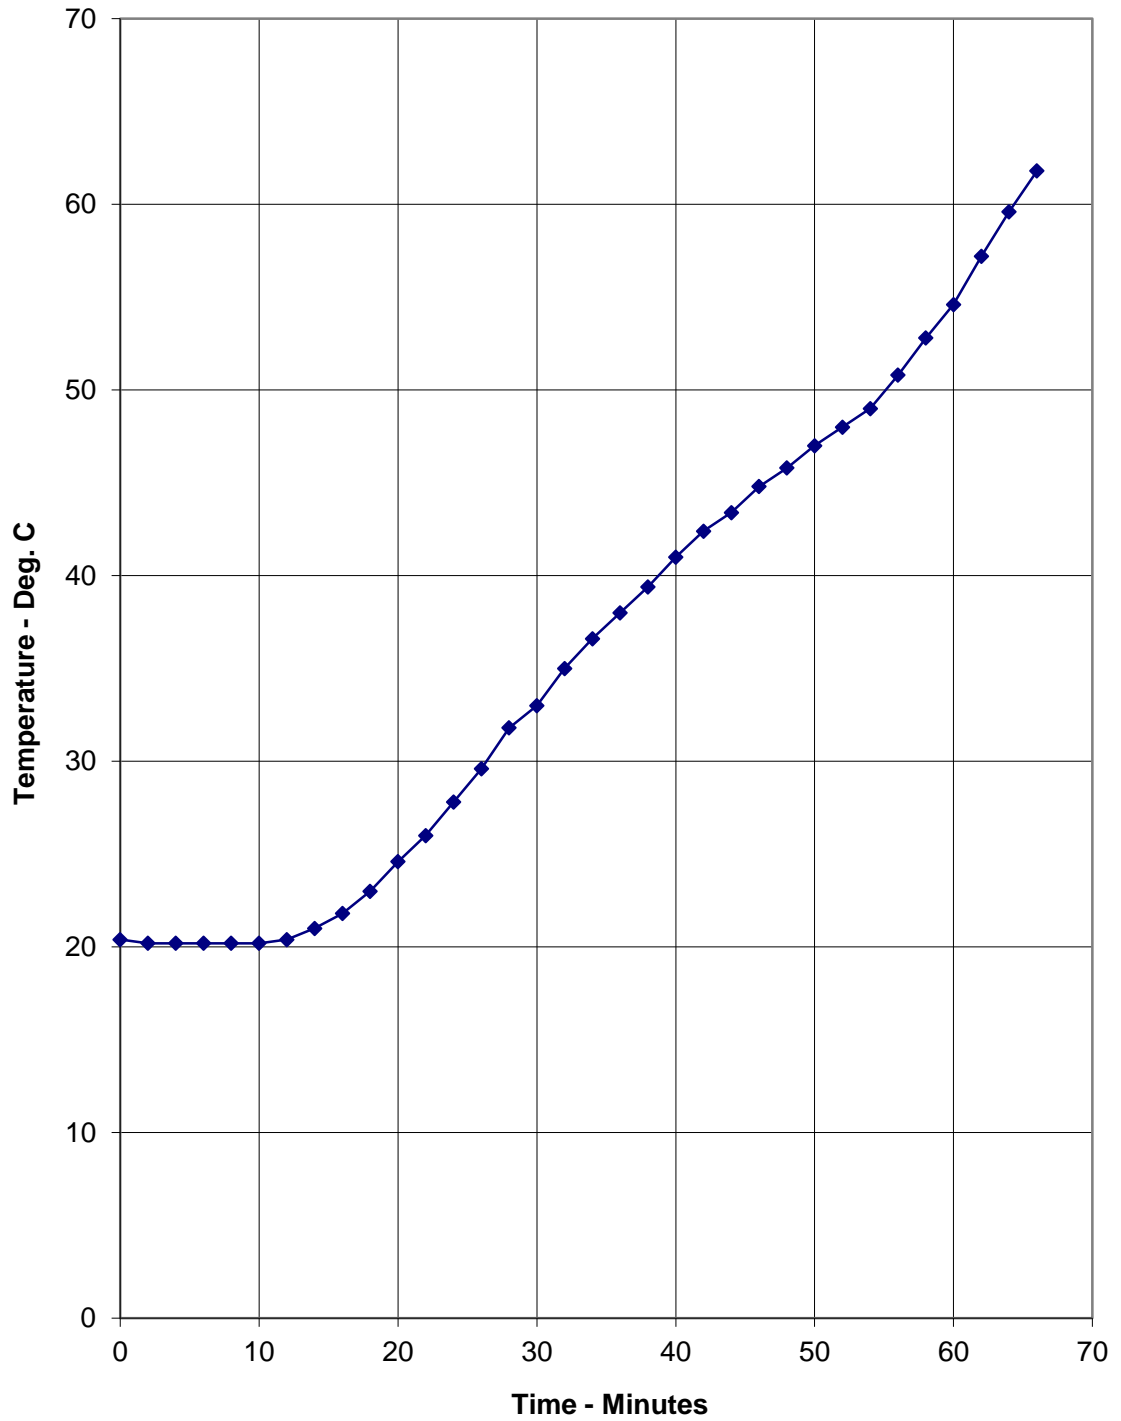
Graph showing mean unexposed surface temperature of the floor assembly

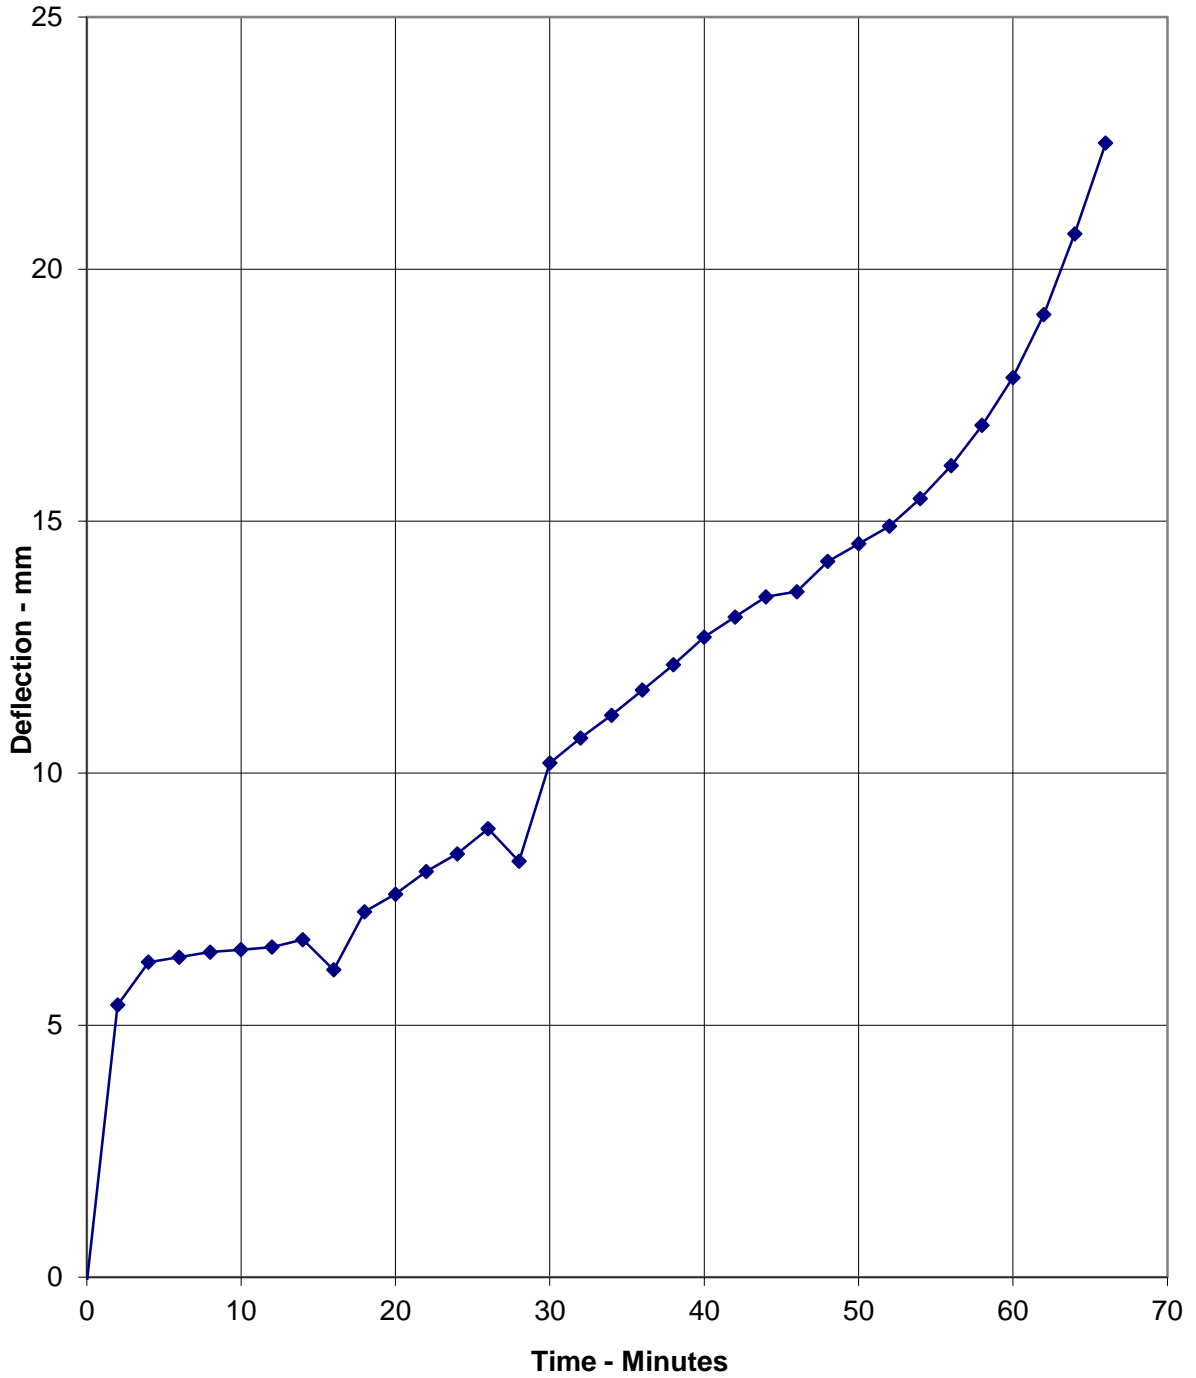
Graph showing the central vertical deflection of the floor assembly during the test

Time Mins	Central Vertical Deflection mm	Rate of Deflection mm/min
0	0	0
2	5	1
4	6	0
6	6	0
8	6	0
10	7	1
12	7	0
14	7	0
16	6	0
18	7	0
20	8	1
22	8	1
24	8	0
26	9	0
28	8	-1
30	10	0
32	11	1
34	11	0
36	12	1
38	12	0
40	13	1
42	13	0
44	14	1
46	14	0
48	14	0
50	15	1
52	15	0
54	15	0
56	16	0
58	17	0
60	18	1
62	19	0
64	21	1
66	23	2

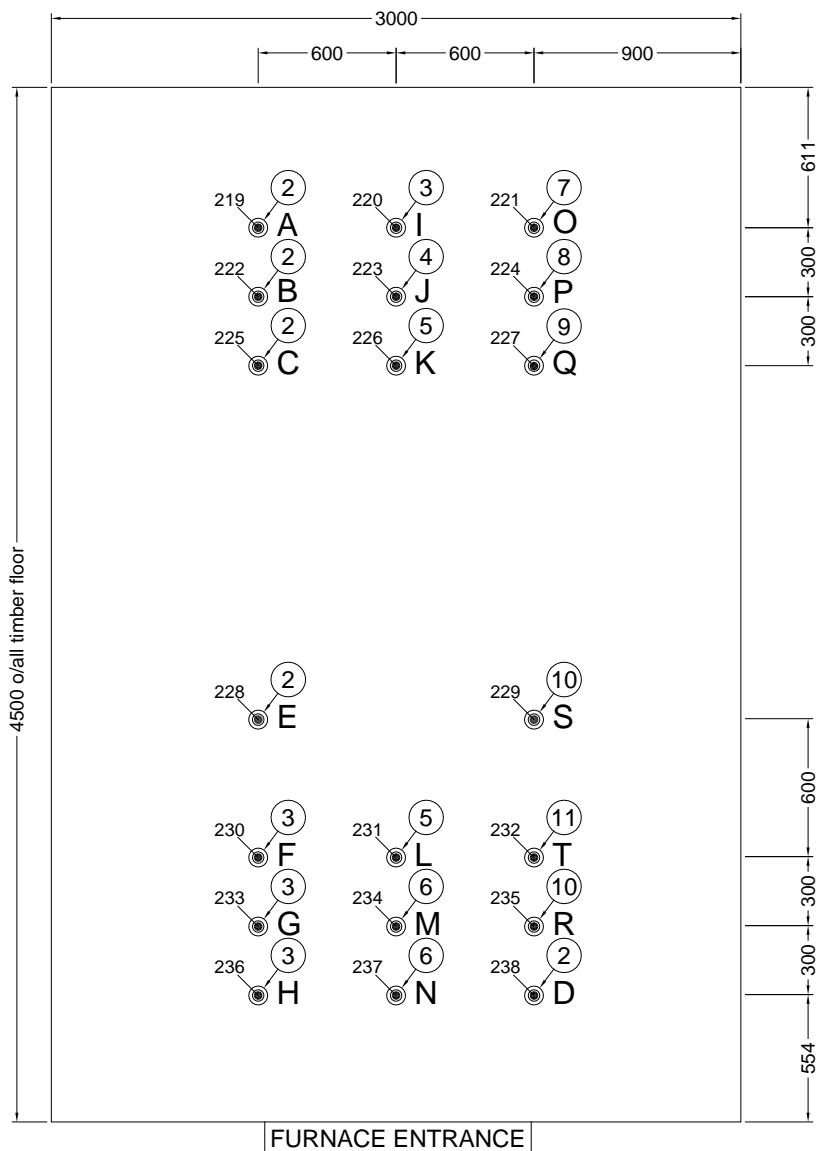
Figure 2 – Details of Downlighter Positions

**DOWNLIGHTER LAYOUT
 PLAN OF THERMOCOUPLE POSITIONS**

- Mineral insulated thermocouples at mid-cavity height

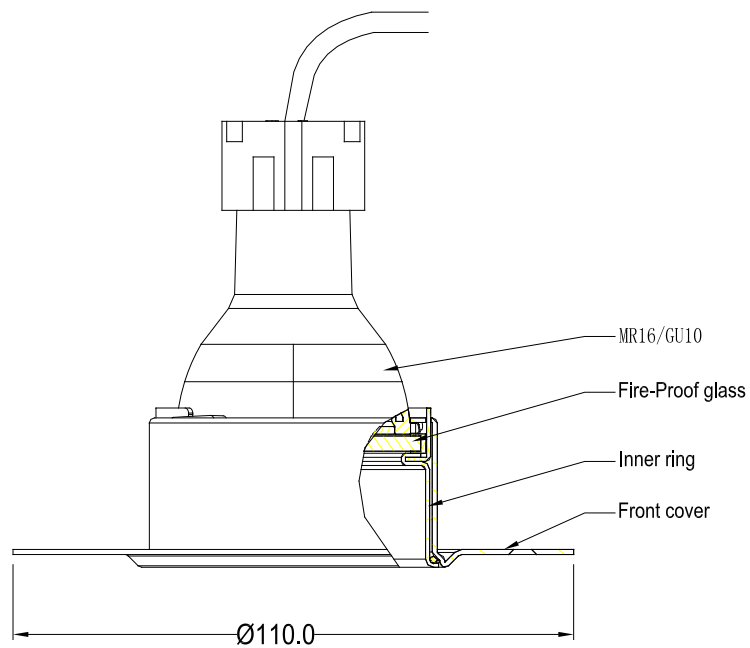
Figure 3 – Details of Downlighters Specimen A

Fixed
ILD LFR60FXXX
Cut out: $\text{Ø}60$

2. Specimens A, B, C, D, E	
Manufacturer	: Integral LED
Type	: Round, fixed, Agate LED recessed downlight
Reference	: See Figs 3 to 7.
Materials	
i. front cover	: Steel
ii. inner ring	: Steel
iii. spring	: Stainless steel
iv. diffuser	: Pyrex glass
Overall dimensions and construction	: See Figs 3 to 7.
Cut out size	: Varies see relevant figure.
Driver	: None
Lamp	: GU10/MR16

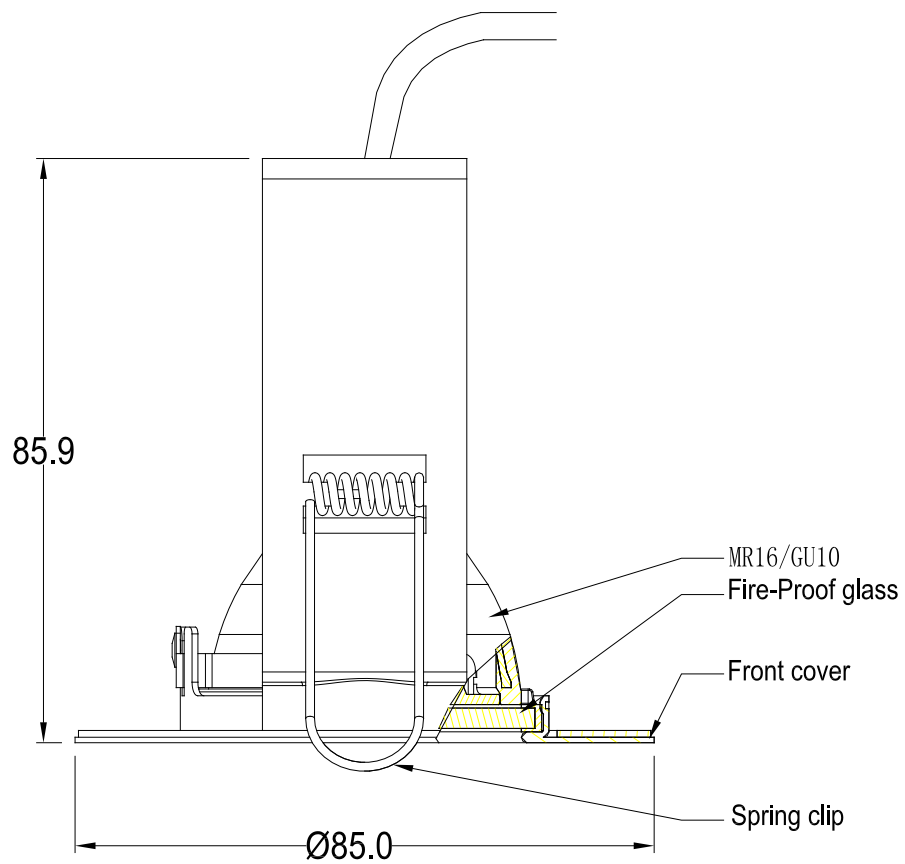
Figure 5 – Details of Downlighters Specimen C

Fixed
ILD LFR70DXXX
with bracket
Cut out: $\phi 70$

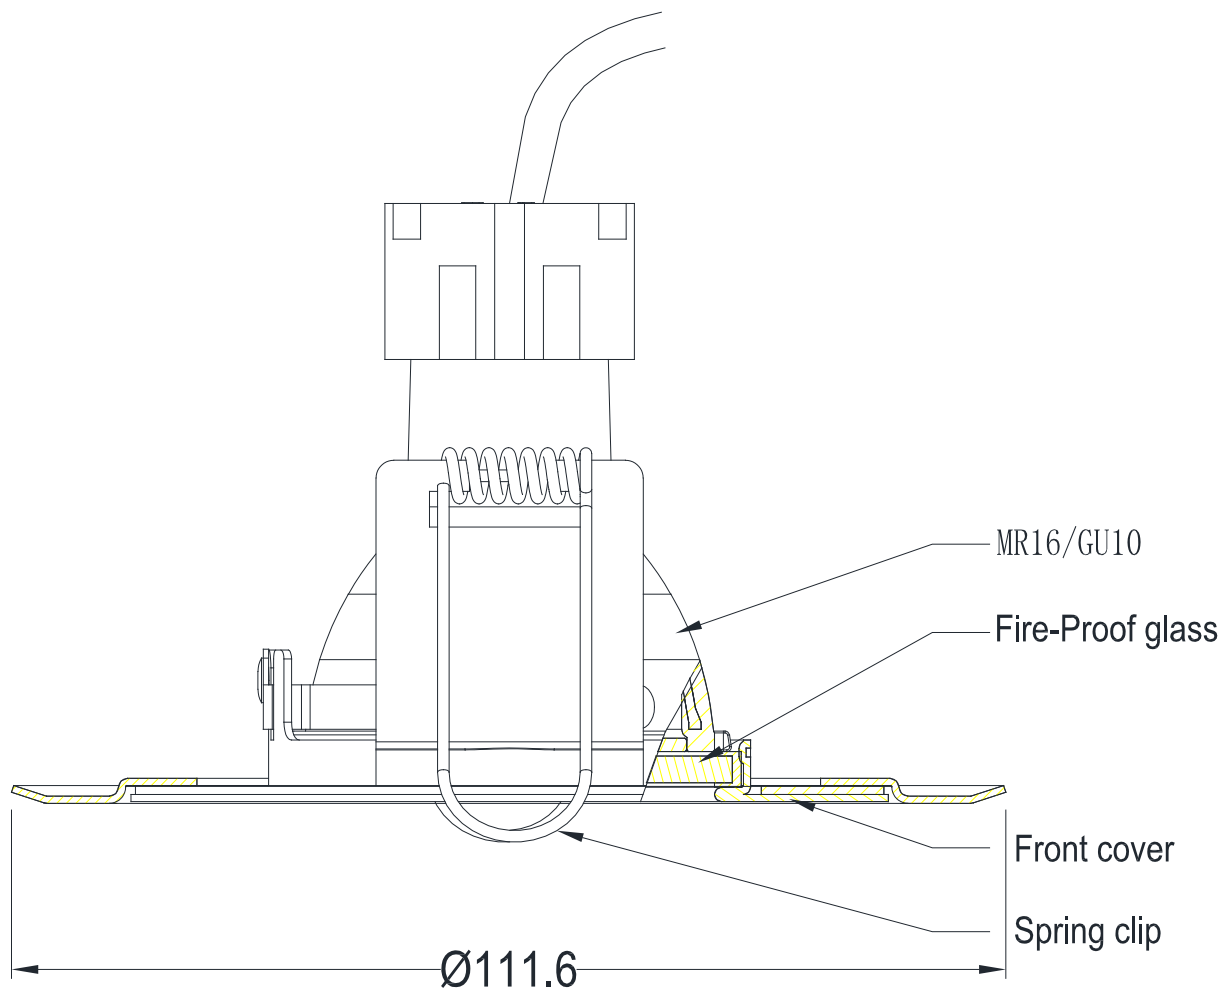
Figure 7 – Details of Downlighters Specimen E

Fixed
ILD LFR70DXXX
accessory of Slim Fire
Cut out: $\text{Ø}100\text{mm}$

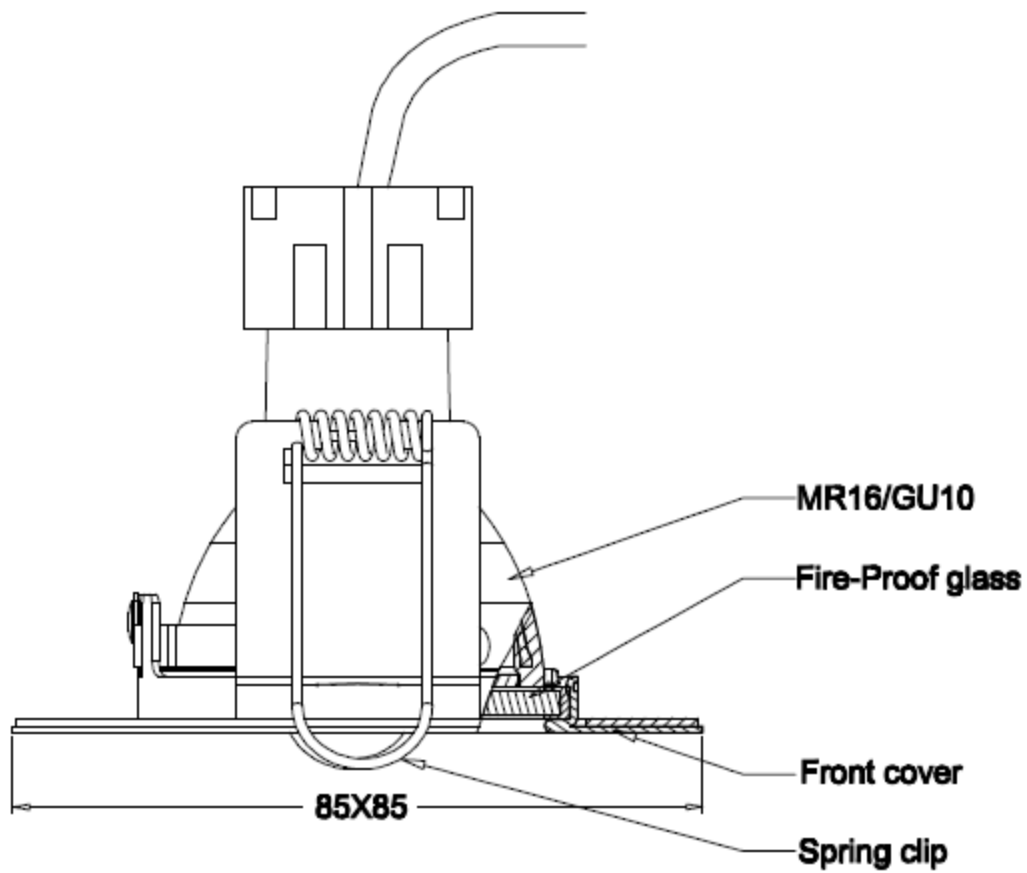
Figure 8 – Details of Downlighters Specimen F

**Fixed model
ILDLFR70DXXX
Slim fire square bezel
Cut out: Ø70mm**

<u>Item</u>	<u>Description</u>
3. Specimen F, G, H, I	
Manufacturer	: Integral LED
Type	: Square, fixed, LED recessed downlight
Reference	: See Figs 8 to 11.
Materials	
i. front cover	: Steel
ii. spring	: Stainless steel
iii. diffuser	: Pyrex glass
Overall dimensions and construction	: Please see Figs. 8 to 11
Cut out size	: Various see relevant figures
Driver	: None
Lamp	: GU10/MR16
4. Specimen J	: Specimen reported separately
5. Specimen K, L	: Specimens reported separately
6. Specimen M, N	: Specimens reported separately
7. Specimens O	: Specimen reported separately
8. Specimens P	: Specimen reported separately
9. Specimen Q	: Specimen reported separately
10. Specimens R, S	: Specimens reported separately
11. Specimen T	: Specimen reported separately

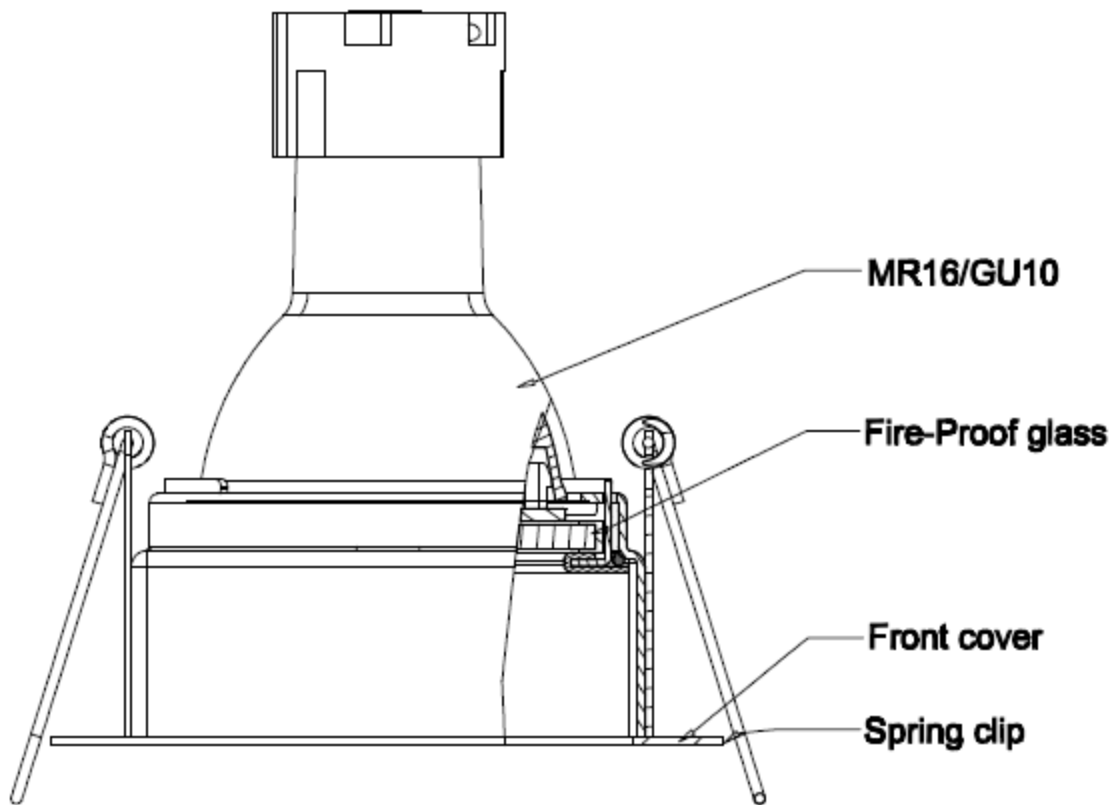
Figure 10 – Details of Downlighters Specimen H

Fixed model
ILDLFR70EXXX
Slim fire square bezel
Cut out:Ø70X70mm

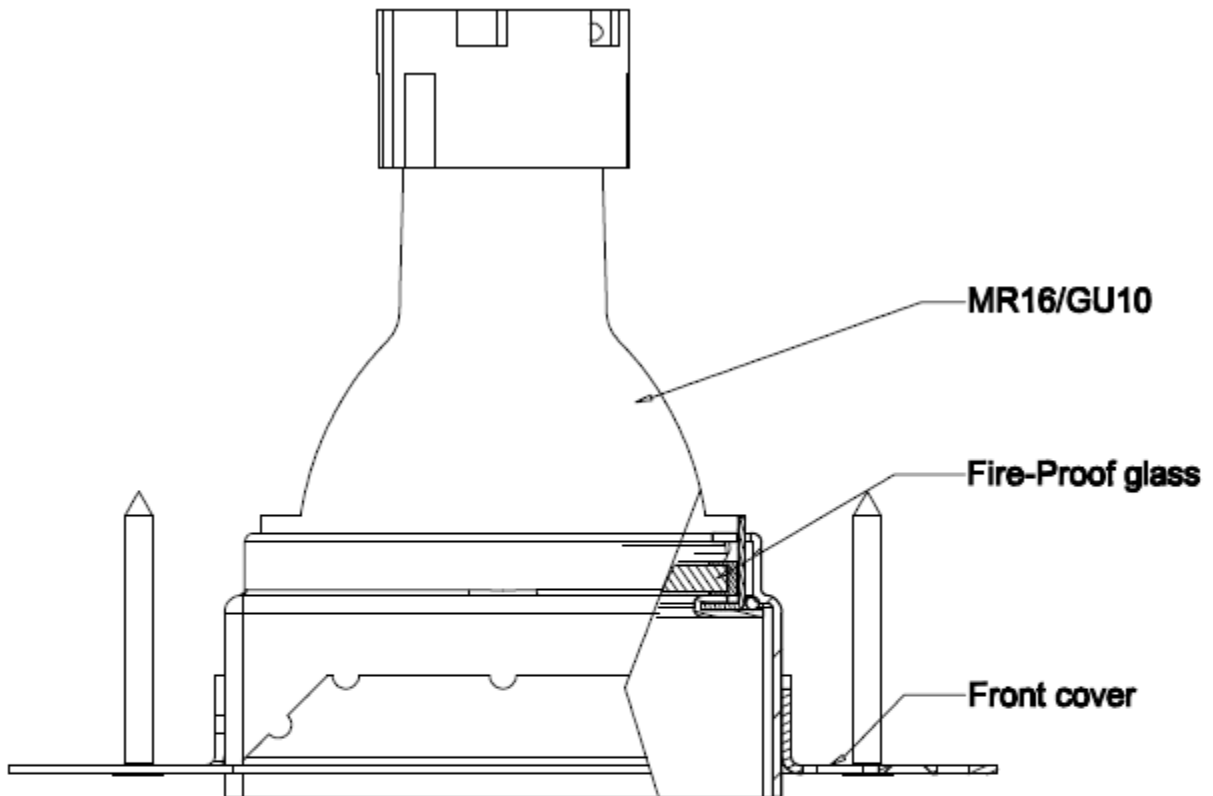
Figure 11 – Details of Downlighters Specimen I

**Fixed model
ILD LFR70FXXX
Trimless fire square bezel
Cut out: Ø70X70mm**

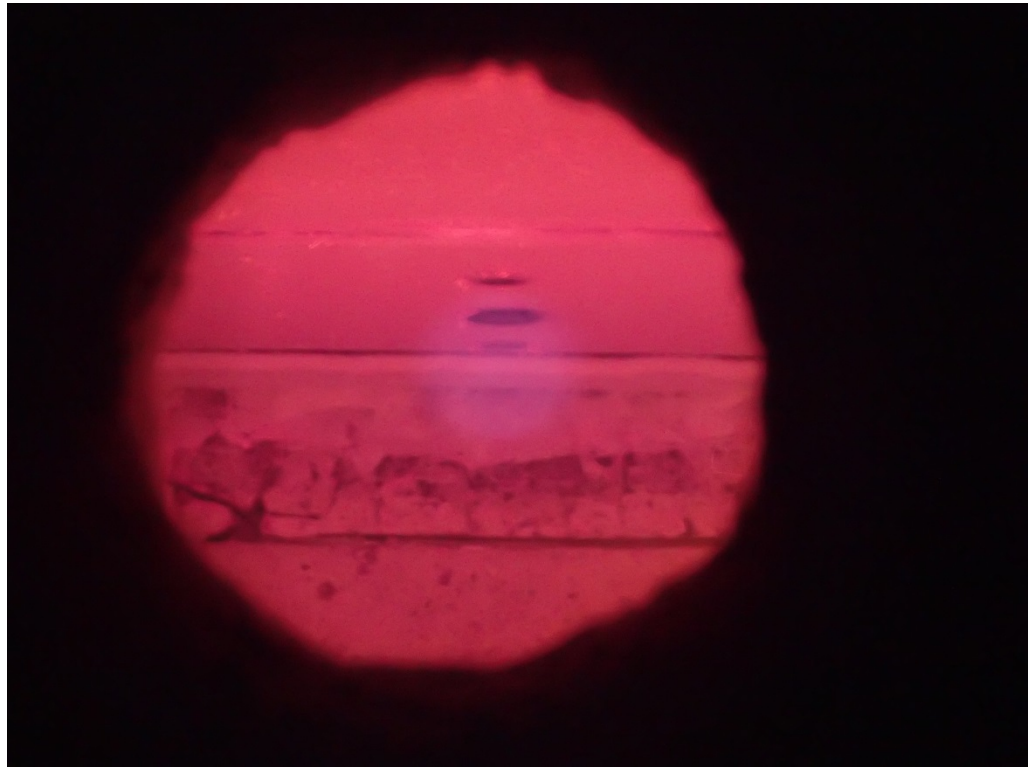
View of the exposed ceiling after a test duration of approximately 30 minutes

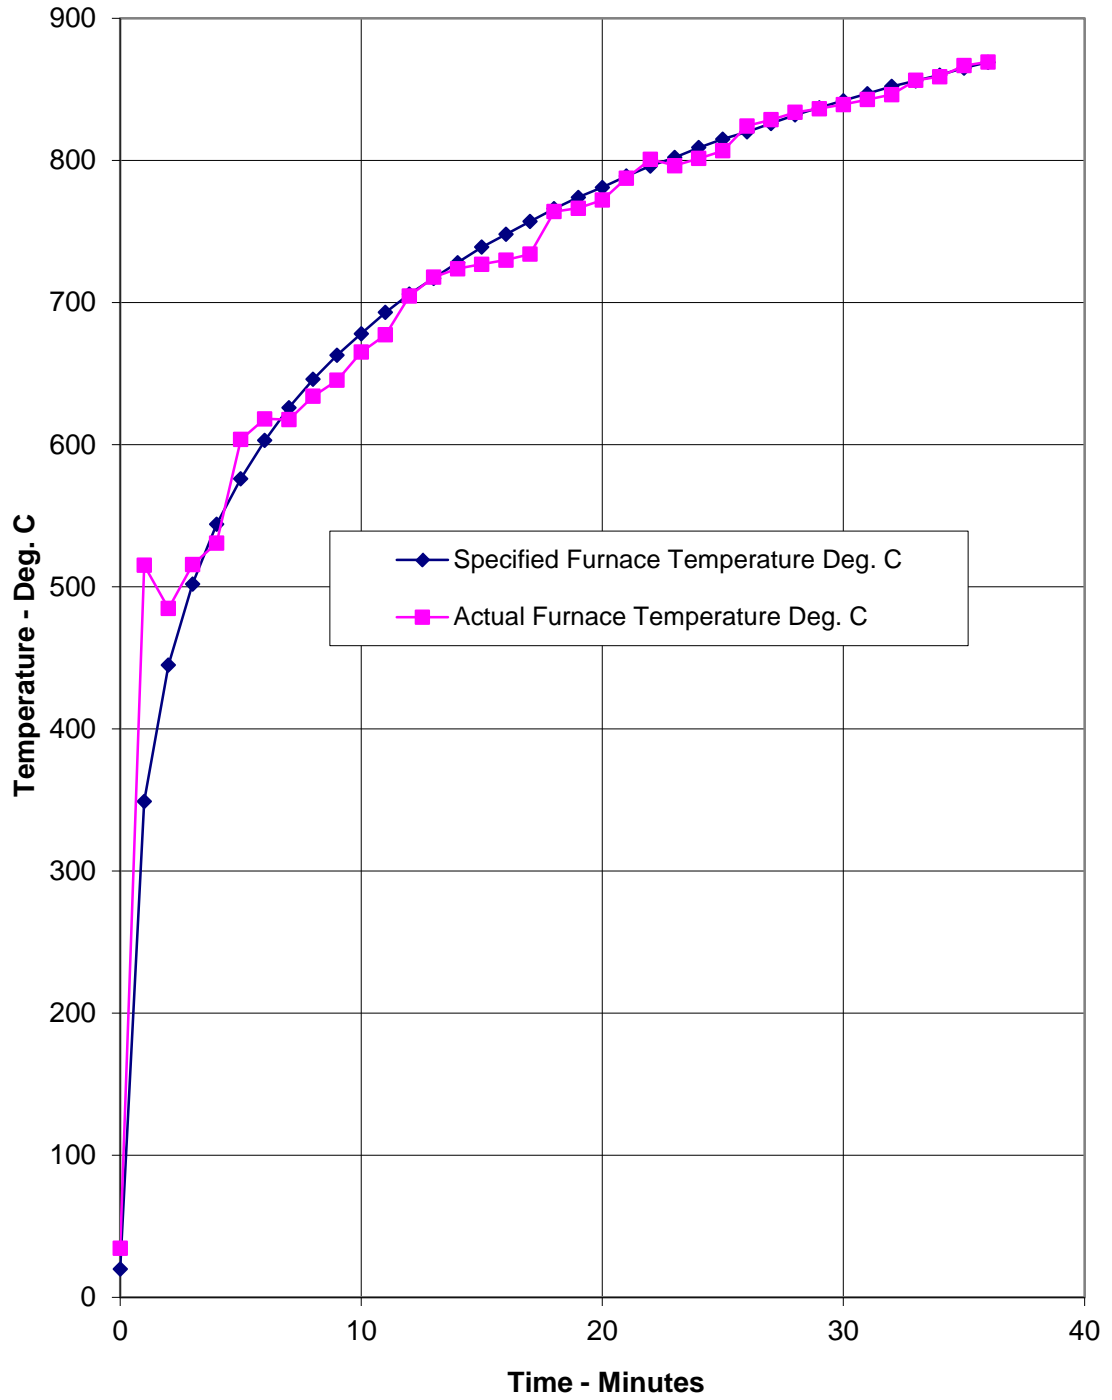
Graph showing specified and actual furnace temperatures

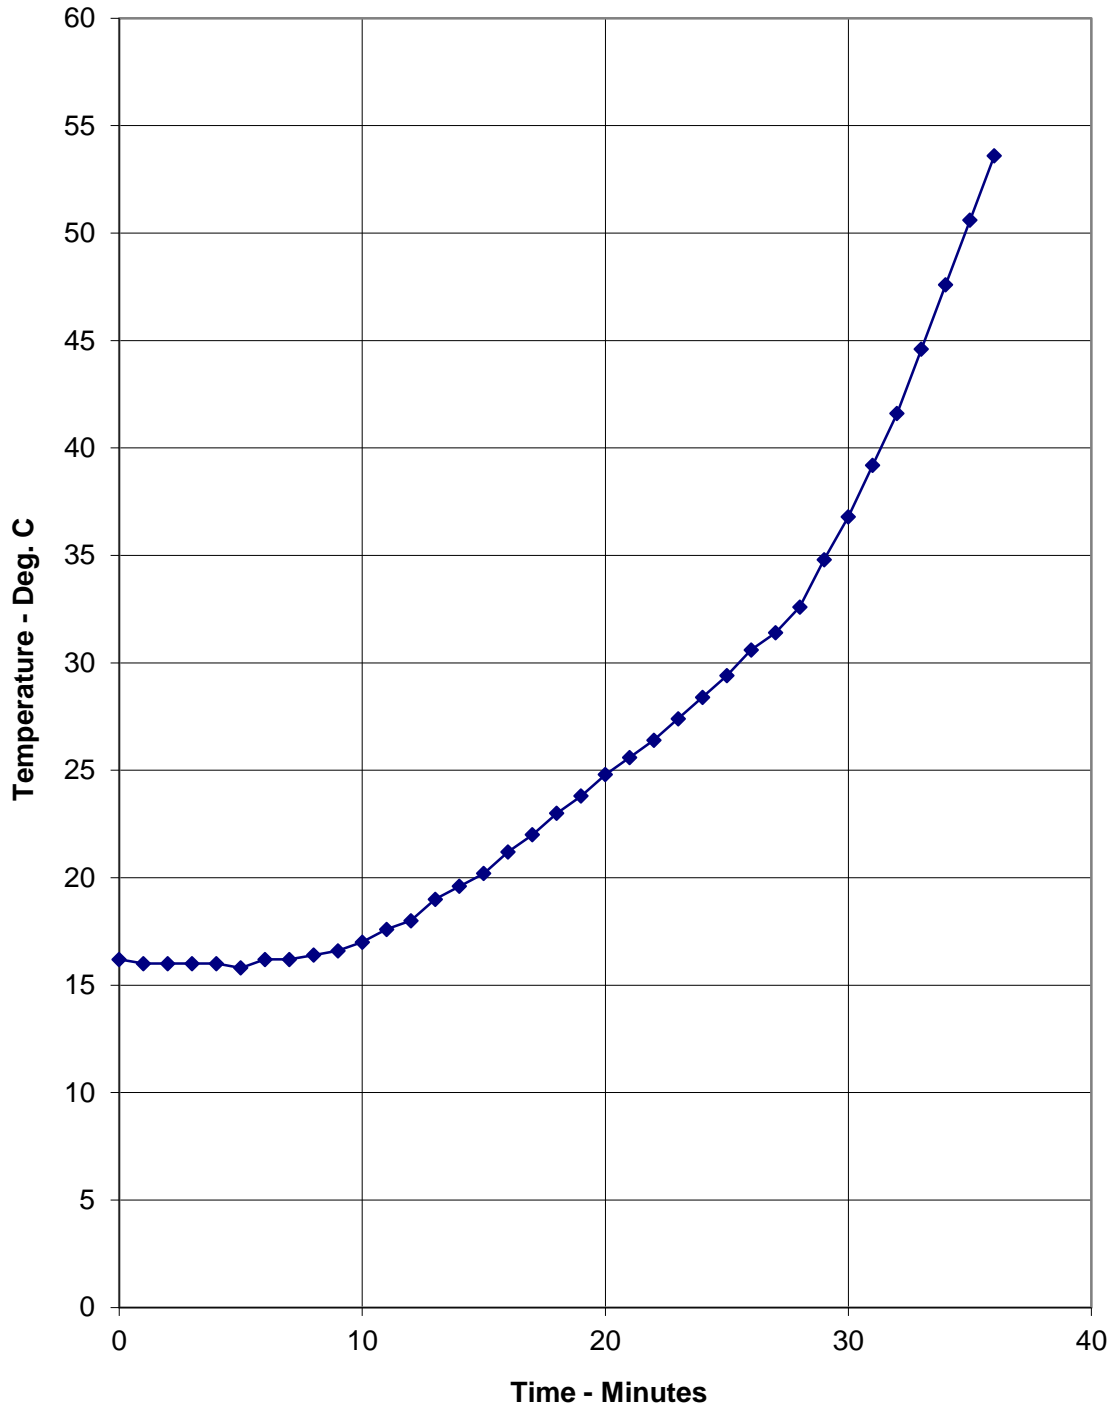
Graph showing mean unexposed surface temperature of the floor assembly

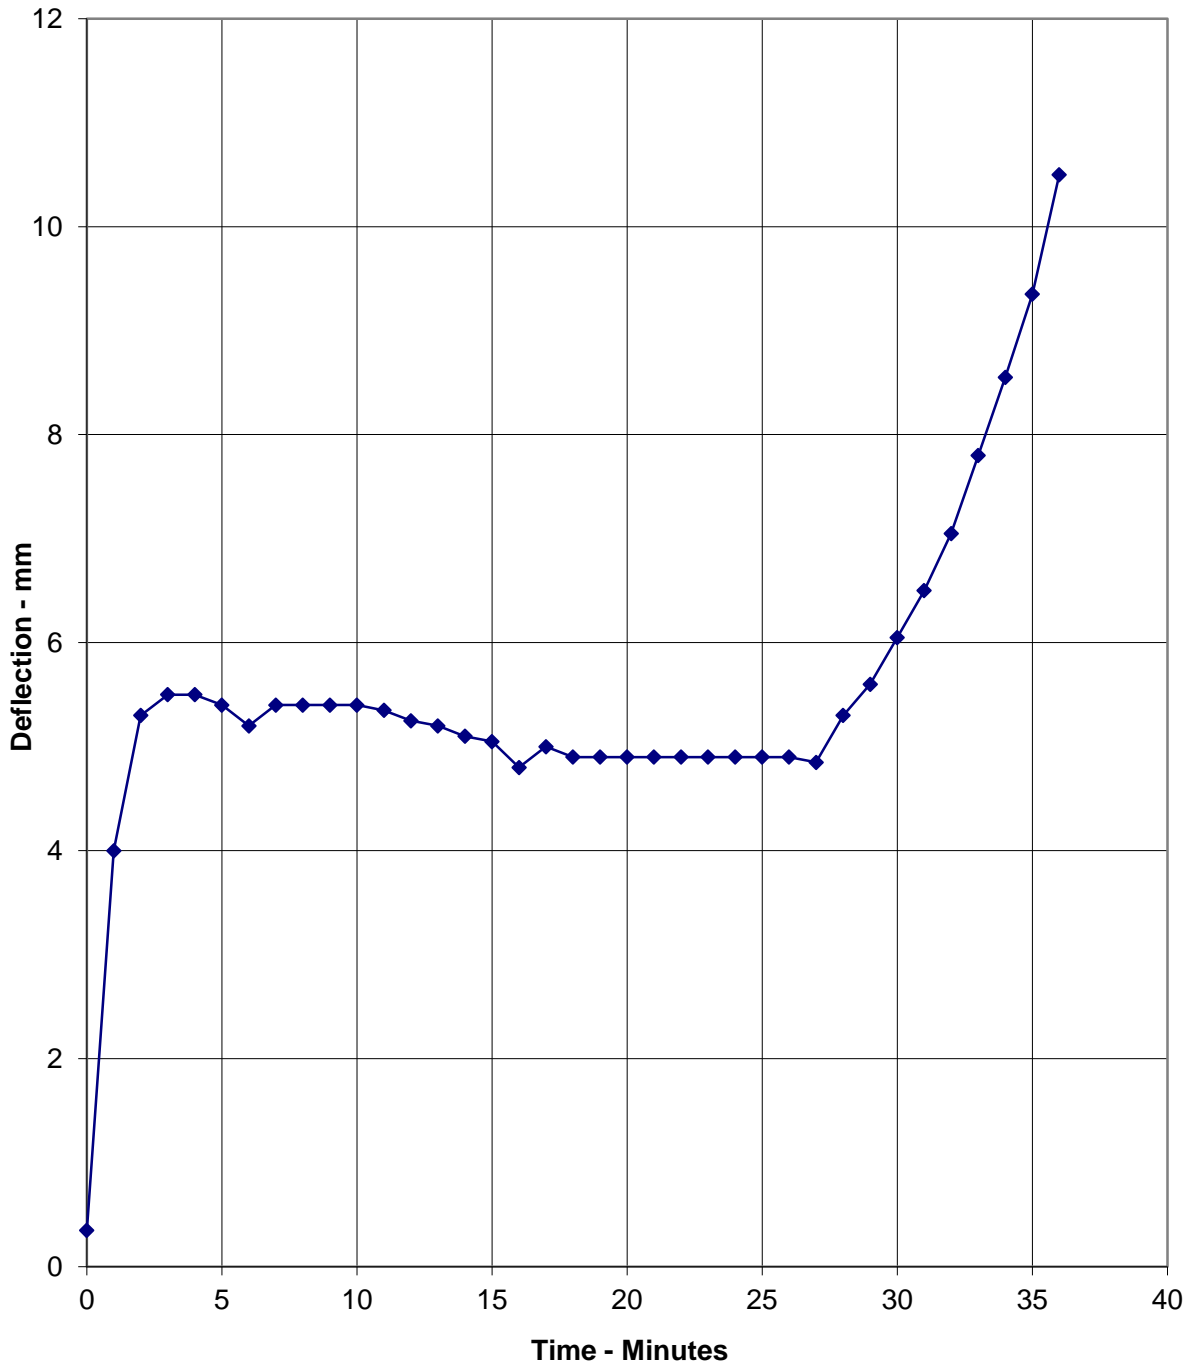
Graph showing the central vertical deflection of the floor assembly during the test

Time Minutes	Central Vertical Deflection mm	Rate of Deflection mm/min
0	0	0
1	4	4
2	5	1
3	6	1
4	6	0
5	5	-1
6	5	0
7	5	0
8	5	0
9	5	0
10	5	0
11	5	0
12	5	0
13	5	0
14	5	0
15	5	0
16	5	0
17	5	0
18	5	0
19	5	0
20	5	0
21	5	0
22	5	0
23	5	0
24	5	0
25	5	0
26	5	0
27	5	0
28	5	0
29	6	1
30	6	0
31	7	1
32	7	0
33	8	1
34	9	1
35	9	0
36	11	2

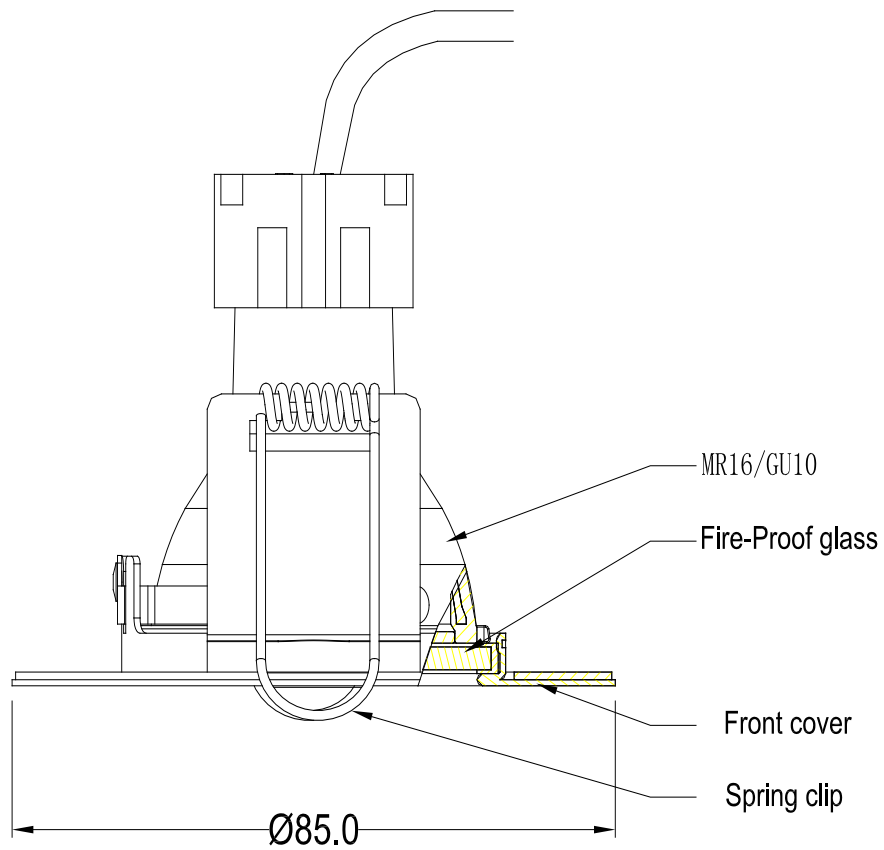
Figure 7 – Details of Downlighter Specimen G

Fixed
ILD LFR70DXXX
Cut out: $\text{Ø}70$

8. Specimen G	
Manufacturer	: Integral LED
Type	: Round, fixed, LED recessed downlight
Reference	: ILDLFR70DXXX without bracket
Materials	
i. front cover	: Steel
ii. diffuser	: Pyrex glass
iii. spring	: Stainless steel
Overall dimensions and construction	: See Figure 9 for details
Cut out size	: 70 mm
Driver	: None
Lamp	: GU10/MR16

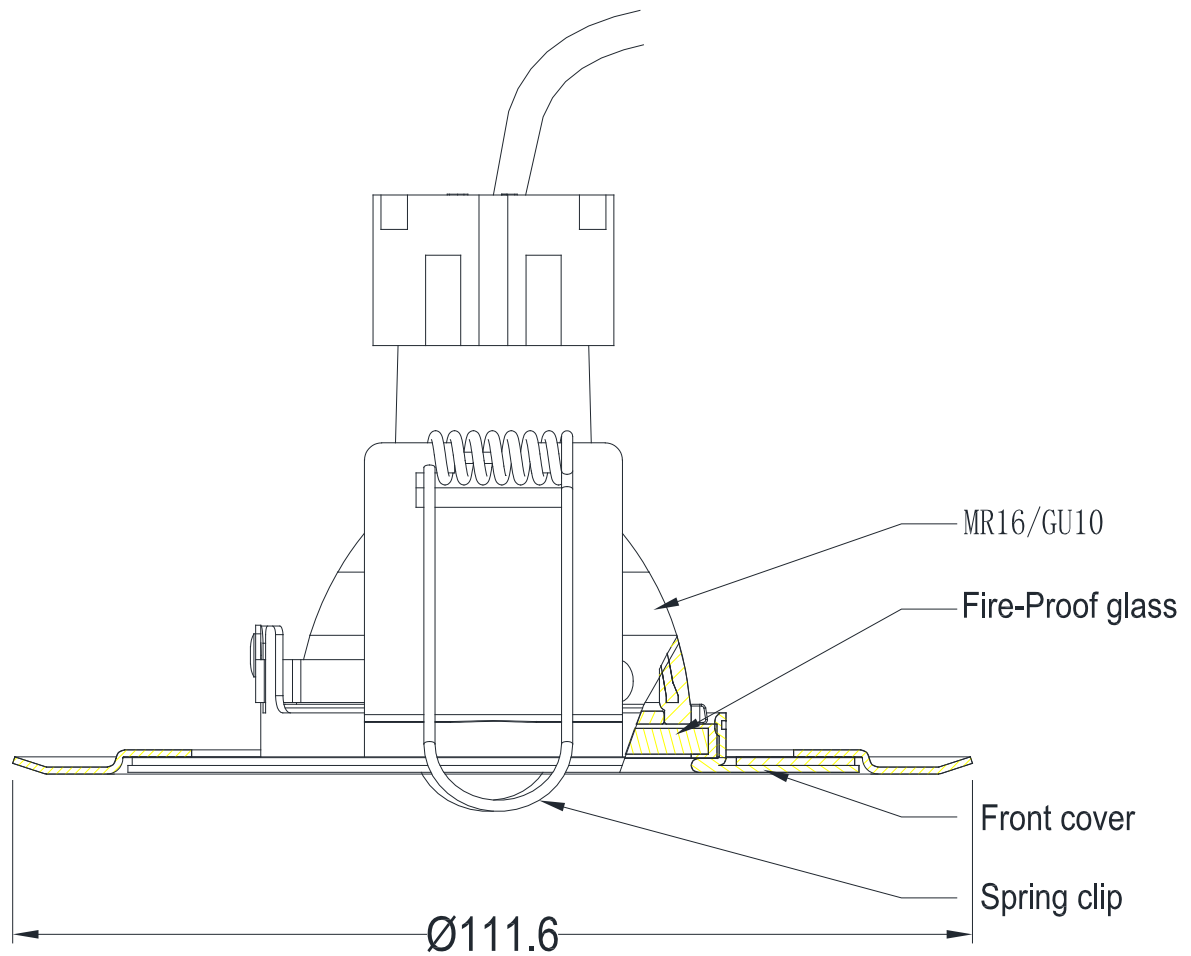
Figure 8 – Details of Downlighter Specimen I

Fixed
ILDLFR70DXXX
accessory of Slim Fire
Cut out: $\text{Ø}100\text{mm}$
