The Fire Resistance Performance of a Specimen of a Loadbearing Timber Floor Assembly Protected by a Plasterboard Ceiling Designed to Provide 60 minutes Fire Resistance, Incorporating Twenty Downlight Light Fittings, Tested in Accordance with BS 476: Part 21: 1987, Clause 7

371969B

Integral LED

19th May 2017

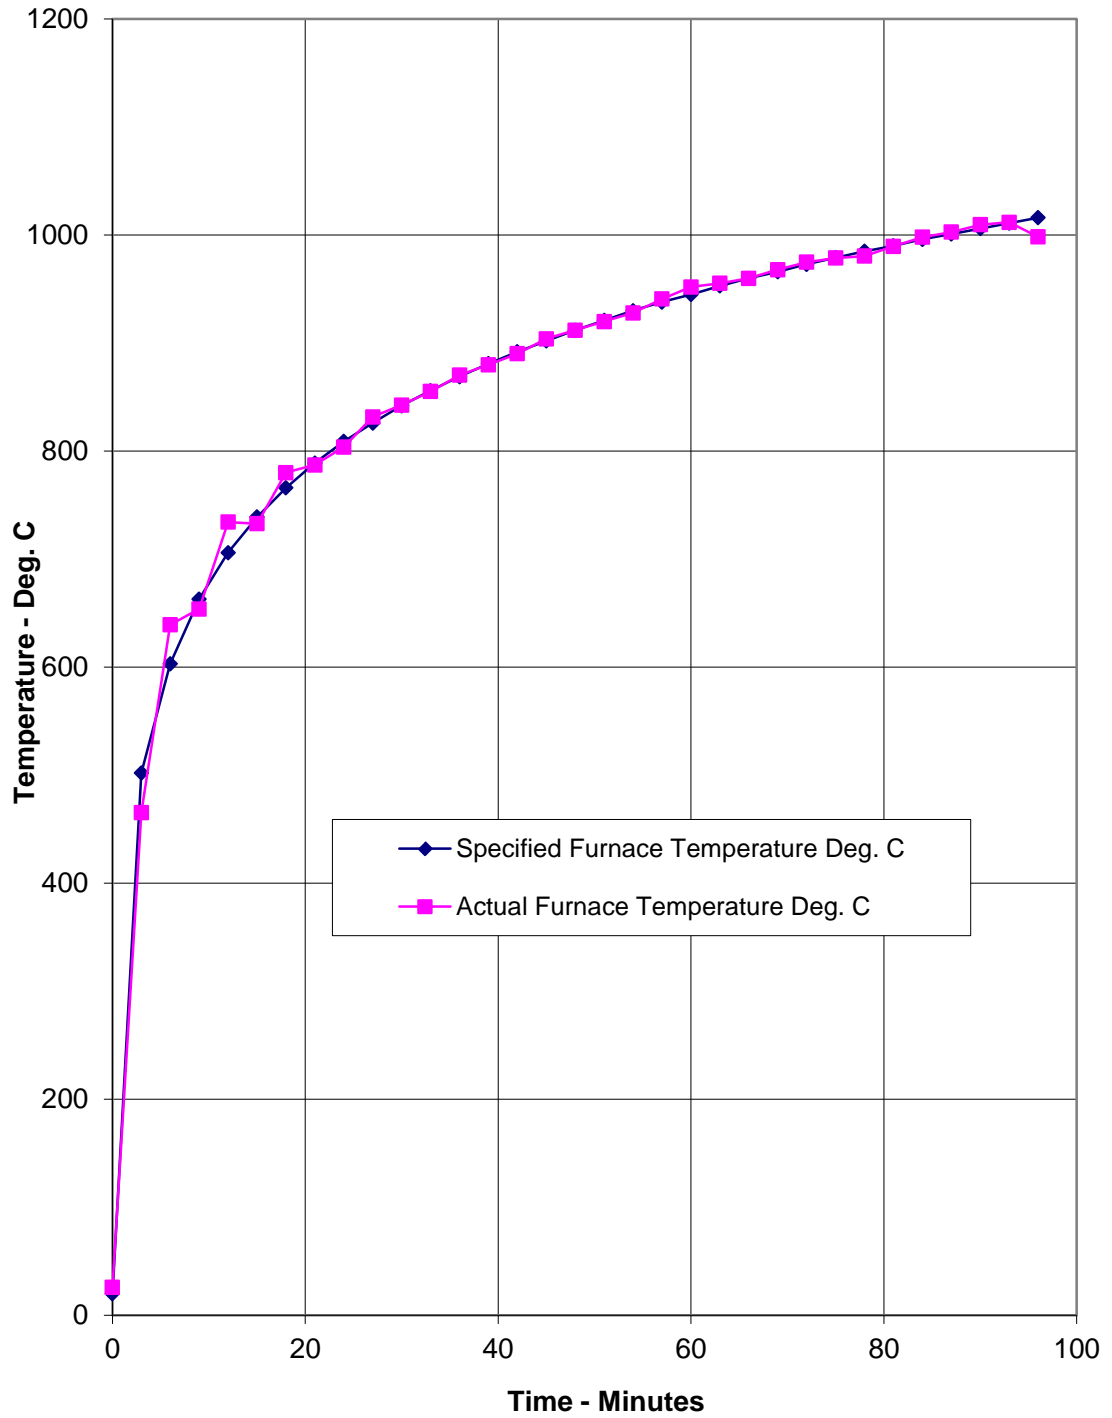
Graph showing specified and actual furnace temperatures

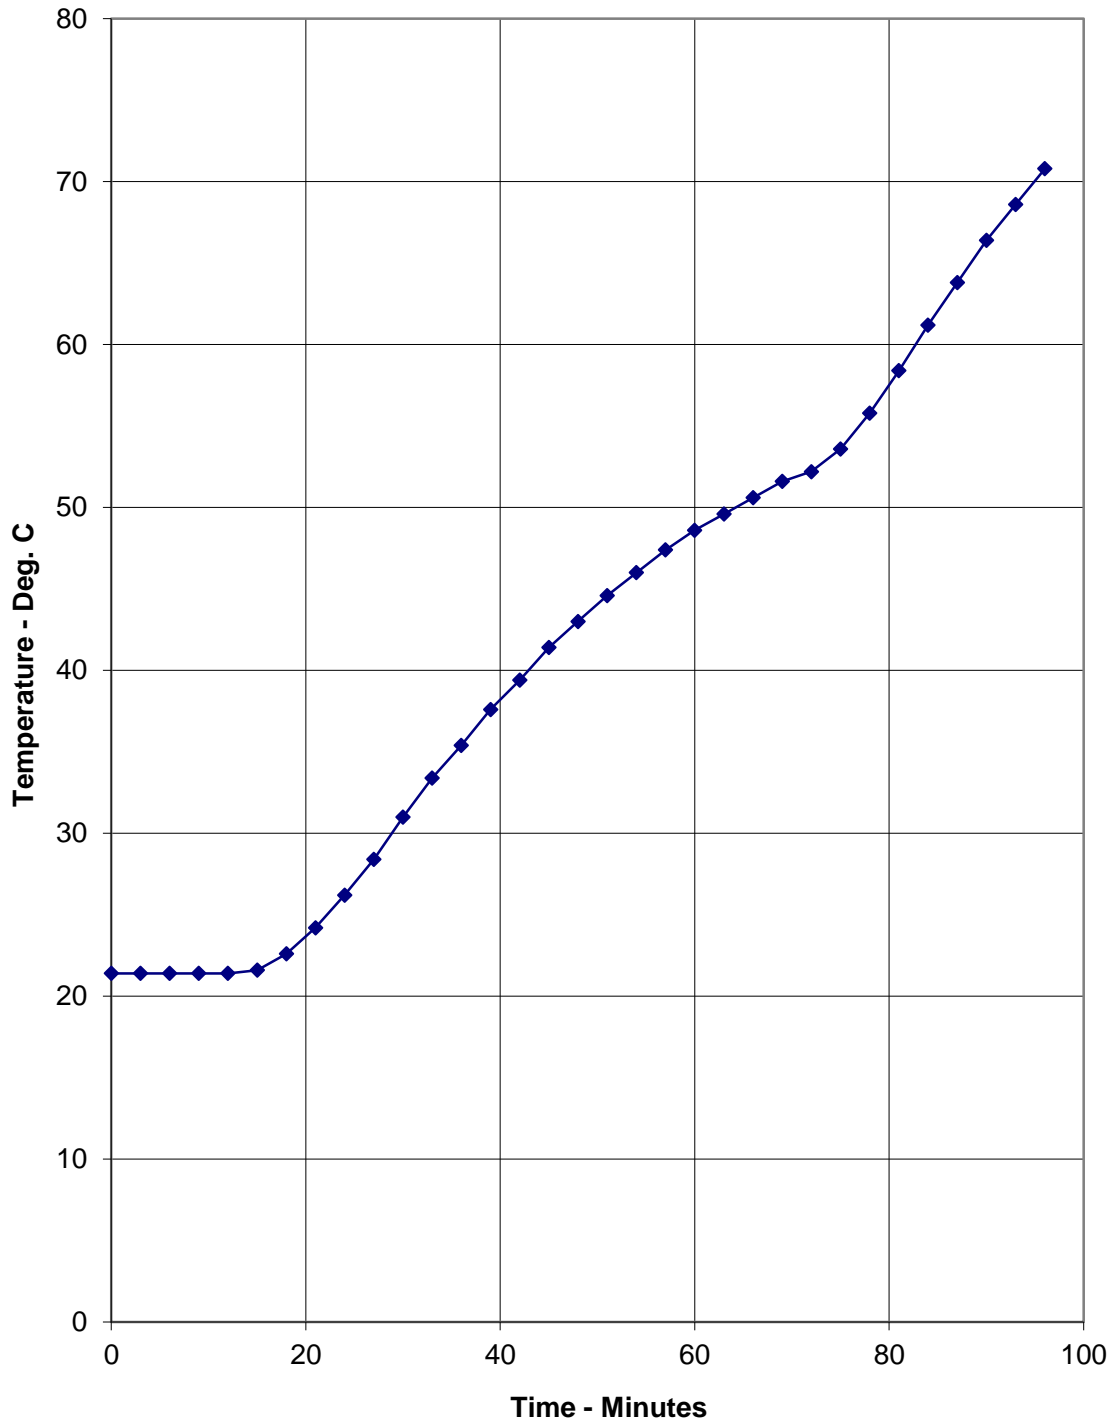
Graph showing mean unexposed surface temperature of the floor assembly

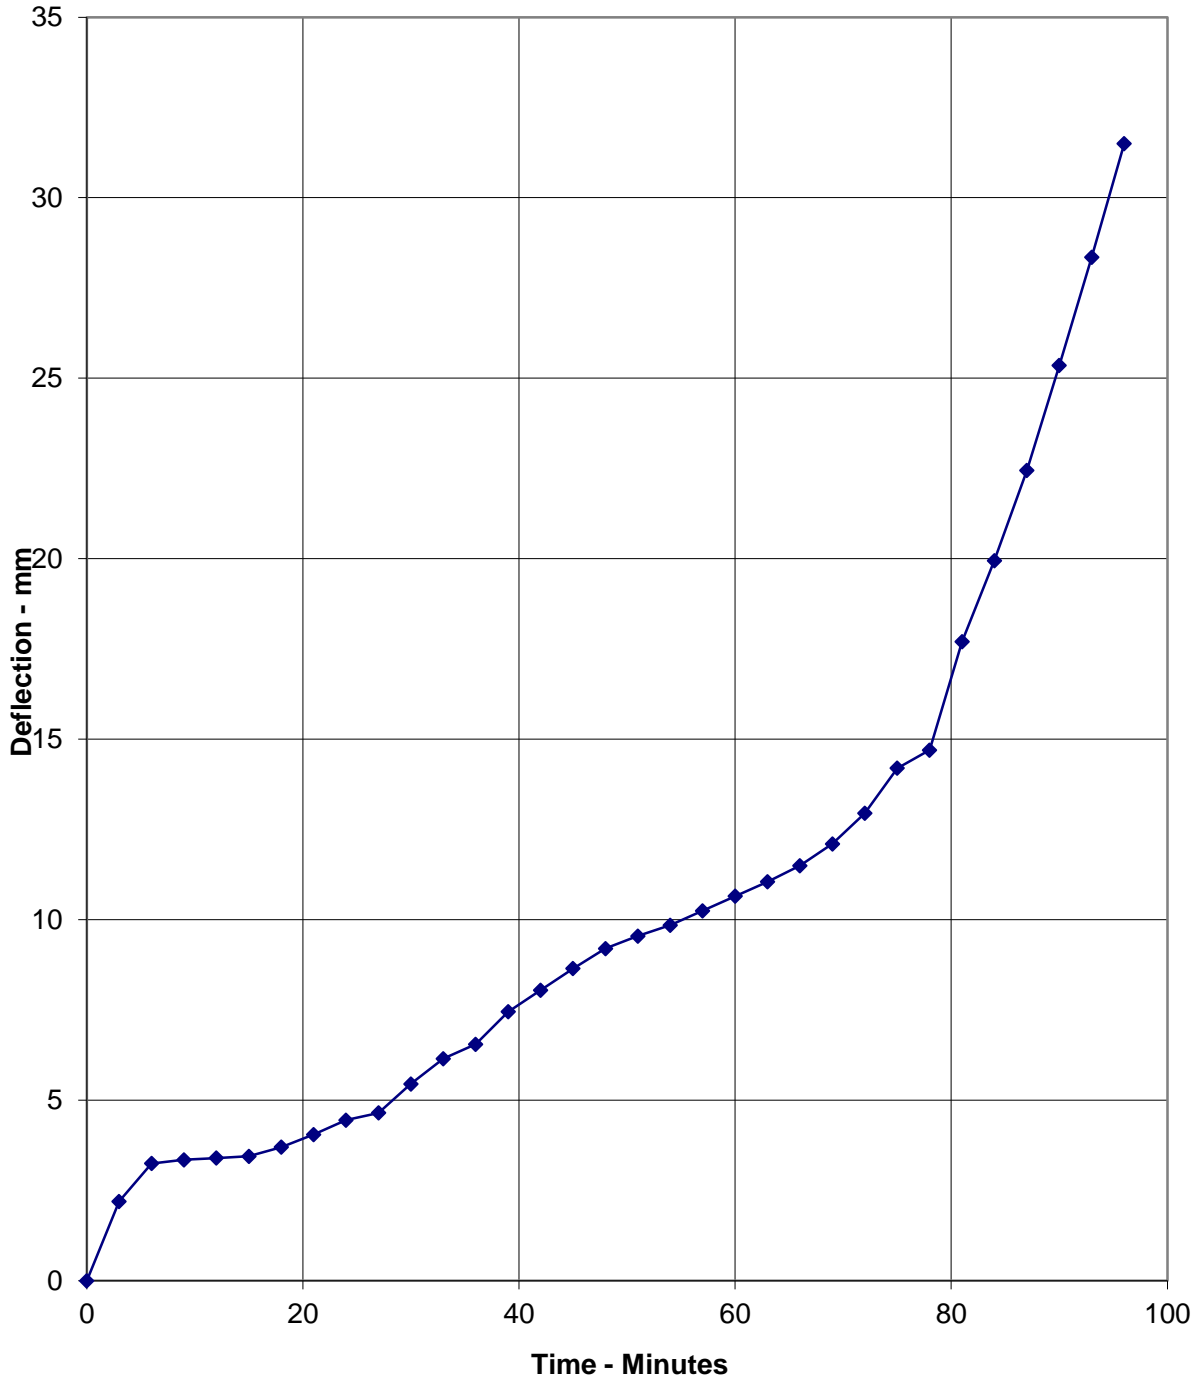
Graph showing the central vertical deflection of the floor assembly during the test

Time Mins	Central Vertical Deflection mm	Rate of Deflection mm/min
0	0	0
3	2	0
6	3	0
9	3	0
12	3	0
15	3	0
18	4	0
21	4	0
24	4	0
27	5	0
30	5	0
33	6	0
36	7	0
39	7	0
42	8	0
45	9	0
48	9	0
51	10	1
54	10	0
57	10	0
60	11	0
63	11	0
66	12	1
69	12	0
72	13	0
75	14	0
78	15	0
81	18	1
84	20	1
87	22	1
90	25	1
93	28	1
96	32	2
