The Fire Resistance Performance of a Specimen of a Loadbearing Timber Floor Assembly Protected by a Plasterboard Ceiling Designed to Provide 60 minutes Fire Resistance, Incorporating Twenty Downlight Light Fittings, Tested in Accordance with BS 476: Part 21: 1987, Clause 7

371969B

**Integral LED**

19<sup>th</sup> May 2017

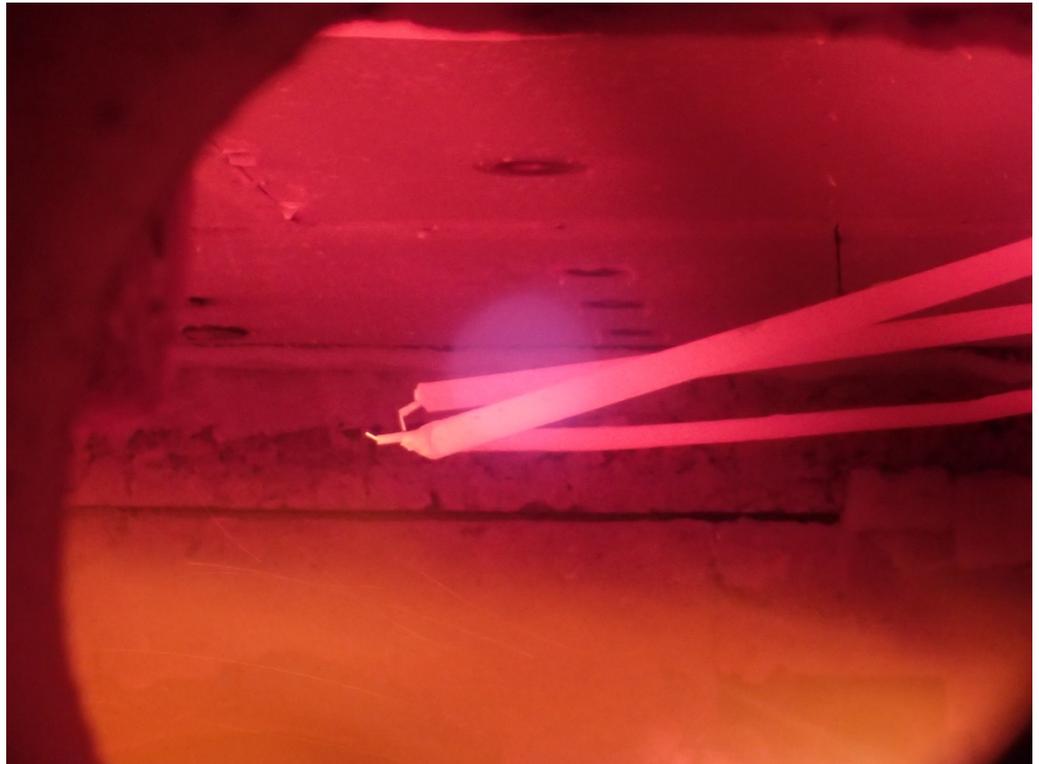
The exposed ceiling assembly after a test duration of approximately 40 minutes

<b>45</b>	<b>00</b>	Small section of the ceiling is falling away on the exposed face.
<b>48</b>	<b>00</b>	No visible significant changes to the unexposed surface of the specimen.
<b>55</b>	<b>00</b>	The gaps between the joints in the ceiling are widening on the exposed face.
<b>60</b>	<b>00</b>	The test specimen is maintaining its loadbearing capacity, integrity, and insulation.
<b>66</b>	<b>00</b>	The test specimen is maintaining its loadbearing capacity, integrity, and insulation. The test is discontinued.

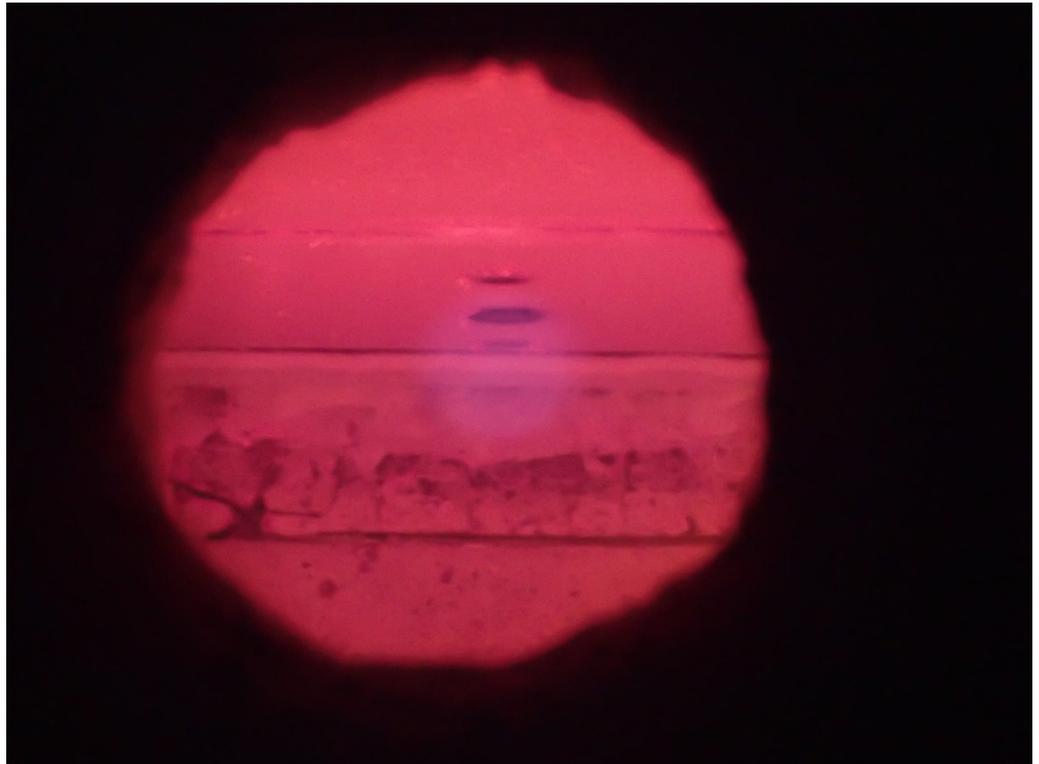
View of the exposed ceiling after a test duration of approximately 30 minutes
