The Fire Resistance Performance of a Specimen of a Loadbearing Timber Floor Assembly Protected by a Plasterboard Ceiling Designed to Provide 60 minutes Fire Resistance, Incorporating Twenty Downlight Light Fittings, Tested in Accordance with BS 476: Part 21: 1987, Clause 7

371969B

Integral LED

Objective To determine the fire resistance performance of a loadbearing timber floor assembly protected by a plasterboard ceiling designed to provide 60 minutes fire resistance, incorporating twenty downlight light fittings, when tested in accordance with Clause 7 of BS 476: Part 21: 1987.

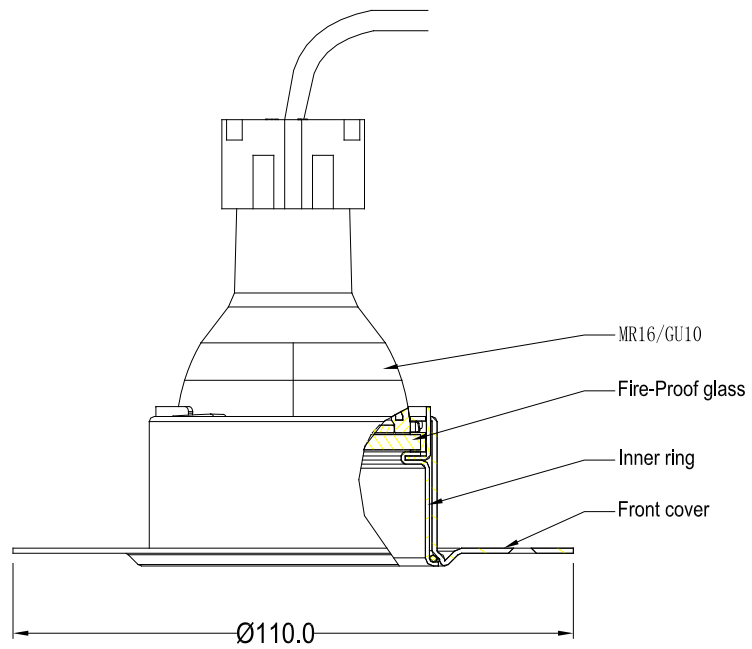
Figure 3 – Details of Downlighter Specimen A

Fixed
ILD LFR60FXXX
Cut out: $\text{Ø}60$

2. Specimens A, B, C, D, E	
Manufacturer	: Integral LED
Type	: Round, fixed, Agate LED recessed downlight
Reference	: See Figures 3 to 7.
Materials	
i. front cover	: Steel
ii. inner ring	: Steel
iii. spring	: Stainless steel
iv. diffuser	: Pyrex glass
Overall dimensions and construction	: See Figures 3 to 7.
Cut out size	: Varies see relevant figure.
Driver	: None
Lamp	: GU10/MR16

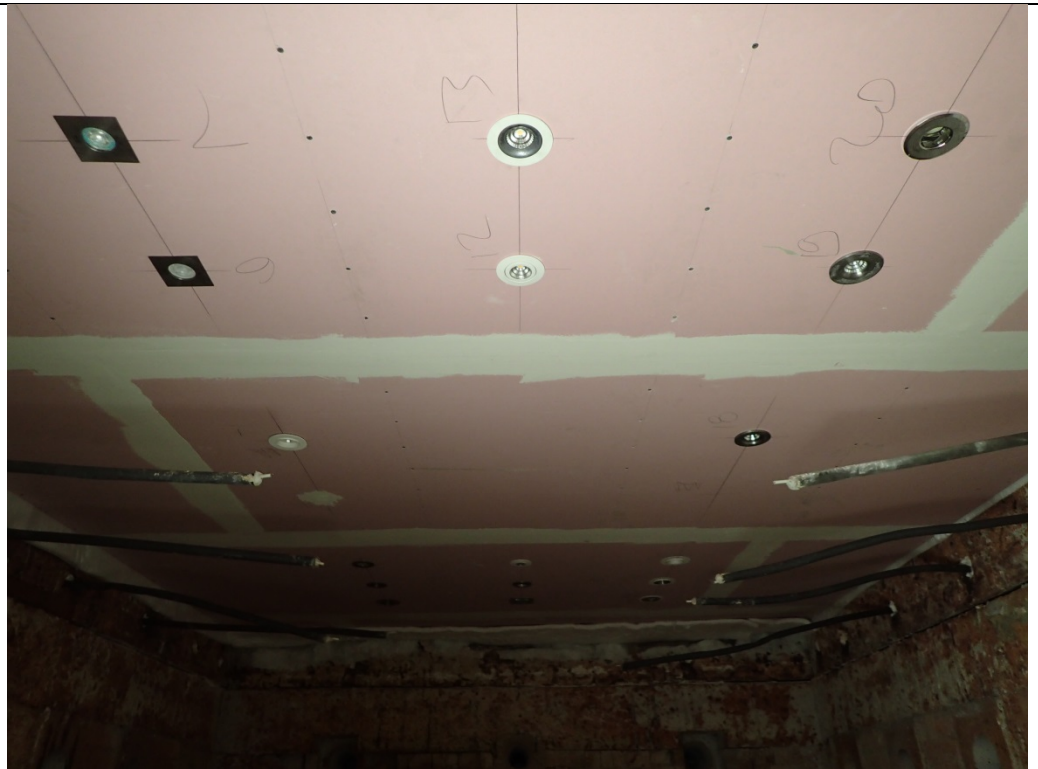
The exposed face of the assembly prior to testing

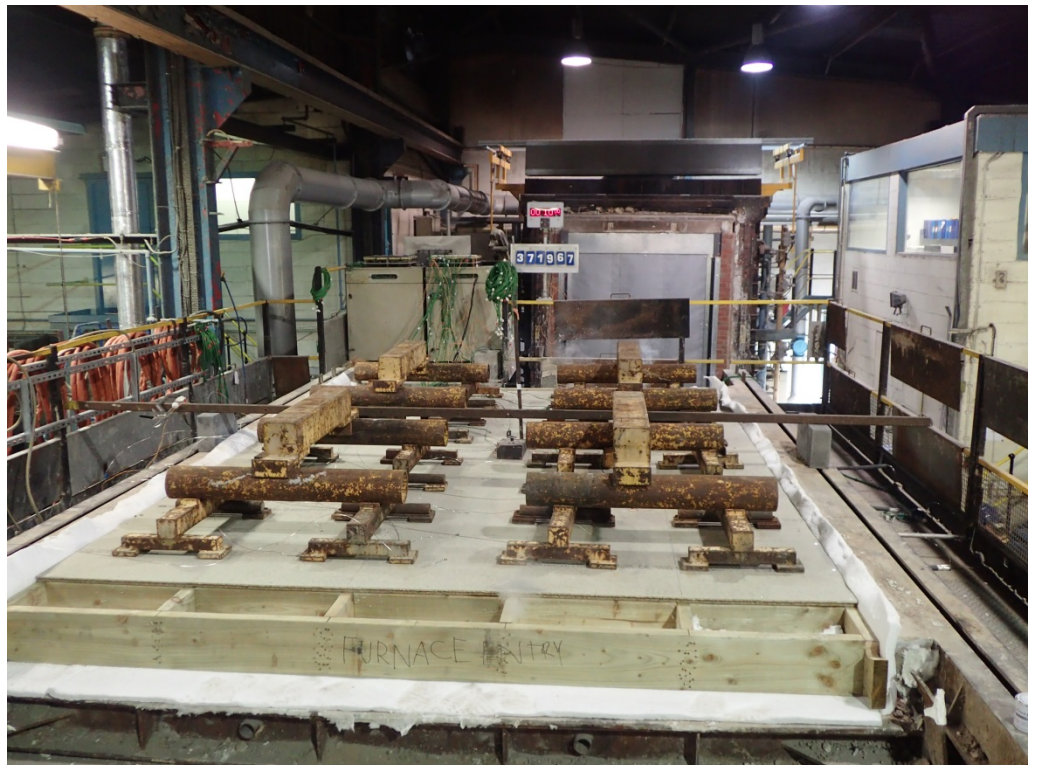
The unexposed face of the assembly after 10 minutes of testing

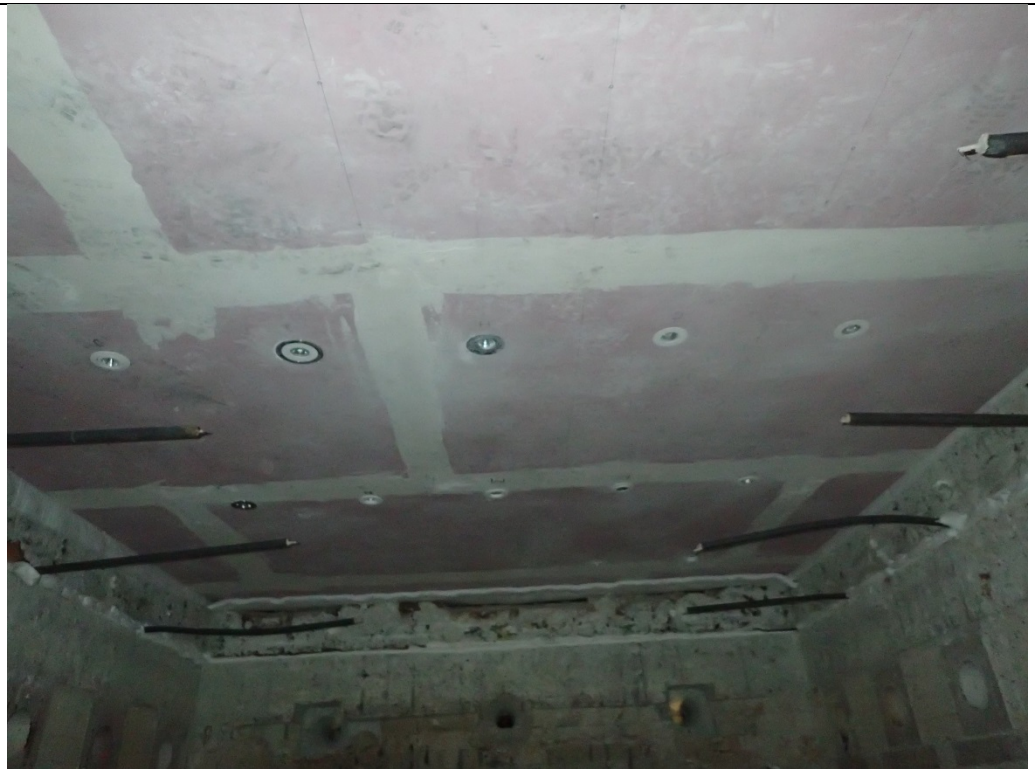
The exposed face of the assembly prior to testing
