The Fire Resistance Performance of a Specimen of a Loadbearing Timber Floor Assembly Protected by a Plasterboard Ceiling Designed to Provide 60 minutes Fire Resistance, Incorporating Twenty Downlight Light Fittings, Tested in Accordance with BS 476: Part 21: 1987, Clause 7

371969B

371967B

370975B

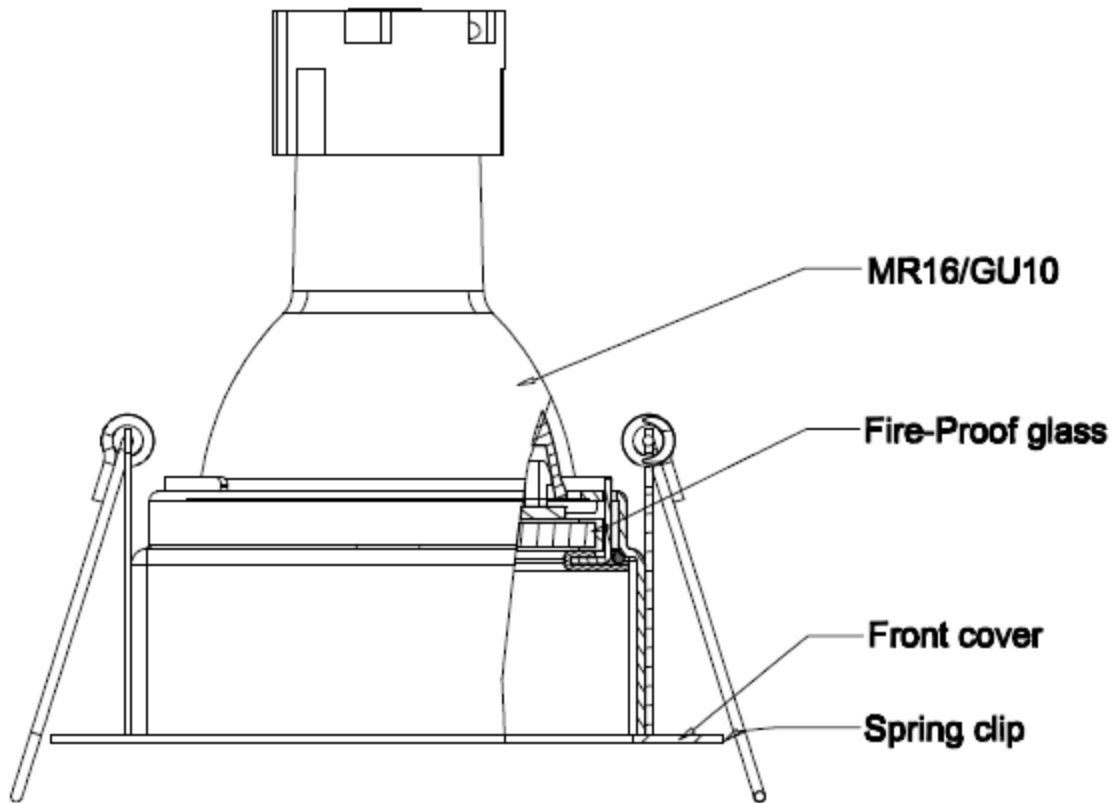
Figure 10 – Details of Downlighters Specimen H

Fixed model
ILDLFR70EXXX
Slim fire square bezel
Cut out:Ø70X70mm

<u>Item</u>	<u>Description</u>
3. Specimen F, G, H, I	
Manufacturer	: Integral LED
Type	: Square, fixed, LED recessed downlight
Reference	: See Figs 8 to 11.
Materials	
i. front cover	: Steel
ii. spring	: Stainless steel
iii. diffuser	: Pyrex glass
Overall dimensions and construction	: Please see Figs. 8 to 11
Cut out size	: Various see relevant figures
Driver	: None
Lamp	: GU10/MR16
4. Specimen J	: Specimen reported separately
5. Specimen K, L	: Specimens reported separately
6. Specimen M, N	: Specimens reported separately
7. Specimens O	: Specimen reported separately
8. Specimens P	: Specimen reported separately
9. Specimen Q	: Specimen reported separately
10. Specimens R, S	: Specimens reported separately
11. Specimen T	: Specimen reported separately
